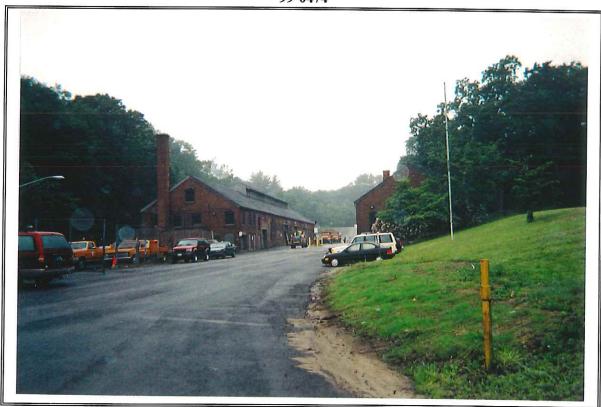
Photograph 1 View of the eastern section of the subject site.

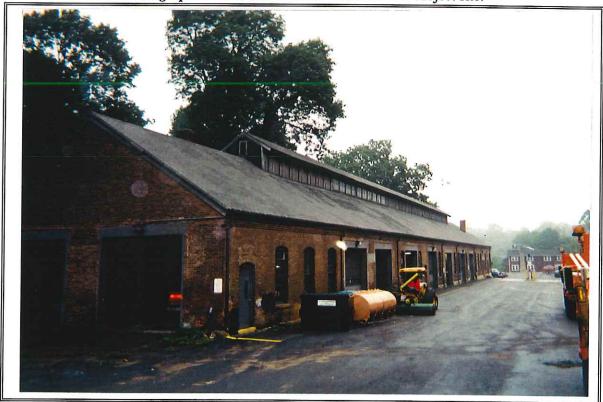
Photograph 2 View of Building 81-115 located on the northern section of the subject site.

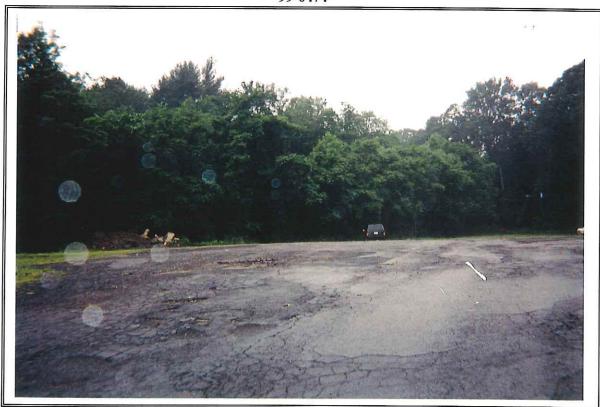
Photograph 3 View of the suspect fill area located on the western section of the subject site.

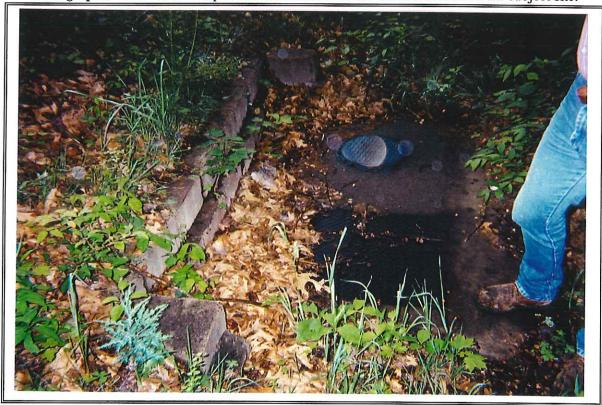
Photograph 4 View of 2,000-gallon #2 heating oil UST located adjacent to the northeastern section of Building 81-115

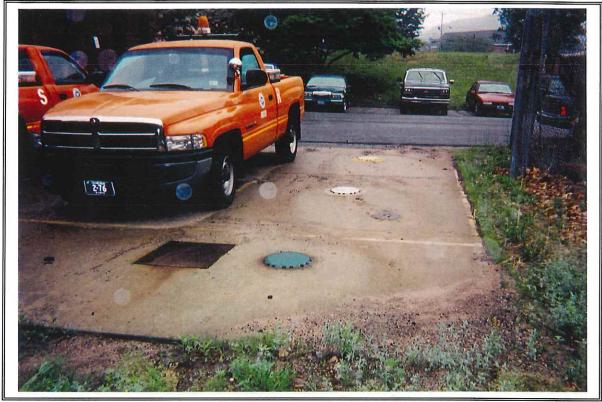
Photograph 5 View of 4,000-gallon diesel and unleaded gasoline USTs and 2,000-gallon #2 heating oil UST located east of Building 81-106.

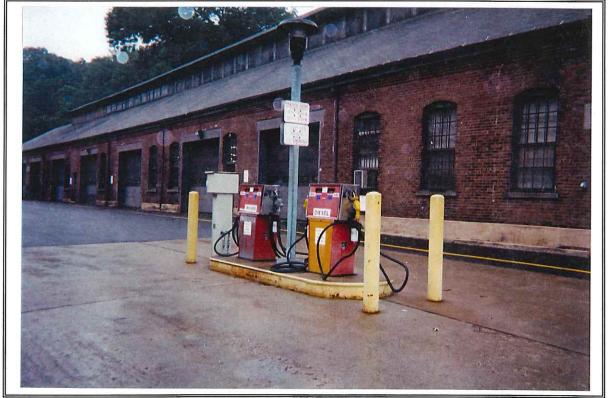
Photograph 6 View of diesel and unleaded gasoline fuel dispensing pumps located centrally between Building 81-115 and Building 81-106.

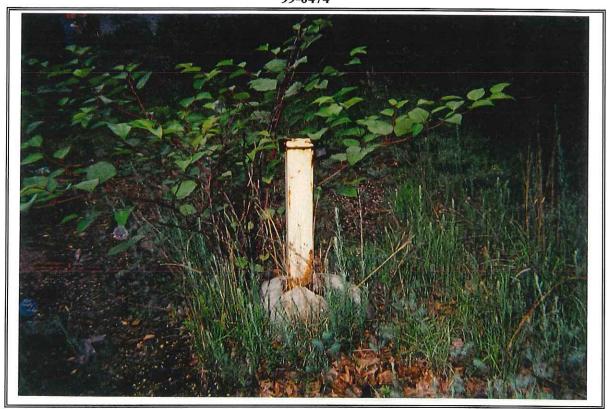
Photograph 7 View of ground water monitoring well located on the western section of the subject site.

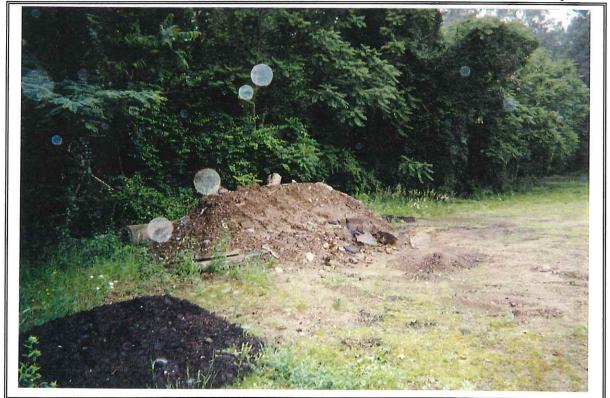
Photograph 8 View of piles containing asphalt, soil, and concrete located on the western section of the subject site.

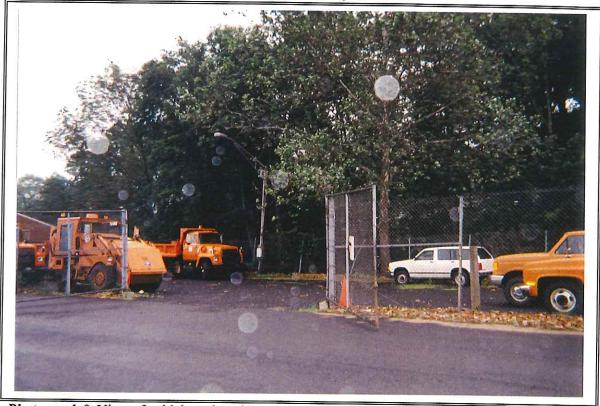
Photograph 9 View of vehicle and equipment compound area located on the eastern section of the subject site.

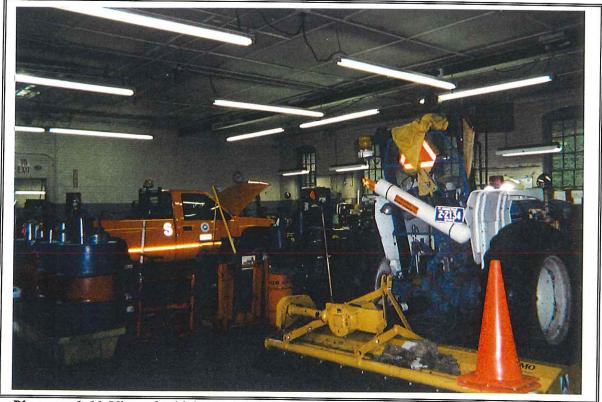
Photograph 10 View of vehicle repair bay located within the central section of Building 81-115.

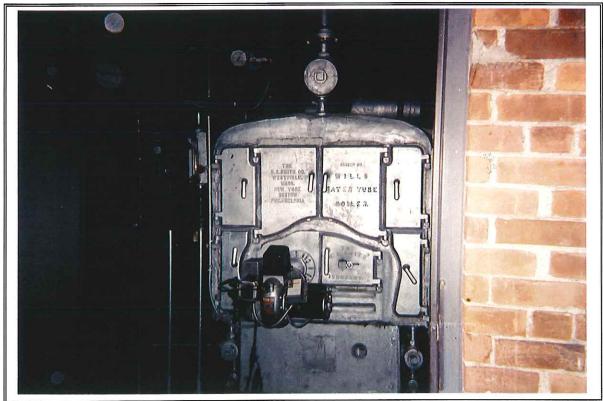
Photograph 11 View of boiler located within Building 81-106.

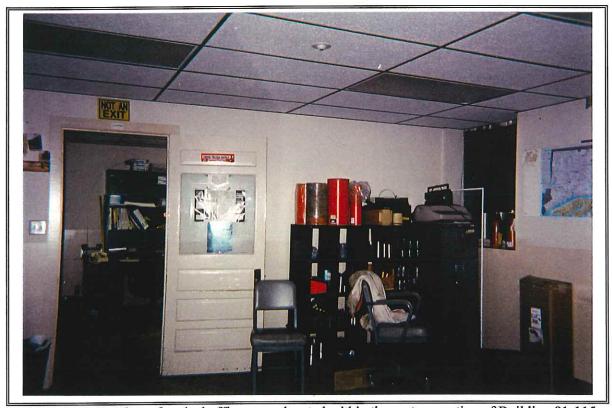
Photograph 12 View of typical office space located within the eastern section of Building 81-115.

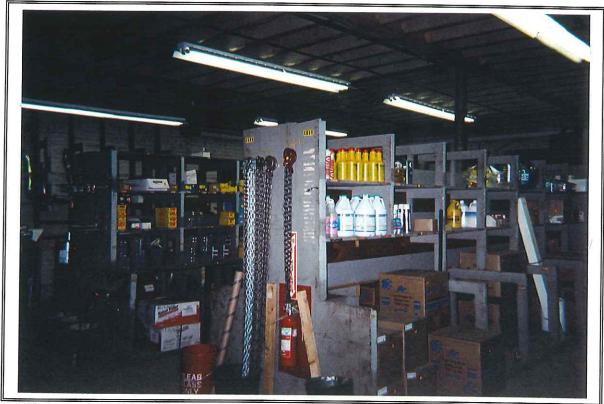
Photograph 13 View of supply storage area located on the eastern section of Building 81-106.

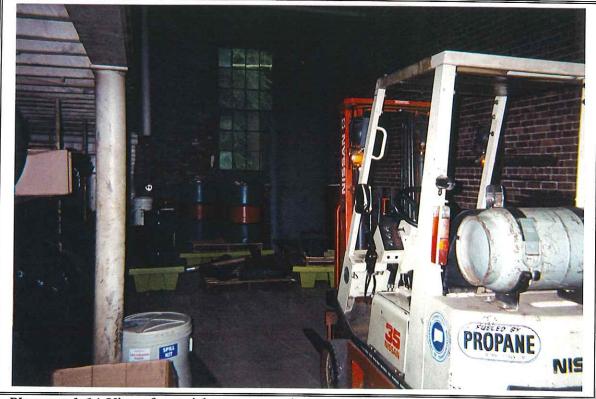
Photograph 14 View of materials storage area located on the eastern section of Building 81-106.

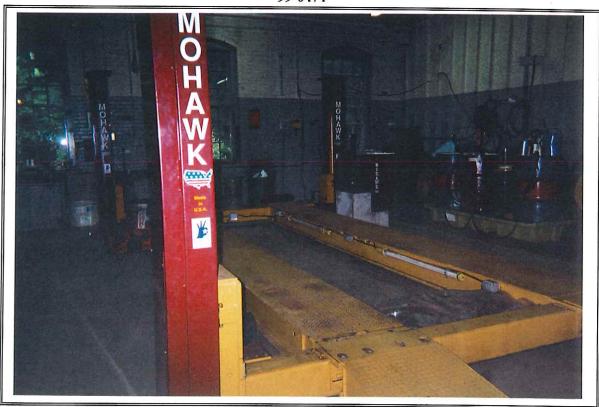
Photograph 15 View of aboveground lift and former area of inground lift located within a repair bay area on the central section of Building 81-106.

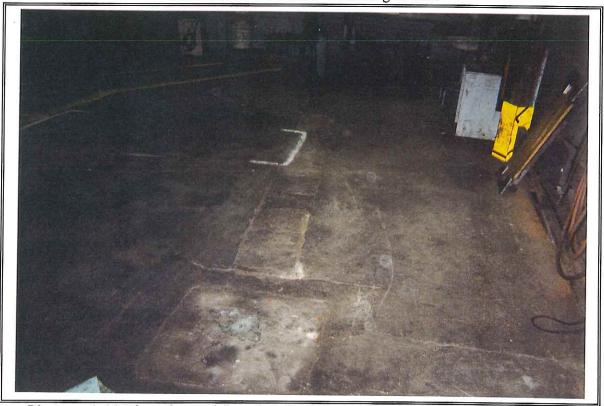
Photograph 16 View of capped floor drain located within a repair bay on the central section of Building 81-106.

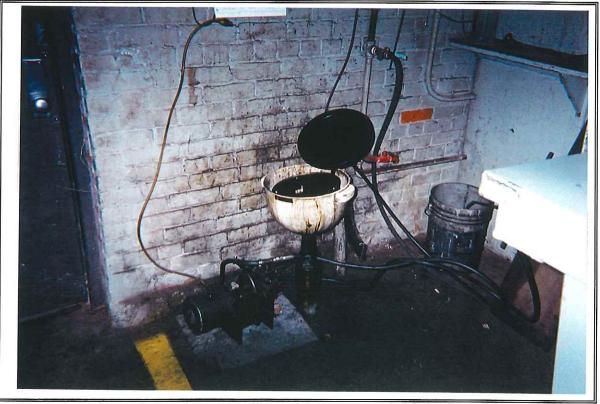
Photograph 17 View of 550-gallon waste oil tank fill pipe located in a repair bay on the central section of Building 81-106. Note the heavily stained concrete adjacent to the fill pipe.

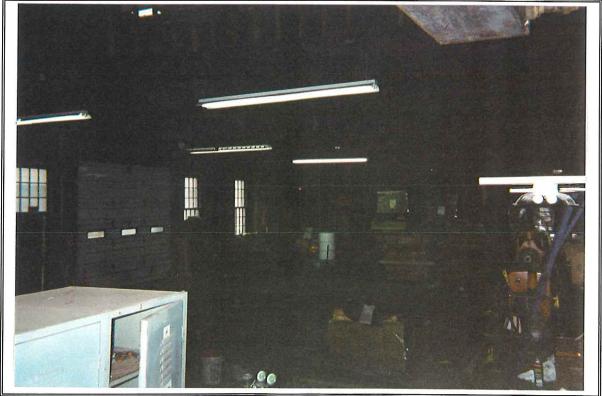
Photograph 18 View of storage area located on the western section of Building 81-106.

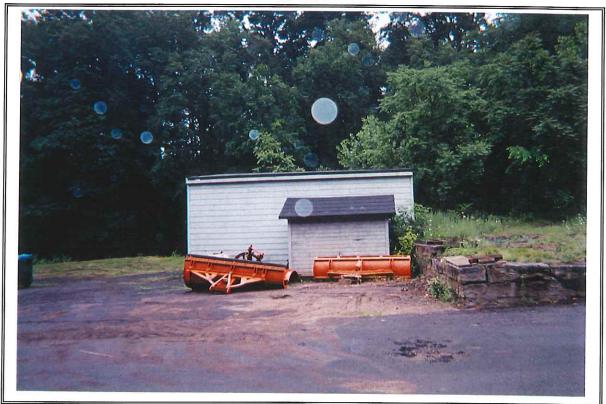
Photograph 19 View of wooden sheds located adjacent to the west of Building 81-106.

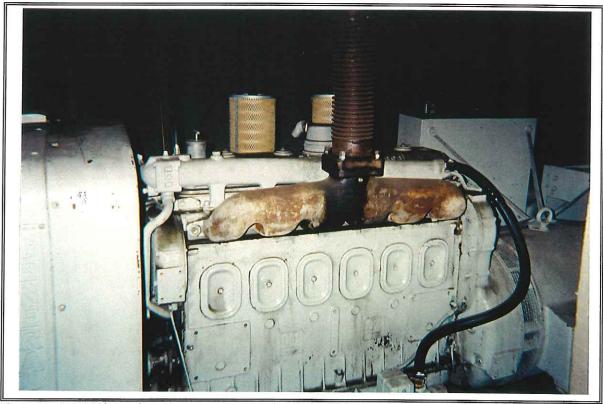
Photograph 20 View of emergency generator located within the generator shed adjacent to the north of Building 81-115.

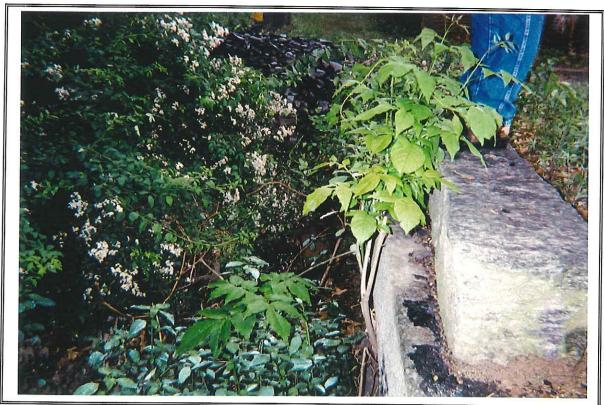
Photograph 21 View of outfall pipe located adjacent to Candlewood Hill Brook on the southern section of the subject site.

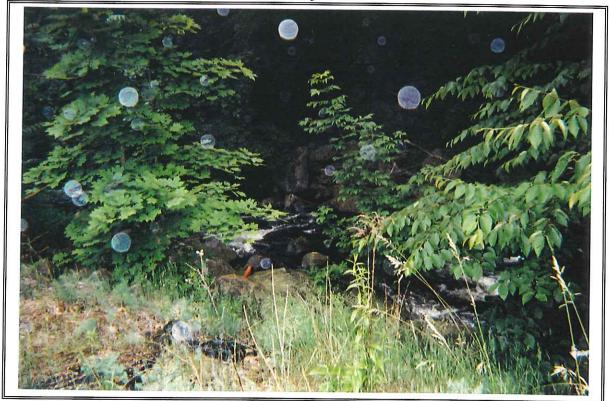
Photograph 22 View of Candlewood Hill Brook on the southern section of the subject site.

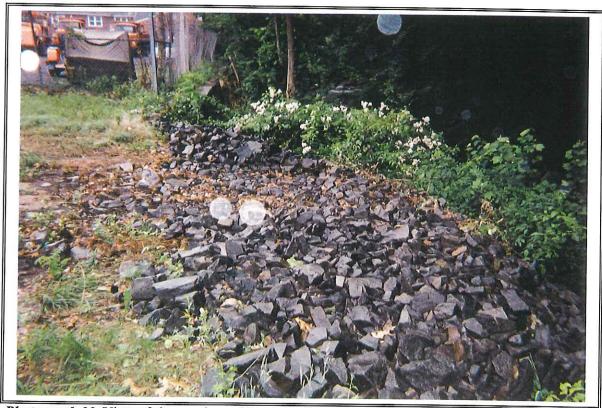
Photograph 23 View of rip-rap channel located adjacent to Candlewood Hill Brook on the southern section of the subject site.

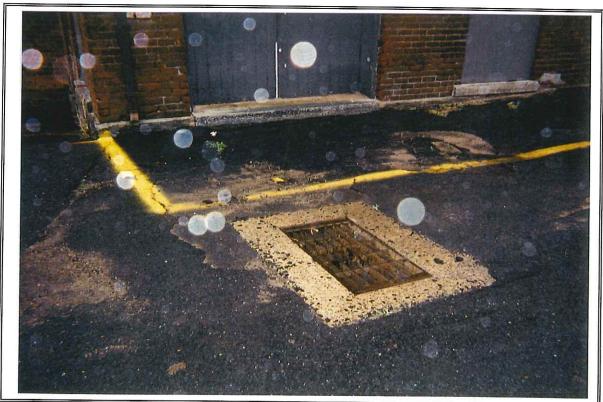
Photograph 24 View of catch basin located adjacent to the northeastern corner of Building 81-106.

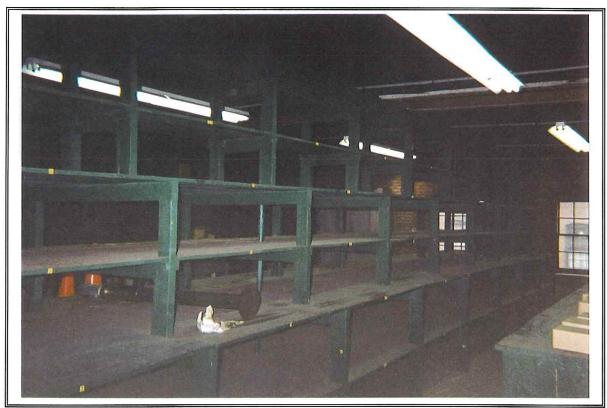
Photograph 25 View of storage area located on the second floor of the eastern section of Building 81-106.

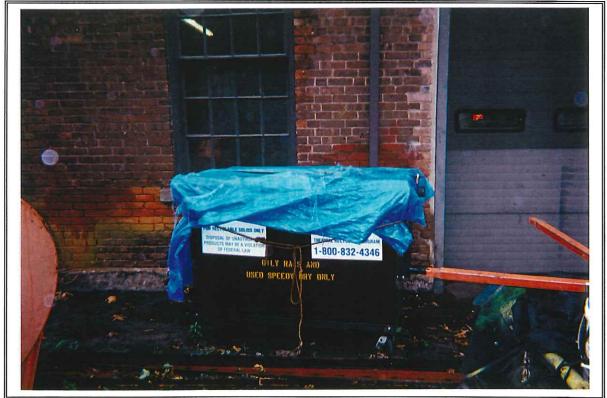
Photograph 26 View of dumpster containing oily rags located adjacent to the southwestern corner of Building 81-115.
