Hazardous Building Materials Inspection

Former Scovil Hoe Mill

11 Candlewood Hill Road

Town of Haddam

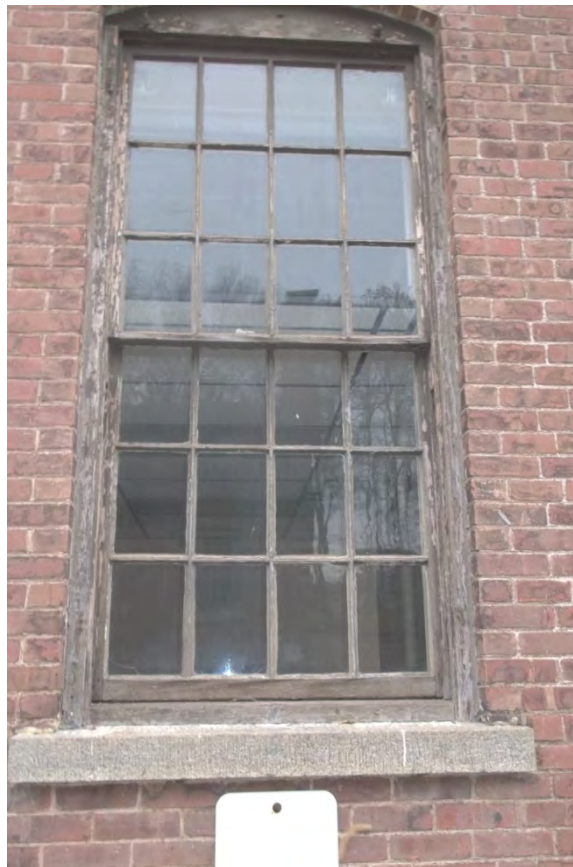
Typical window system

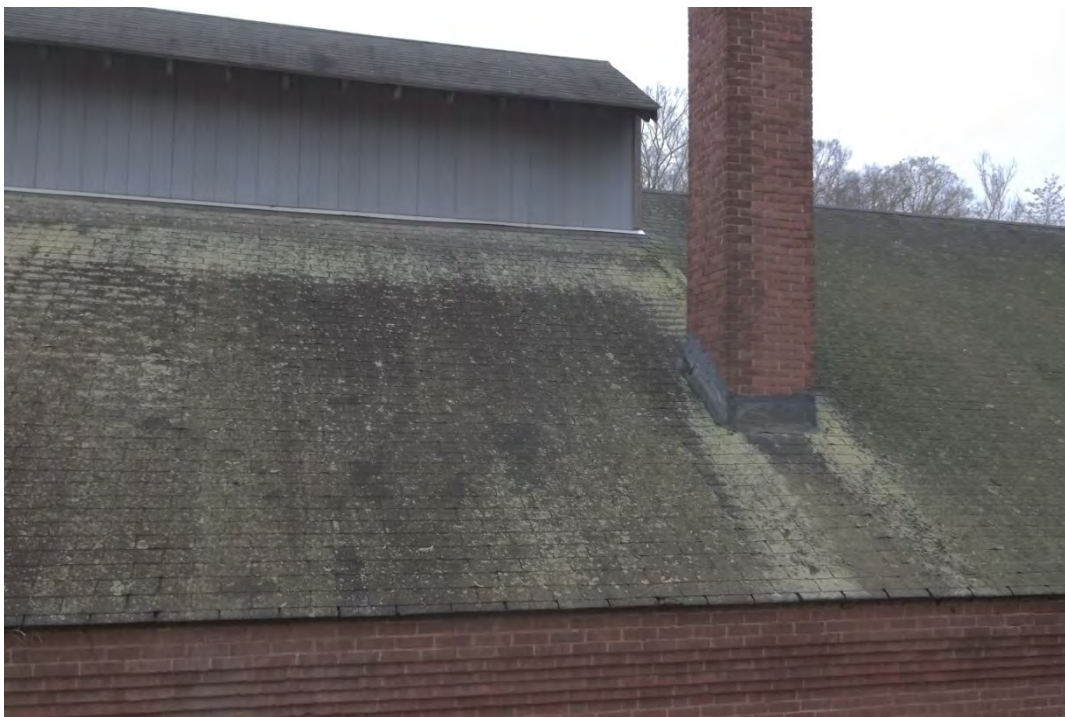
Example of asbestos-containing roof flashing materials/base flashing
