## Structural Condition Report

**City of Haddam**  
**Former Scovil Hoe Facility**  
**11 Candlewood Hill Road**  
**Higganum, CT 01040**

December 13, 2017

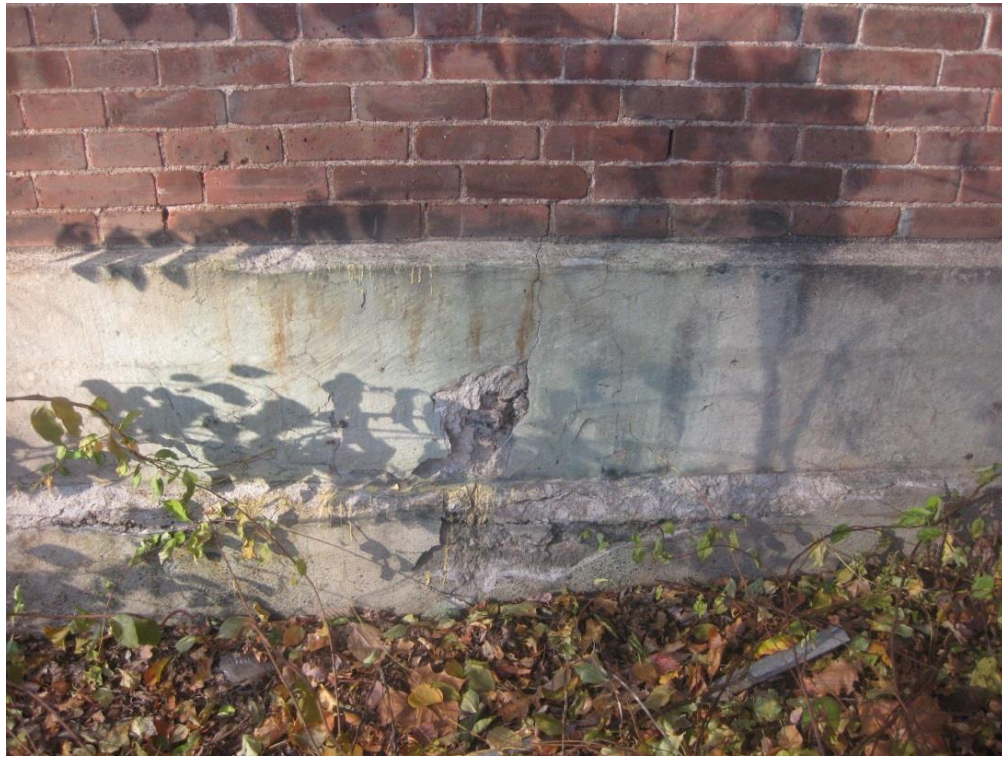
- The building exterior consists of brick walls generally supported on stone foundations, although concrete was noted at some walls (see photo A-1). Some sections of the foundations have minor cracks and concrete spalling (see photo A-1 and A-10), but overall appear to be in adequate condition. No indications of widespread settlement were found.
- Some deterioration was noted at the wood trim and window framing throughout the building, primarily due to water exposure (see photos A-2 and A-6).
- A wooden louver cover located at the back of the building has deteriorated significantly (see photo A-3).

**Photo A-1 – Diagonal crack and concrete spalling at foundation wall**

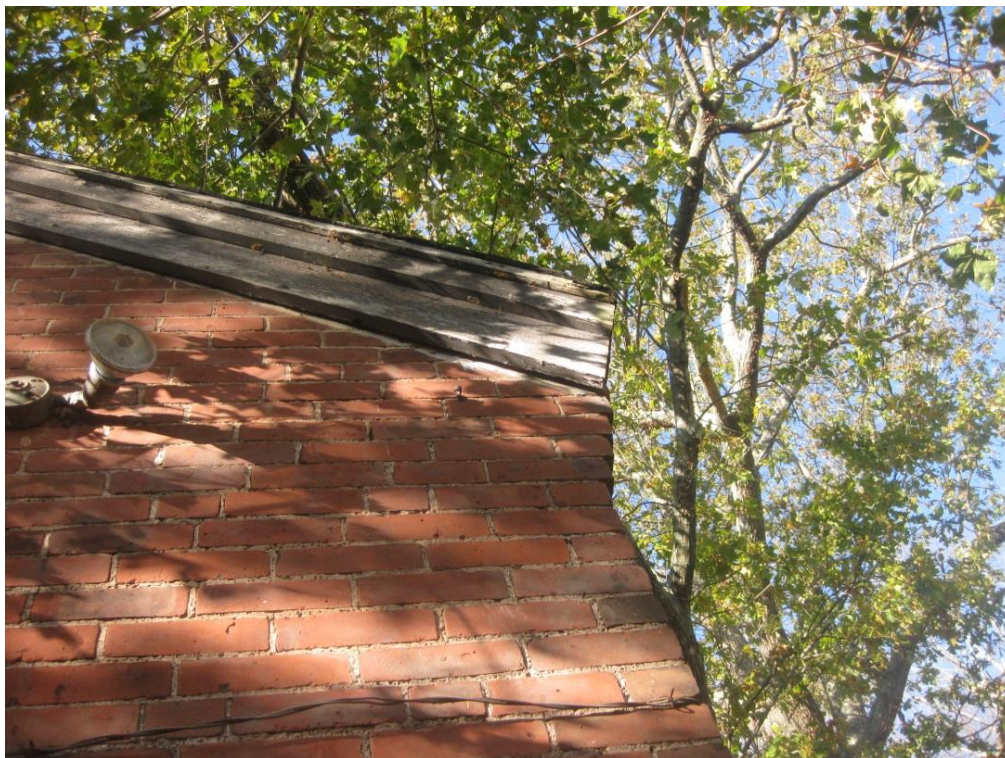
**Photo A-2 – Dry and deteriorated wood fascia**

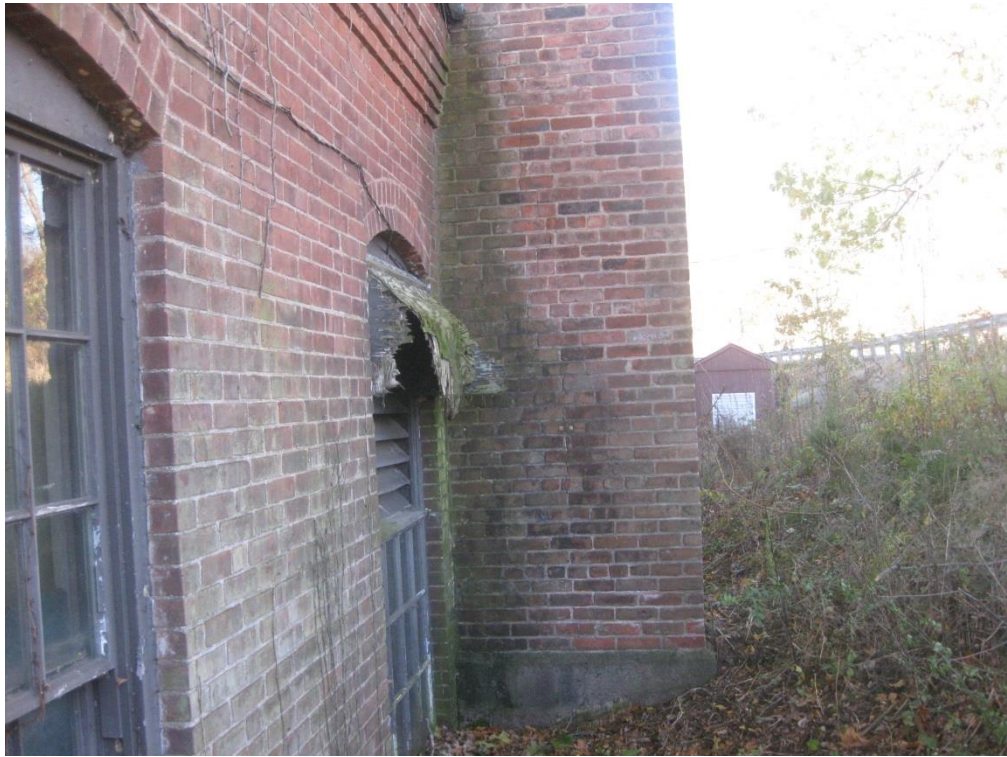
**Photo A-3 – Deteriorated louver cover**

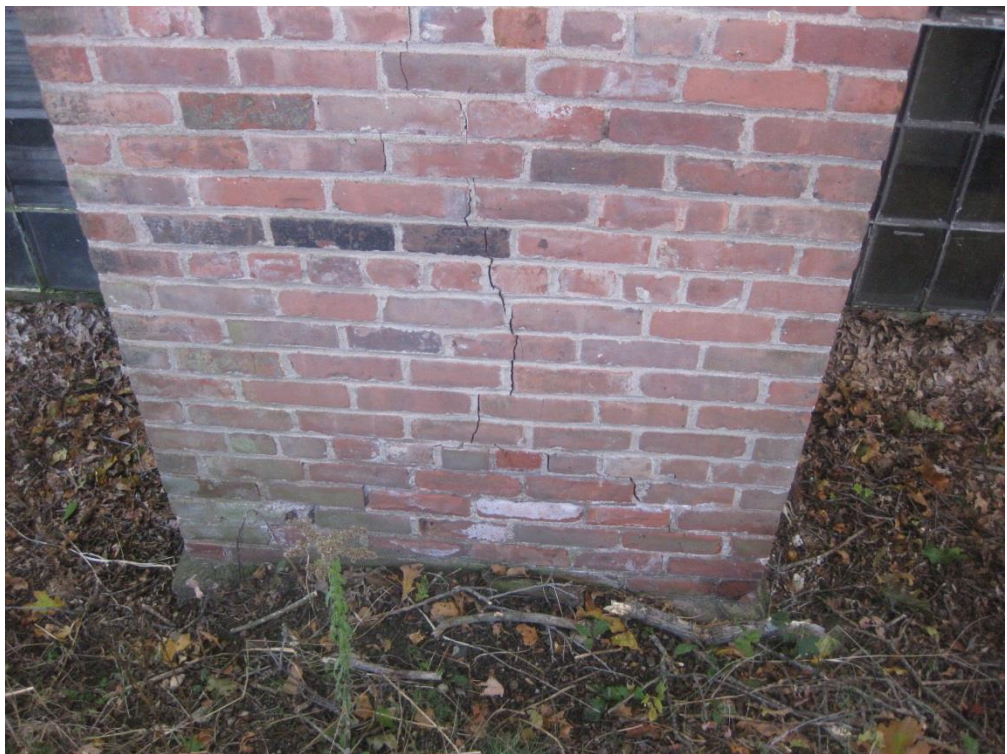
- The chimney located at the eastern side of the building has vertical cracks near the bottom (see photo A-4). Cracks and missing mortar were also noted at the top.

**Photo A-4 – Vertical Crack along Chimney**

- Reinforce or replace deteriorated wood framing.
- Replace roof and floor sheathing damaged by water exposure.
- Replace the roofing at the north side of the building.
- Repoint interior and exterior brick walls as required.
- Repair or consider removal or reduction of the height of chimneys.

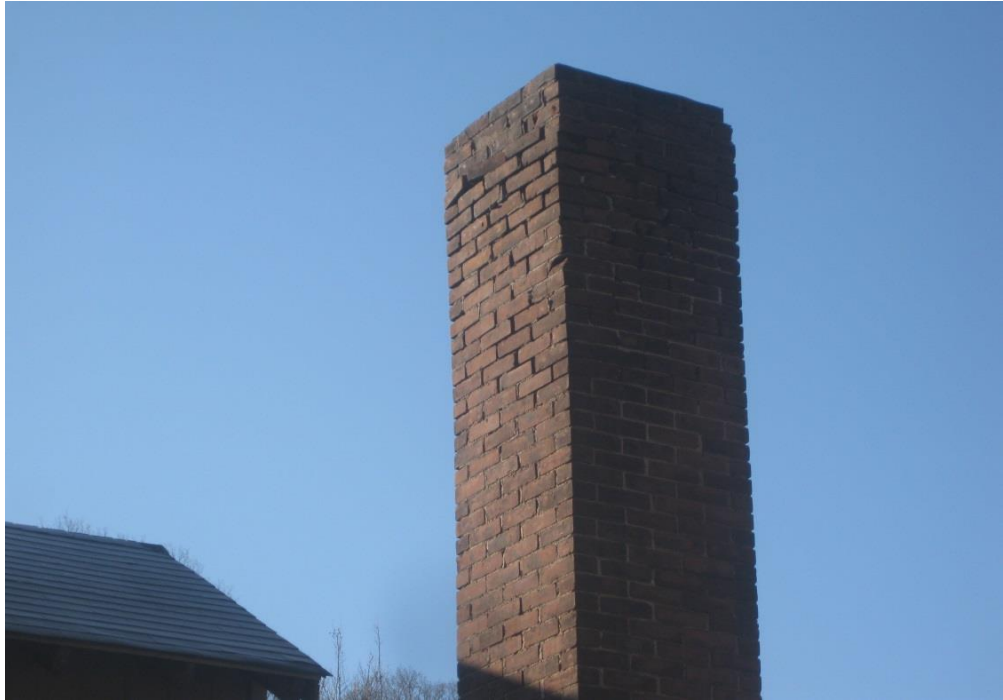
- The top portion of the chimney located on the west side of the building has some brick displacement due to mortar degradation, as well as minor cracks (see photo A-5).

**Photo A-5 – Brick degradation at chimney**

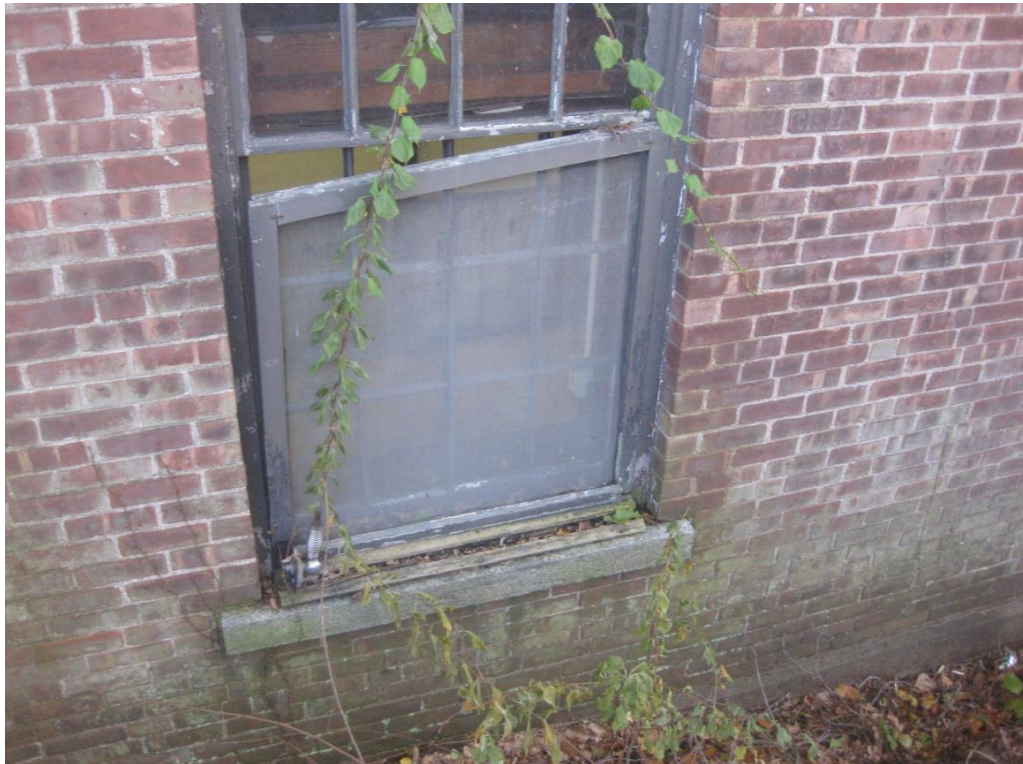
- Some sections of the wood window frames appear loose or displaced, likely due to weather damage (see photo A-6).
- The roofing at the south side of Building A appears to have been replaced fairly recently. The north side of the roof is much older and has more wear and damage (see photos A-7 and A-21).

**Photo A-6 – Deteriorated exterior window frame**

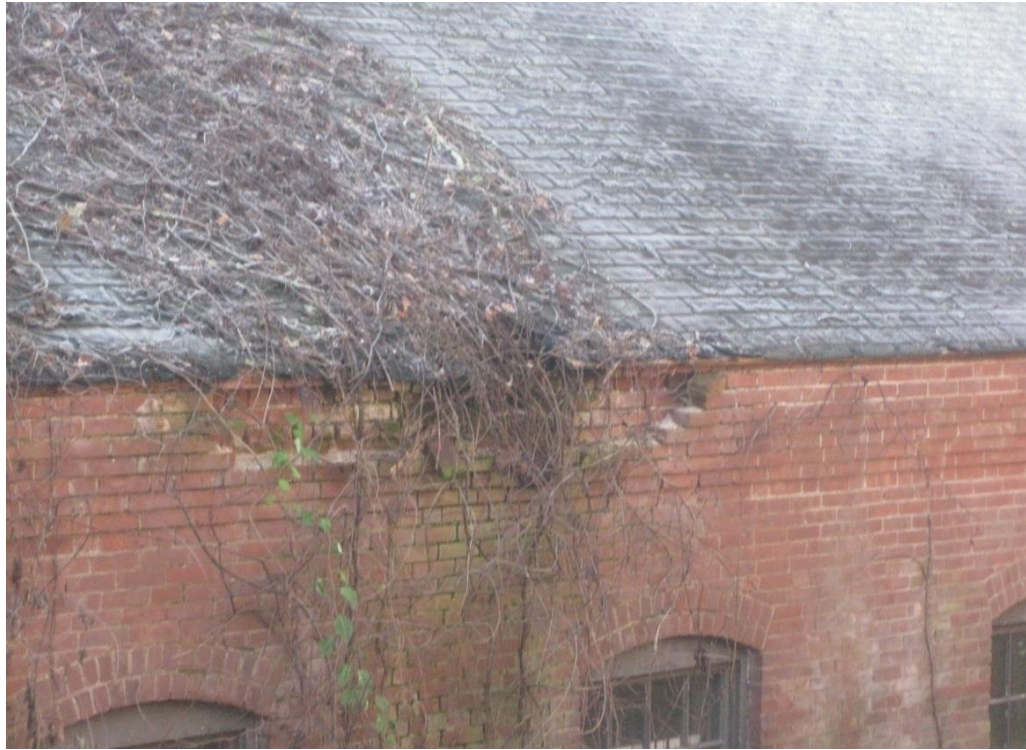
- A section of the north side of the roof, as well as some of the adjoining exterior brick, are overgrown with vegetation and appear to have failed (see photo A-7).

**Photo A-7 – Failed roof shingles and exterior brick at north side of Building A**

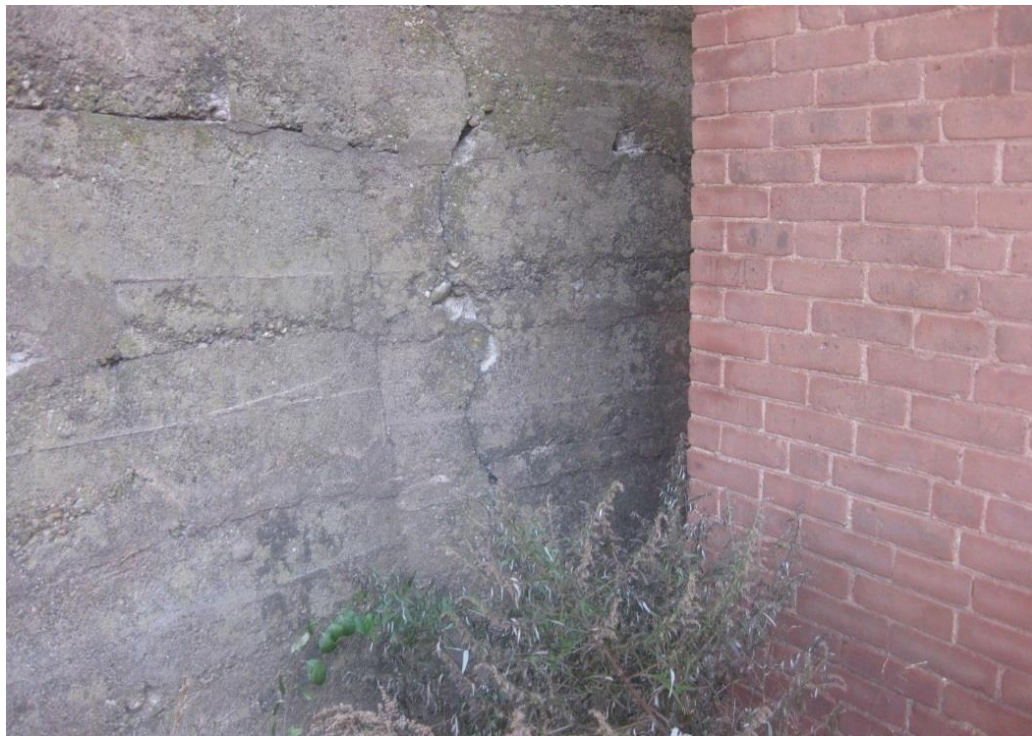
- A concrete retaining wall extends along the north side of the building and continues beyond the building at an angle to the west. A large vertical crack was found in the wall near the change in direction, along with smaller horizontal cracks and spalls. The wall surface is somewhat irregular, but other than the distress at the corner, the wall is generally intact (see photo A-8).

**Photo A-8 – Deterioration at retaining wall parallel to rear wall of Building A**

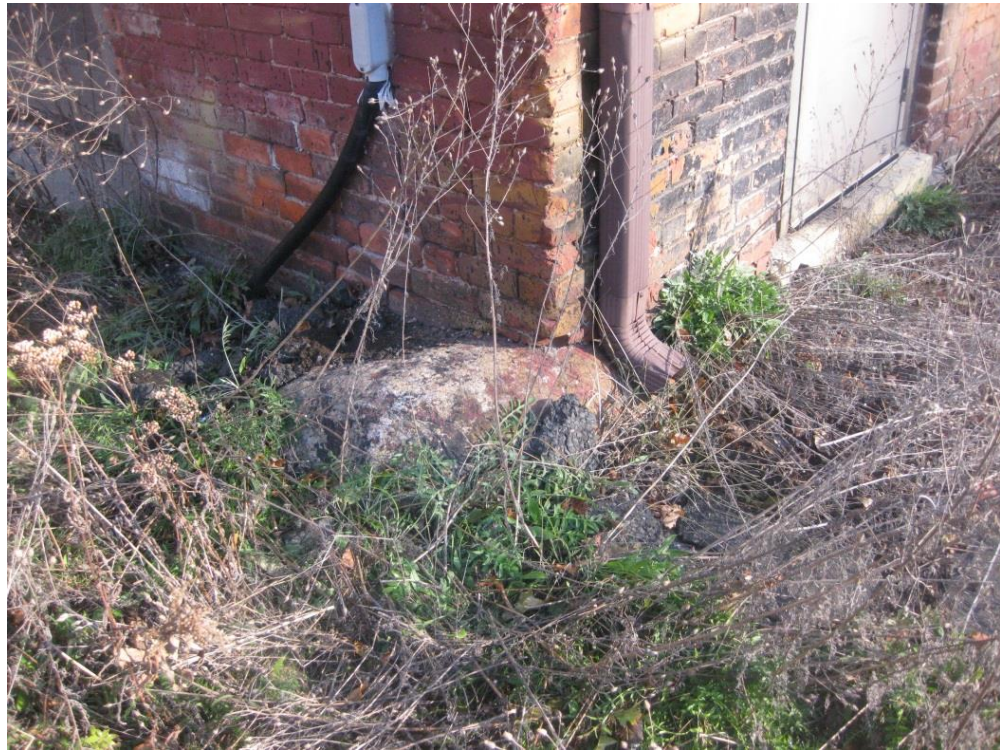
- The exterior wall at the northwestern corner of the building appears to be directly founded on a rock outcropping. Significant mortar loss was noted at this location (see photo A-9).

**Photo A-9 – NW Corner of Building A directly founded on bedrock**

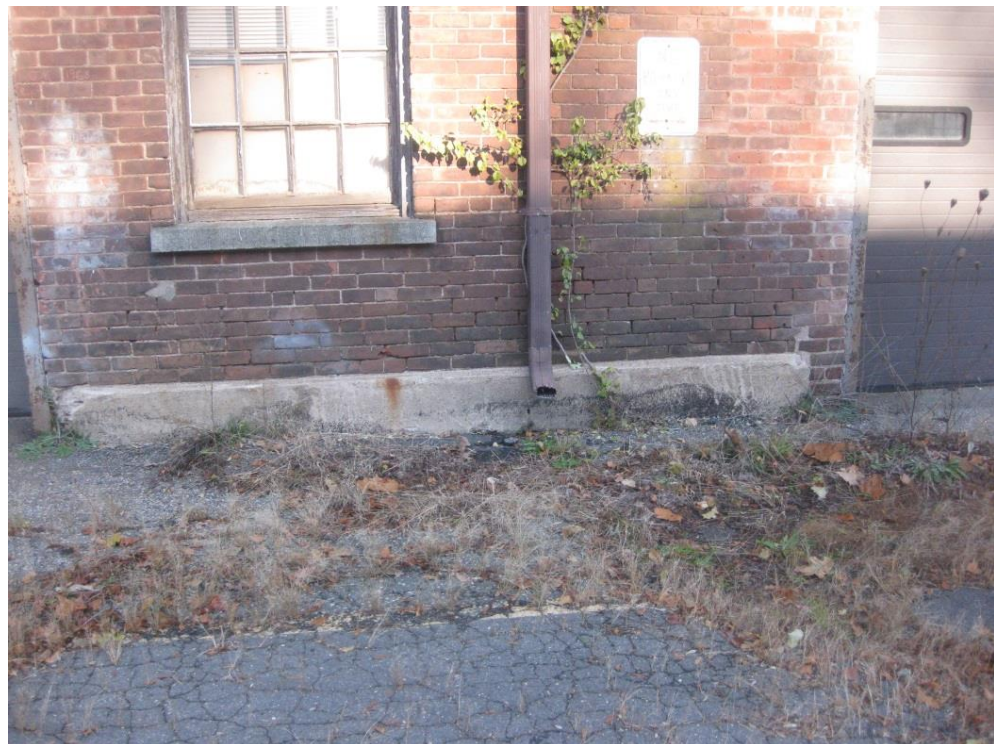
- The brick exterior walls are generally intact, but some areas were noted where mortar has deteriorated and brick units are chipped and cracked (see photo A-10). There was evidence of previous repairs throughout.

**Photo A-10 – Concrete and brick degradation at exterior walls of Building A**

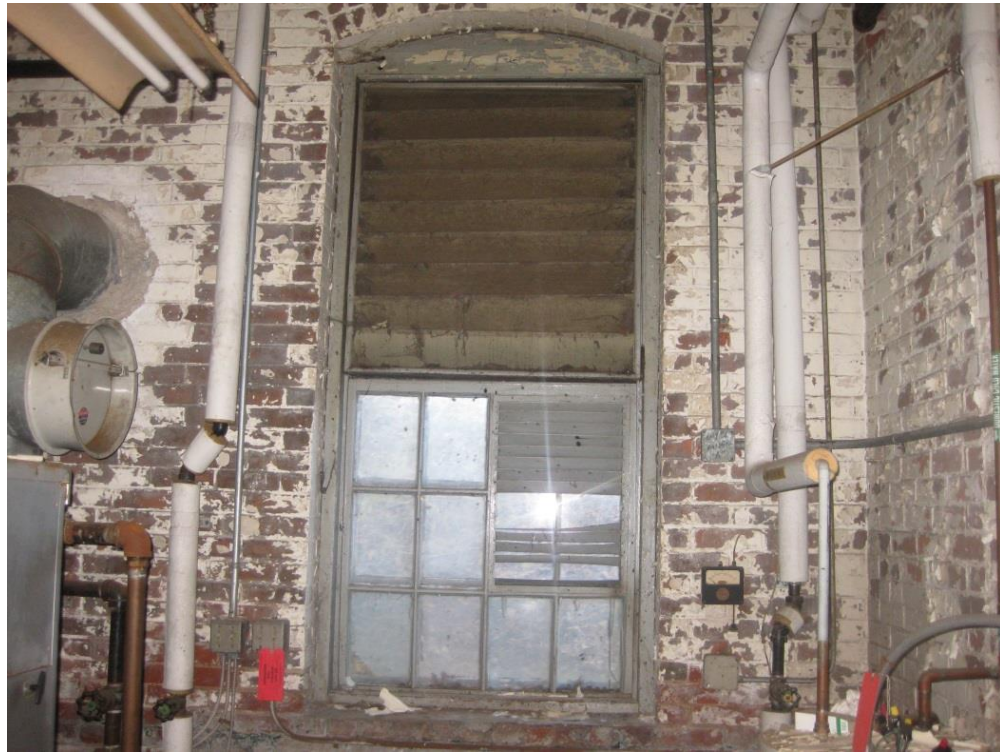
- At section 1, the interior side of the louver appears to be in good condition despite the damage noted at the cover at the exterior. The paint on the brick walls in the mechanical space is chipped and mortar degradation was observed (see photo A-11).

**Photo A-11 – Chipped paint and deteriorated mortar at interior walls**

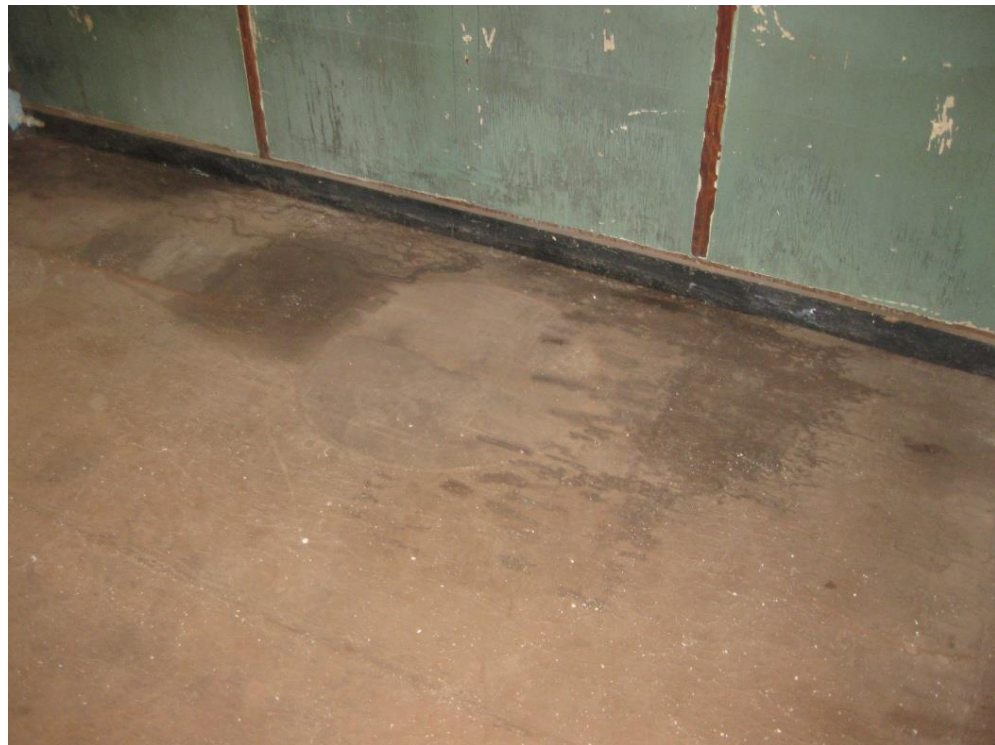
- At section 1, there are two rooms in the back of the building. These rooms have a wood floor over a crawlspace. The flooring shows signs of water infiltration (see photo A-12).

**Photo A-12 – Weathered and water damaged subflooring**

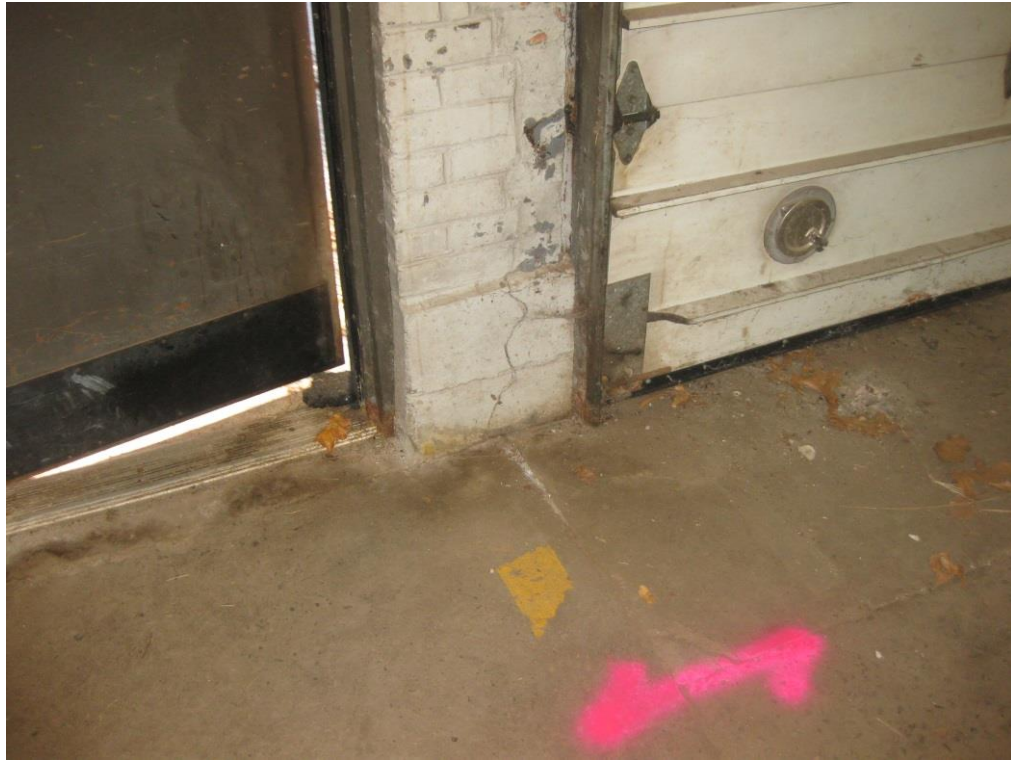
- Vertical cracks were found at the inboard face of a brick pier between door openings. The cracks translate to stepped cracks further up on the pier (see photo A-13).

**Photo A-13 – Stepped and vertical cracks at interior face of exterior wall**

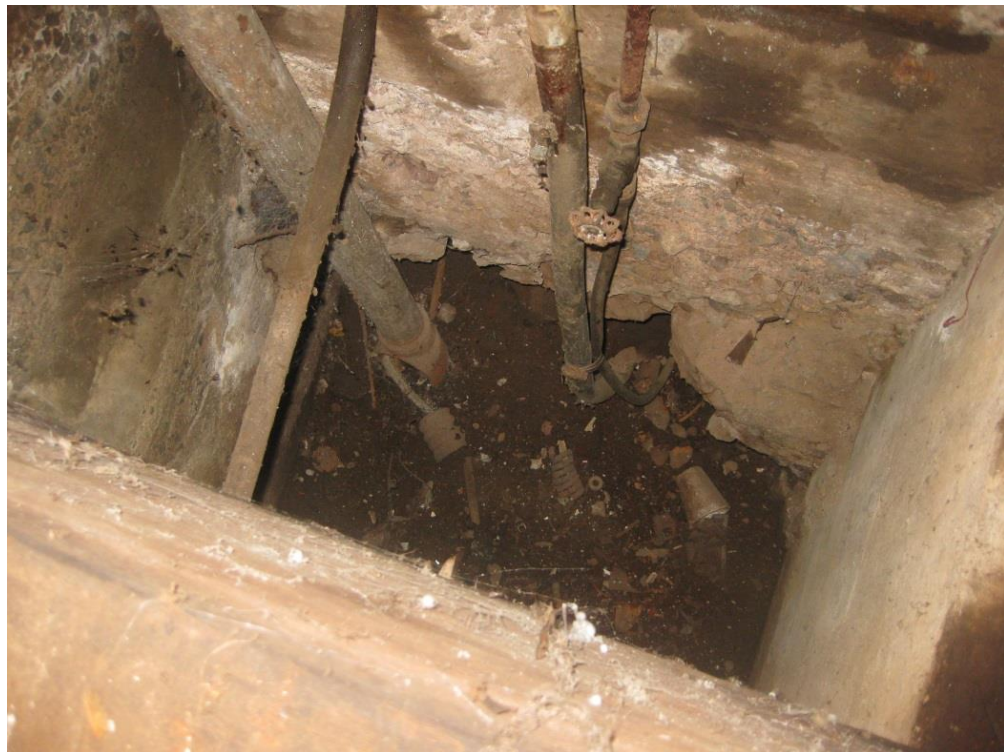
- At section 2, there is a concrete utility pit that connects to a trench that leads to Building B (see photo A-14). The pit is covered with a series of wood planks. The pit, trench and planks appear to be intact.

**Photo A-14 – Utility trench in Building A**

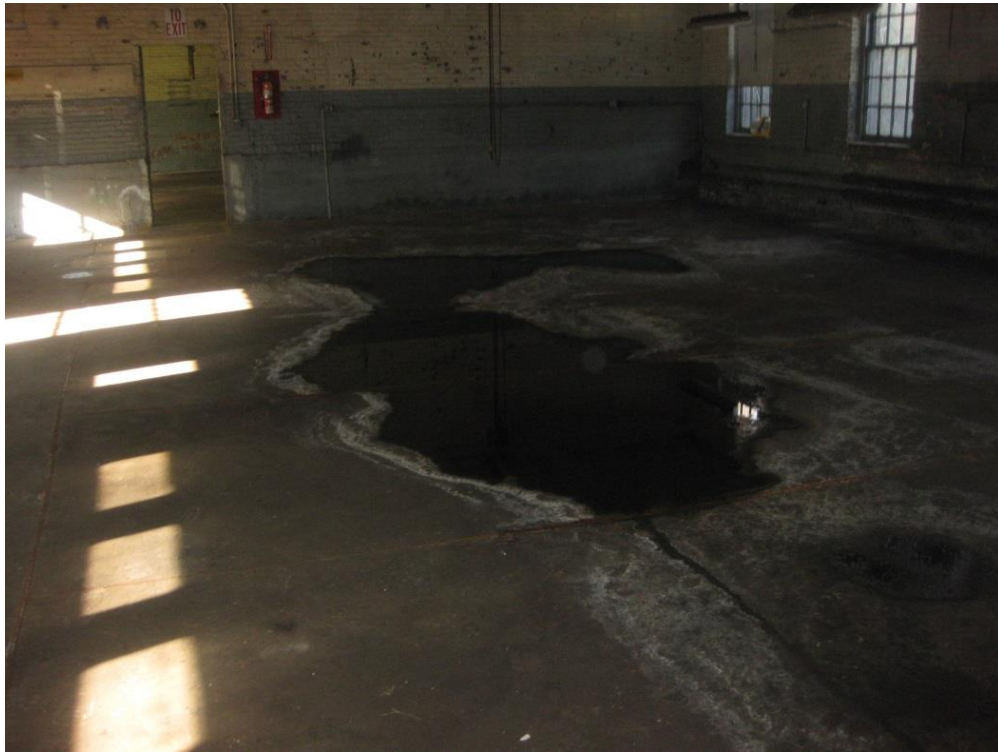
- The concrete slab at some of the garage bays appears to be sloping towards the center. Ponding at the center of the floor was observed (see photo A-15).

**Photo A-15 – Ponding water at concrete slab sloped to center**

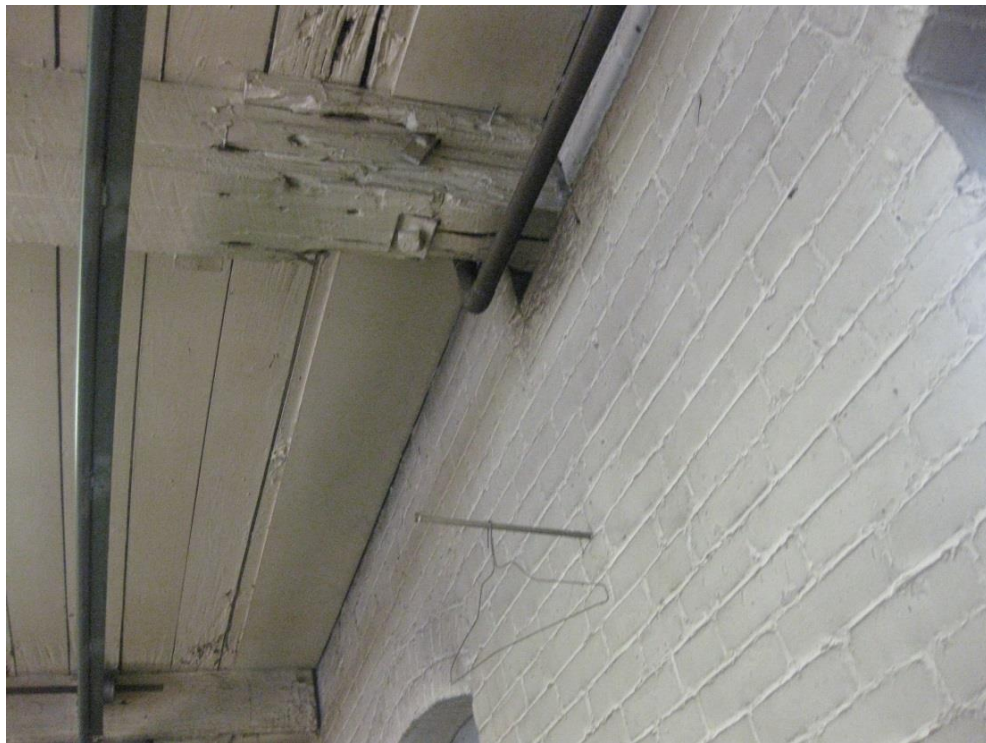
- Some of the timber roof trusses have significant cracks at the bottom chord, particularly close to bearing conditions (see photo A-16).

**Photo A-16 – Deteriorated wood truss chord at bearing seat**

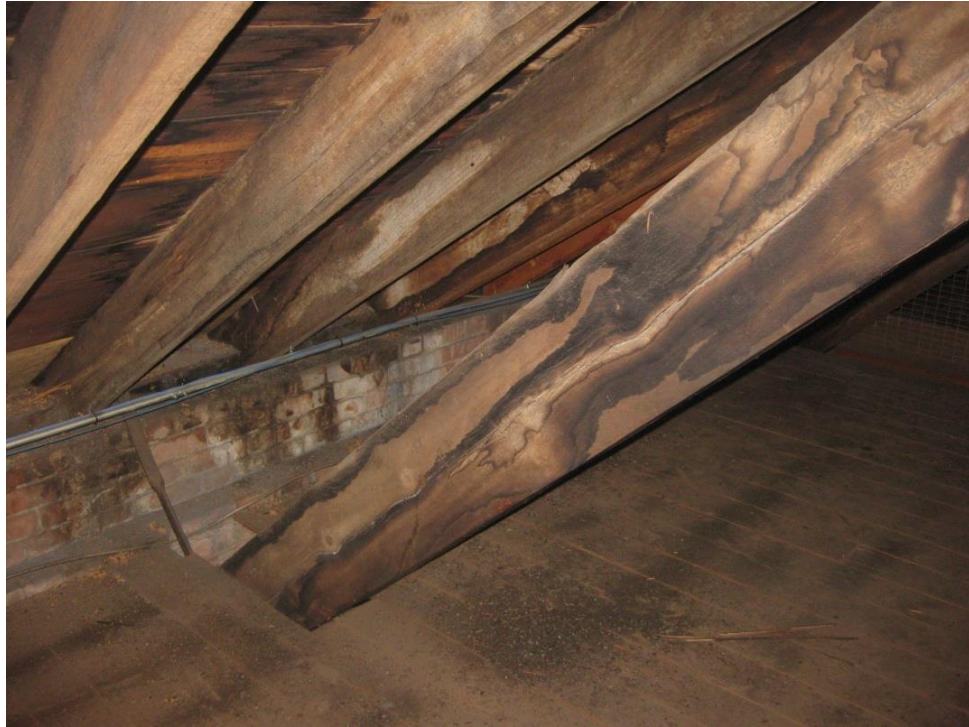
- Access to the attic is located in section 2 near the entrance of the building. The attic allows closer inspection of the gable roof structure, including the trusses, rafters and wood planks (see photo A-17). Signs of water infiltration (staining, mold, rust at nails) can be seen at the underside of the planks and framing, but active leaks were not found. Many of the planks and some roof joists show signs of water exposure and damage (see photos A-18 through A-20).
- Section 2 had several chain joists suspended from the roof framing and mezzanine (see photo A-21). No distress was noted at or around the hoists.

**Photo A-17 – Water damage at roof truss and rafters**

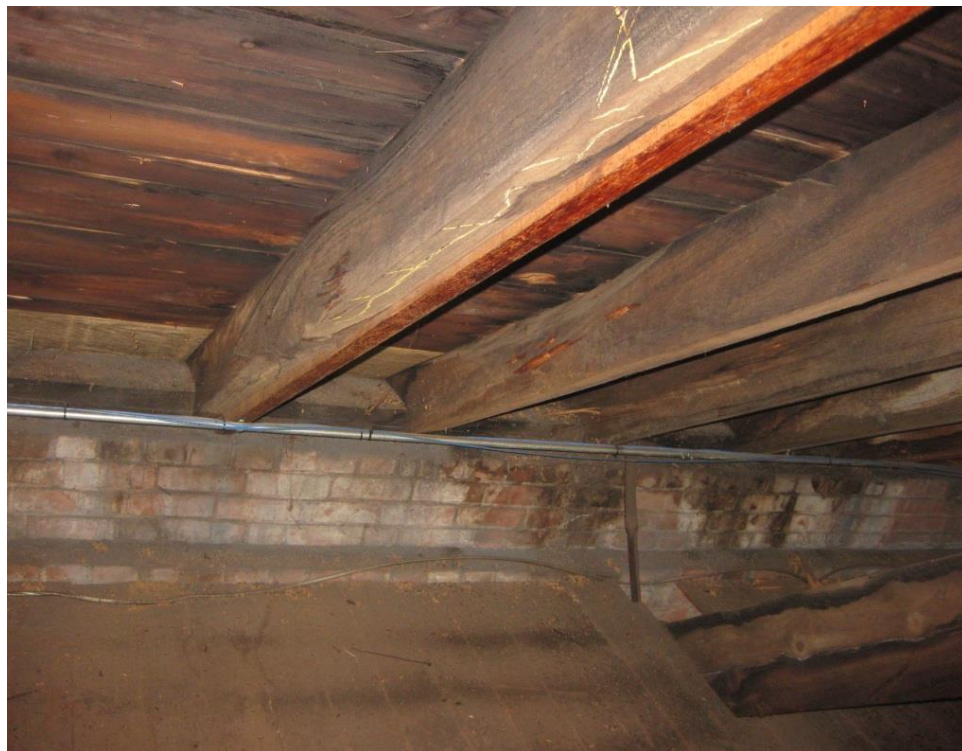
**Photo A-18 – Water damage and horizontal cracks at wood rafters**

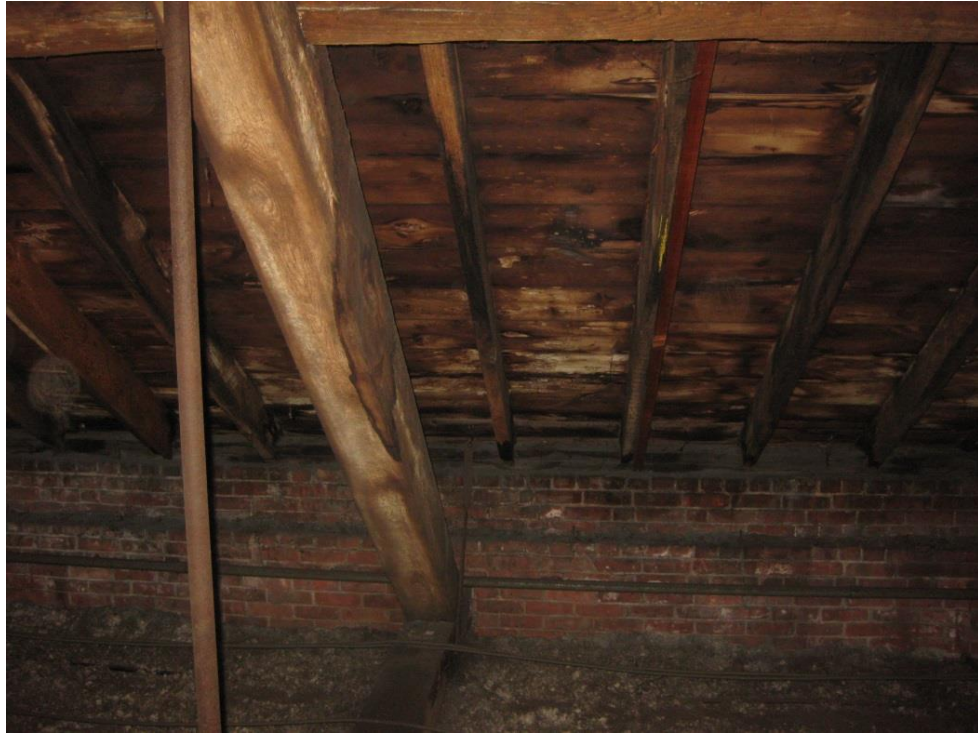
**Photo A-19 – Water damage at roof trusses and rafters**

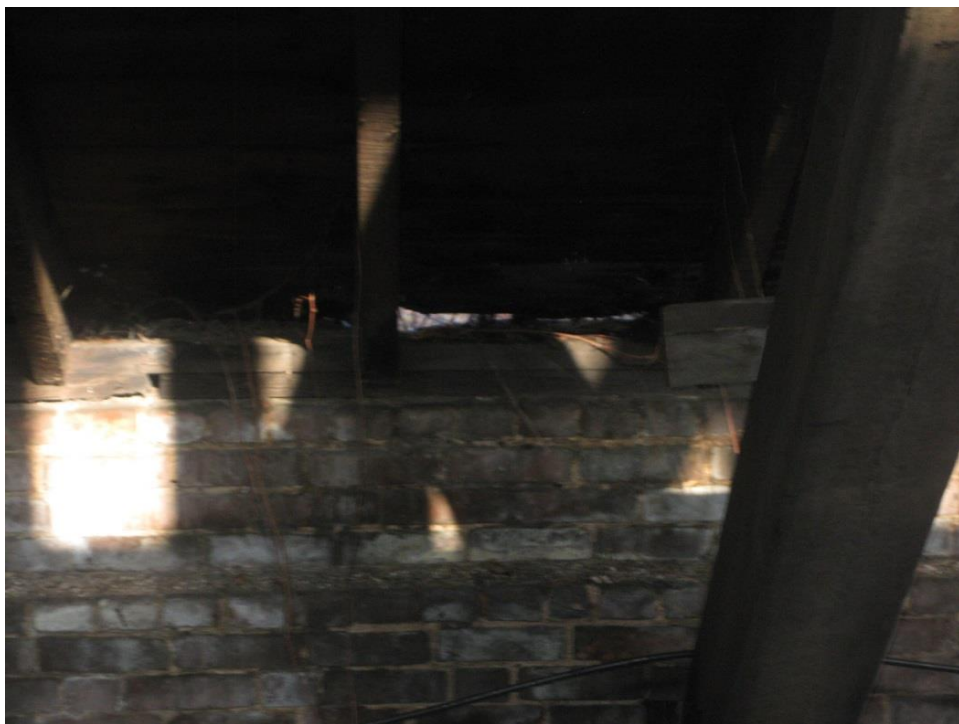
**Photo A-20 – Deteriorated wood roof members and planks**

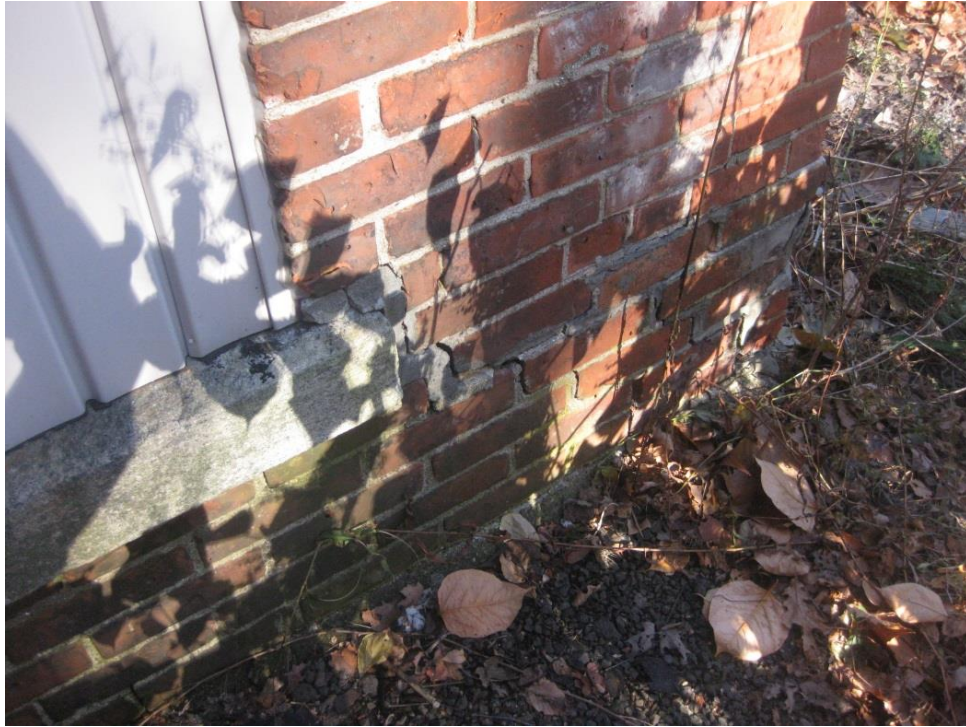
- In general, exterior walls appear to be in adequate condition, with some exceptions as noted.
- There is a significant step crack at the southeast corner of the building (see photo B-1). The crack transmits fully to the interior (see photo B-2).

**Photo B-1 – Stepped crack along mortar joint at SE corner of Building B**

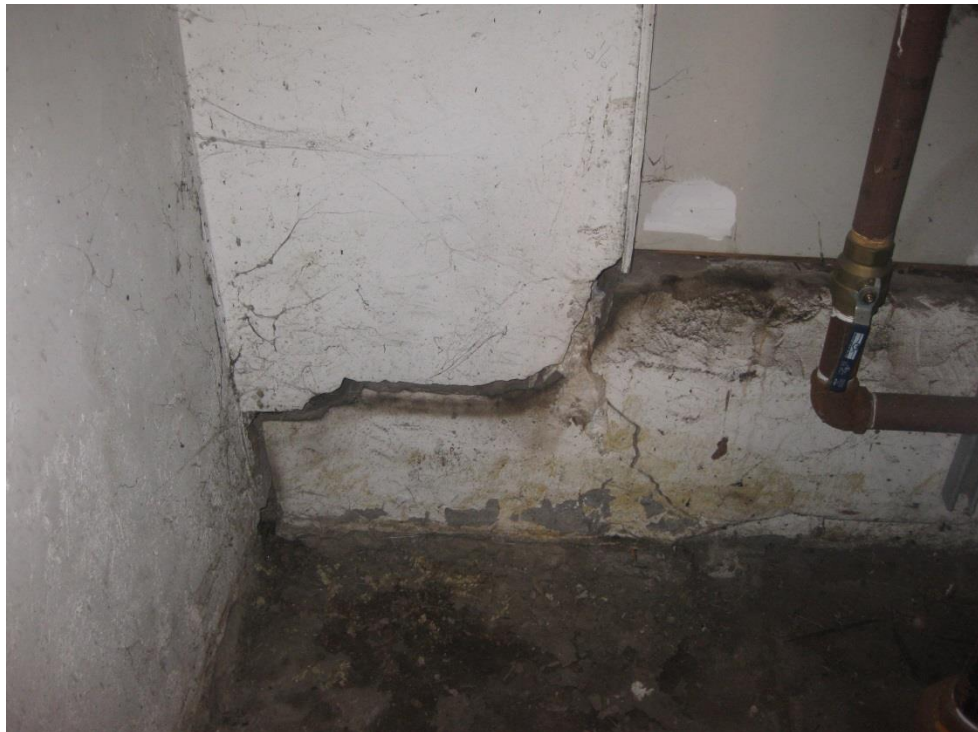
**Photo B-2 – Crack at SE corner of Building B at interior face**

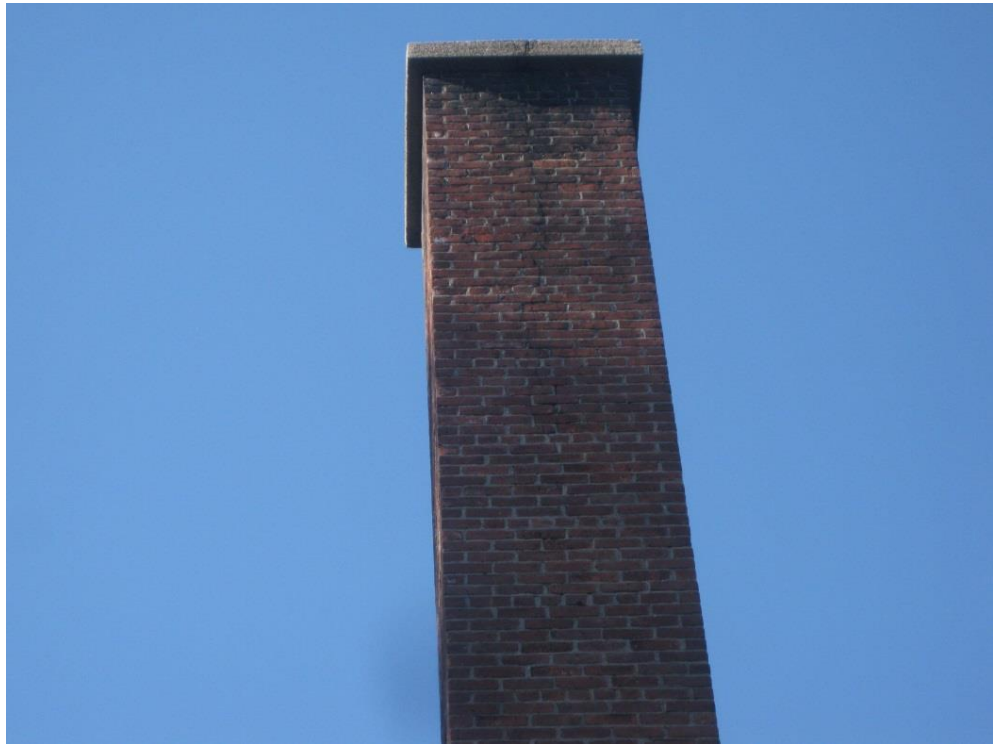
**Photo B-3 – Vertical crack at the chimney of Building**

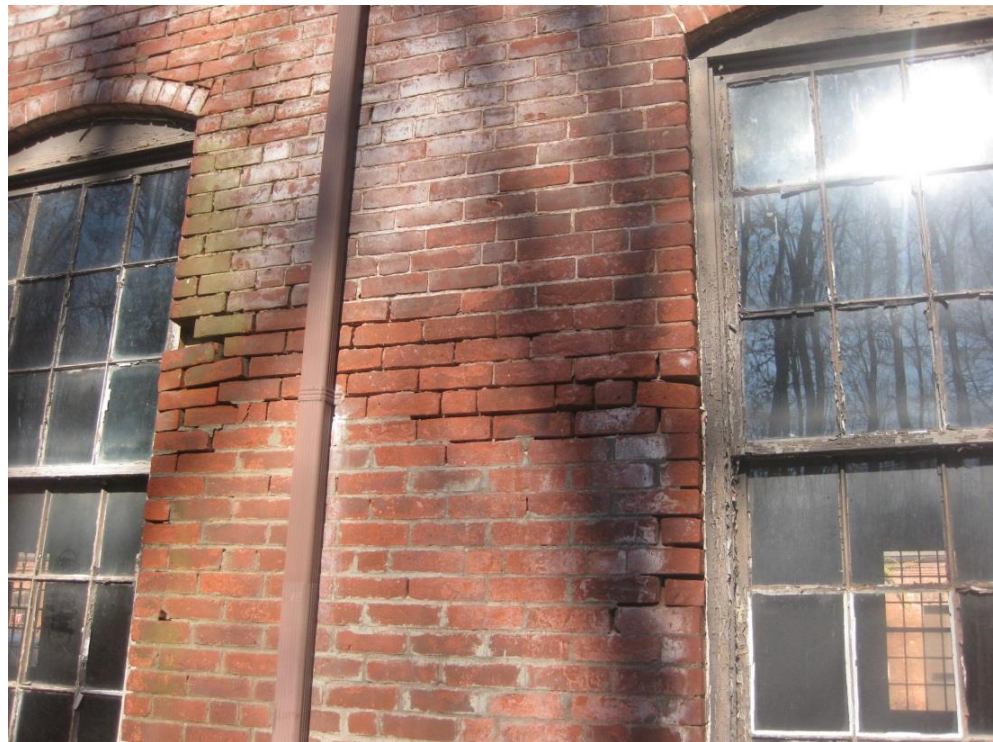
**Photo B-4 – Displaced brick and disintegrated mortar at south exterior wall**

- Reinforce or replace deteriorated wood framing.
- Replace roof and floor sheathing damaged by water exposure and floor sheathing not suitable for the proposed use.
- Replace or reset displaced brick at exterior walls.

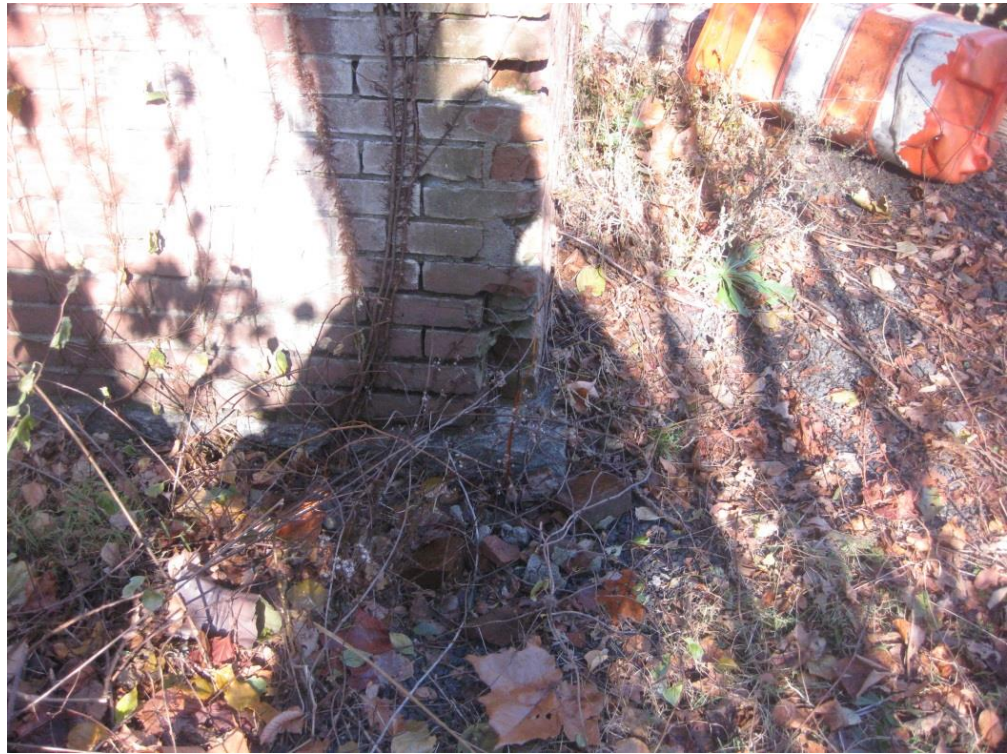
**Photo B-5 – Disintegrated mortar and spalling at SE corner of Building B**

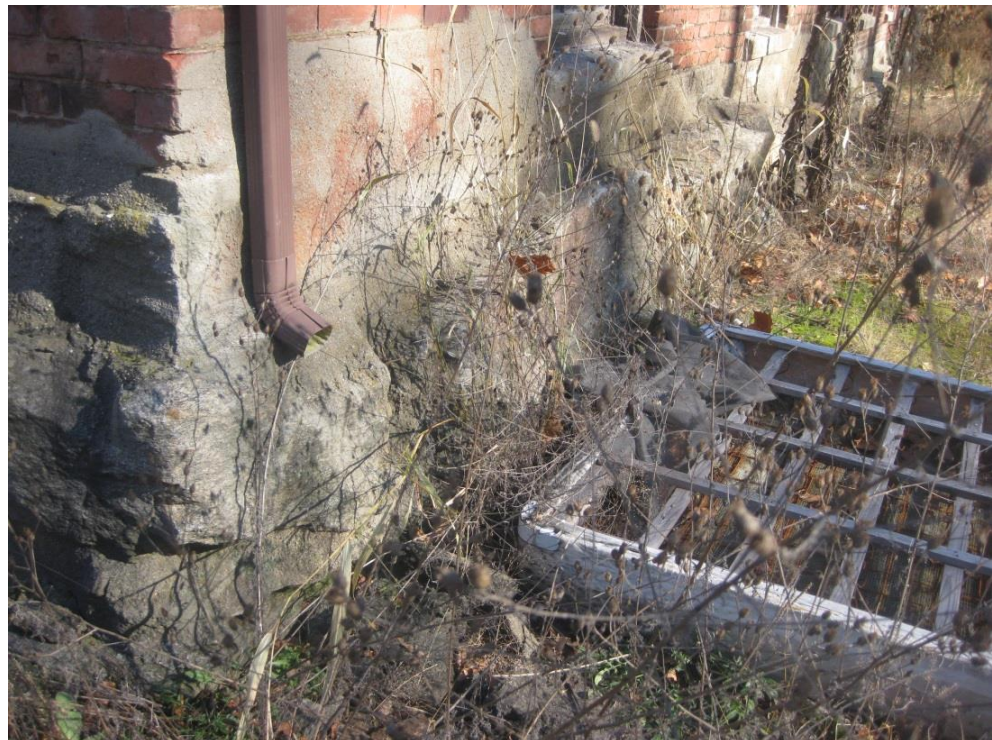
**Photo B-6 – Section of exterior wall founded on rock outcropping**

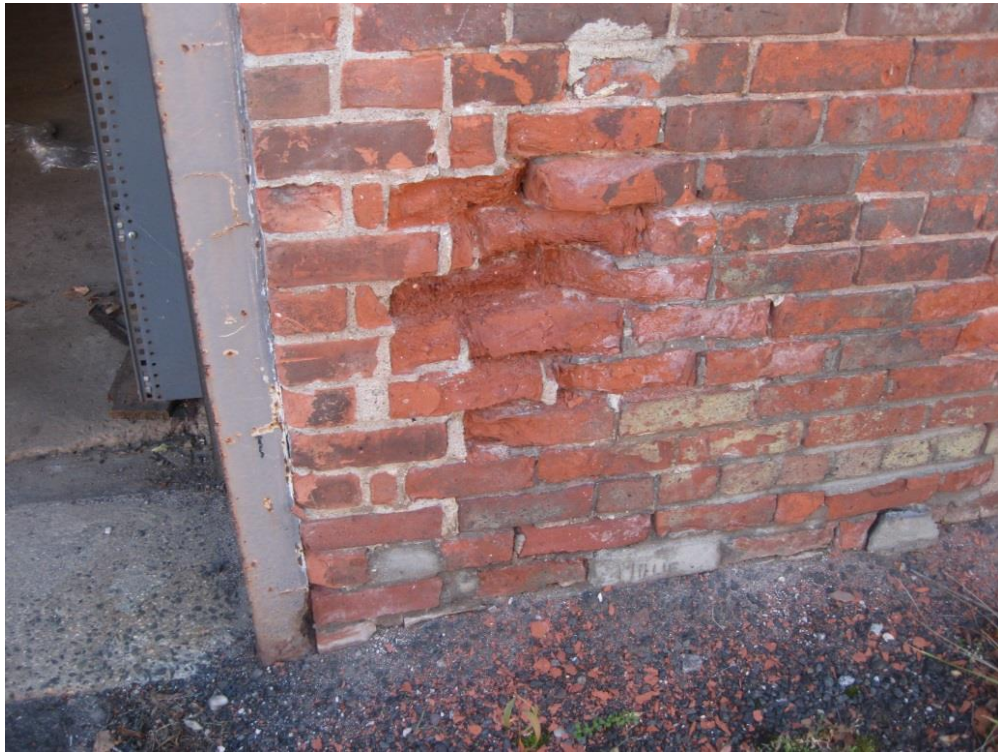
**Photo B-7 – Brick damage on exterior brick wall due to impact**

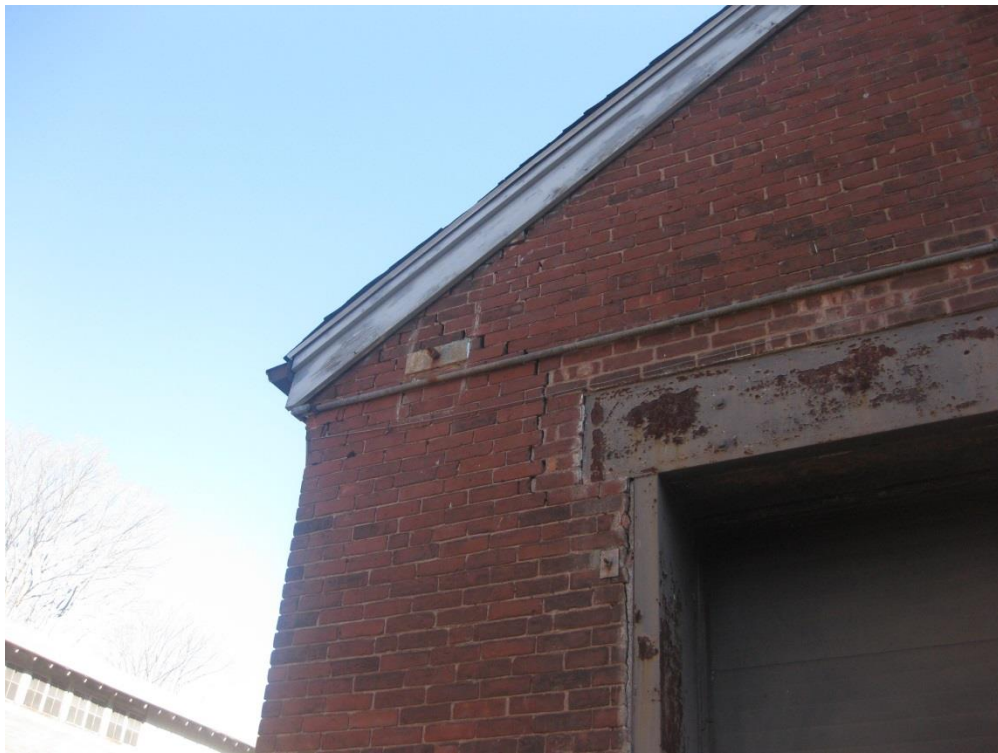
**Photo B-8 – Stepped crack at infilled garage door**
