## Structural Condition Report

**City of Haddam**  
**Former Scovil Hoe Facility**  
**11 Candlewood Hill Road**  
**Higganum, CT 01040**

December 13, 2017

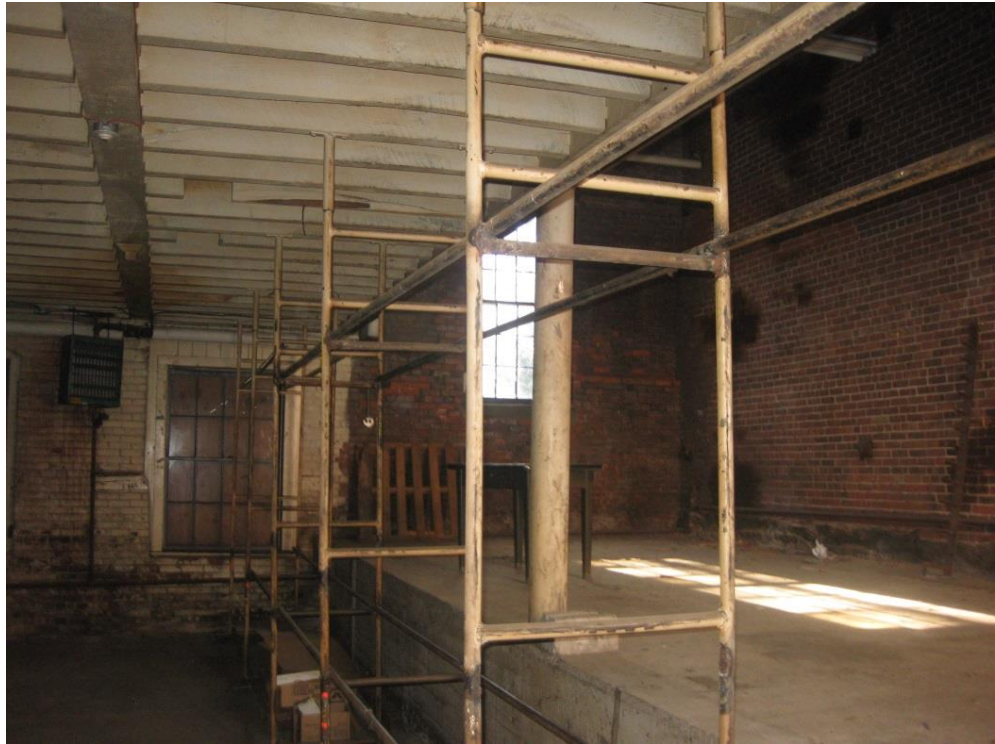
- Section 1 of the building has added post shoring that reinforces the west end of the mezzanine above the area where the main floor slab is lower (see photo B-9).

**Photo B-9 – Retaining wall, framing and shoring at east end of Building B**

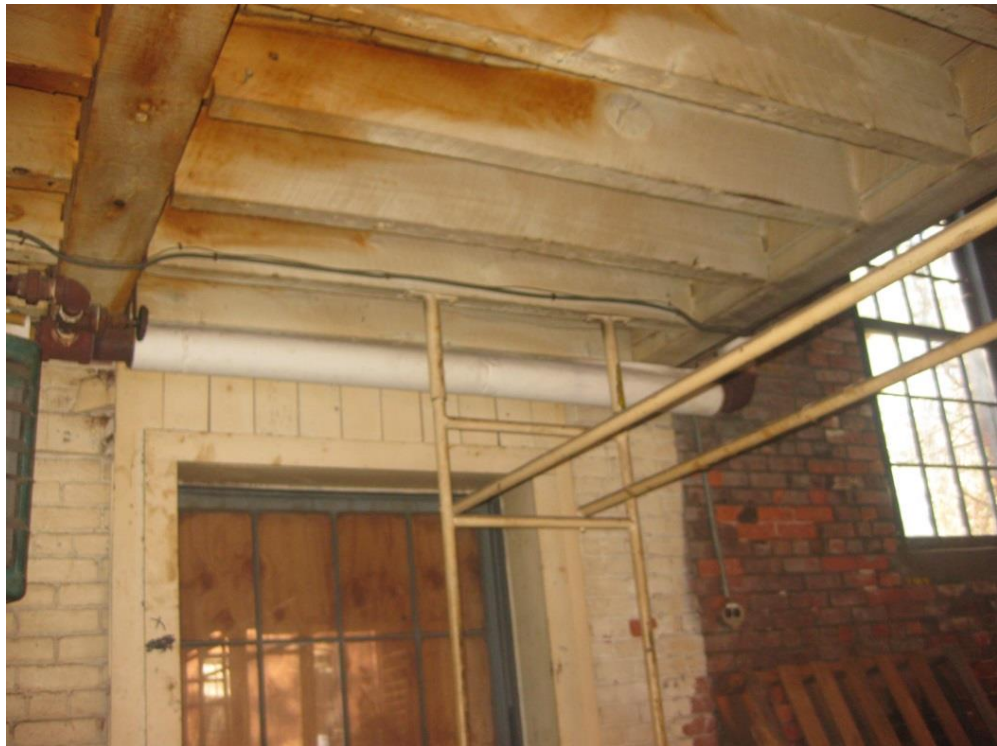
- The wood framing that supports the mezzanine in section 1 of the building has signs of water damage as well as some deterioration at the bearing ends (see photo B-10).

**Photo B-10 –Moisture stains on wood beams at mezzanine**

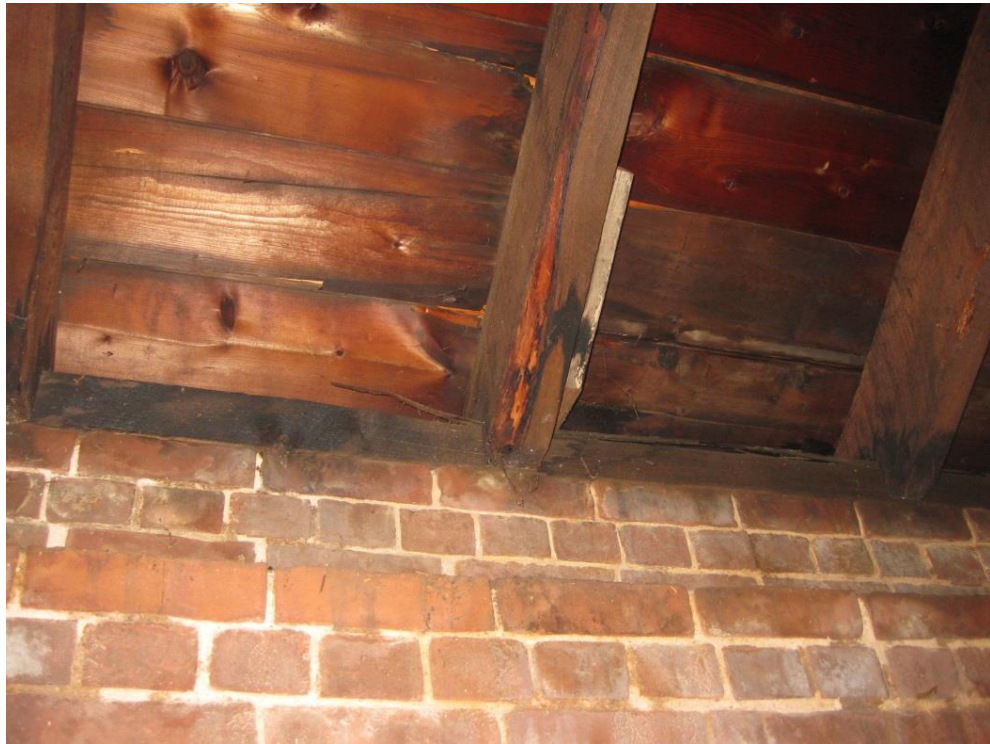
**Photo B-11 – Weathered roof planks and cracked rafters**

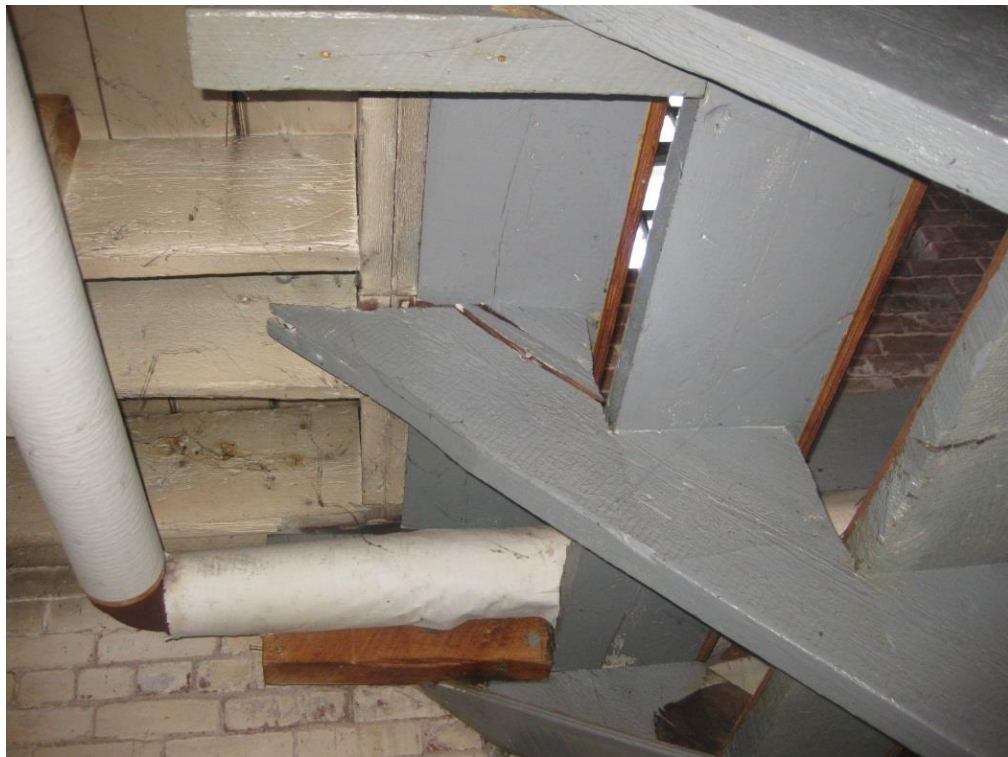
**Photo B-12 – Wood stringer failure at mezzanine stair**

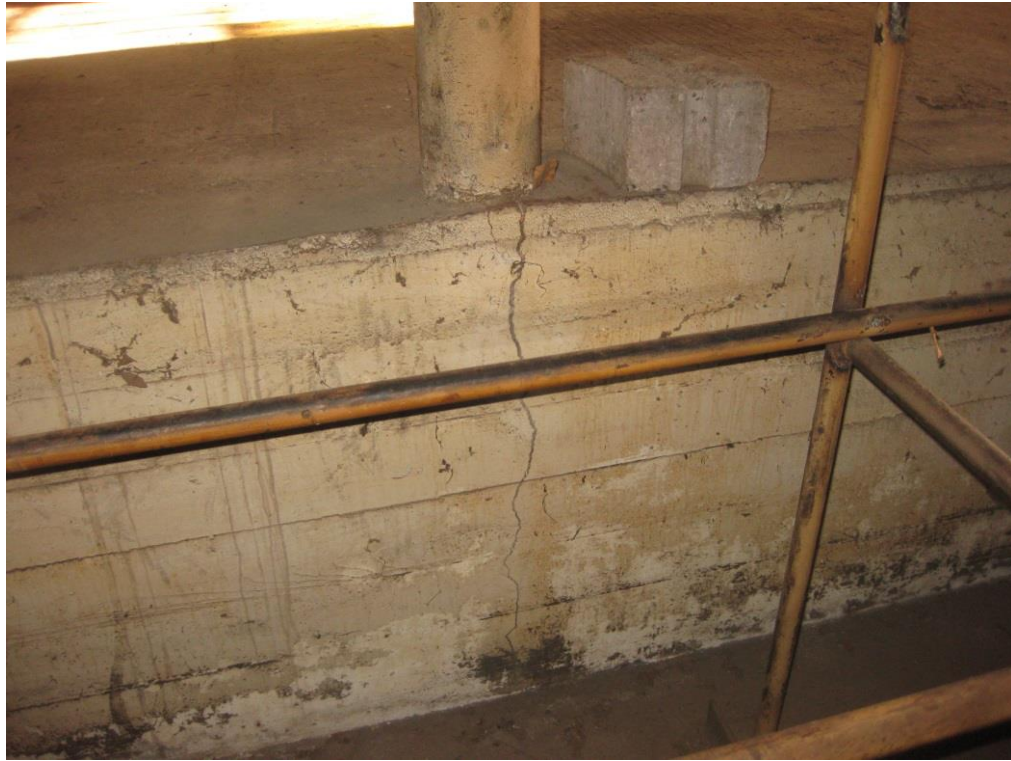
- There is a vertical concrete crack in an interior retaining wall that separates the two different floor levels, directly below an interior column (see photo B-13).

**Photo B-13 – Vertical crack at concrete wall directly below column**

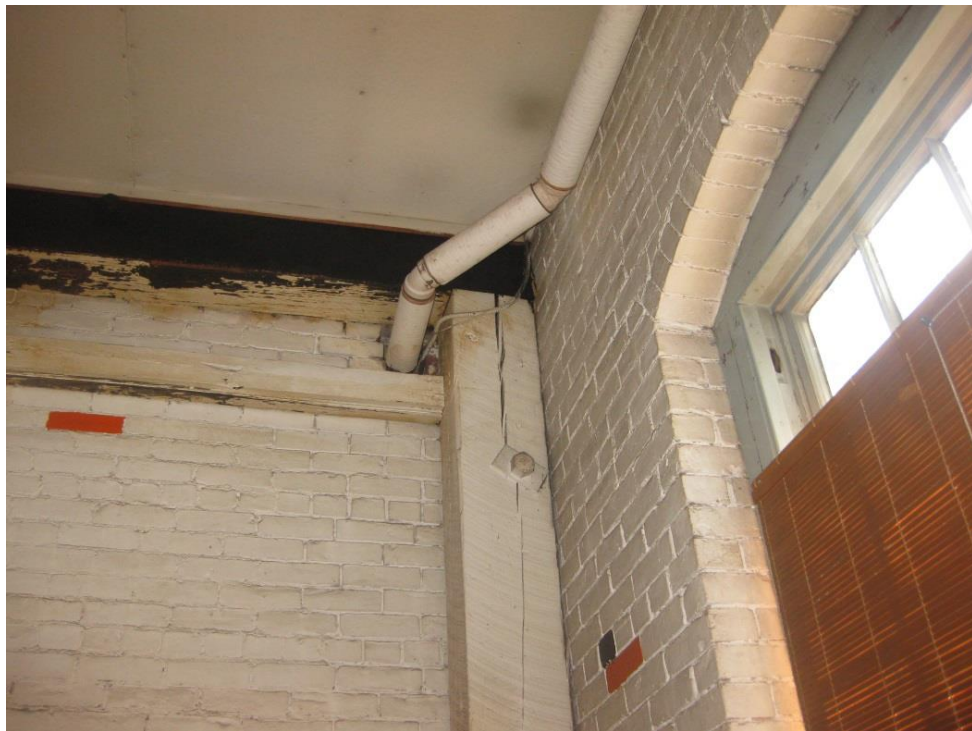
**Photo B-14 – Significant vertical crack at wood column**

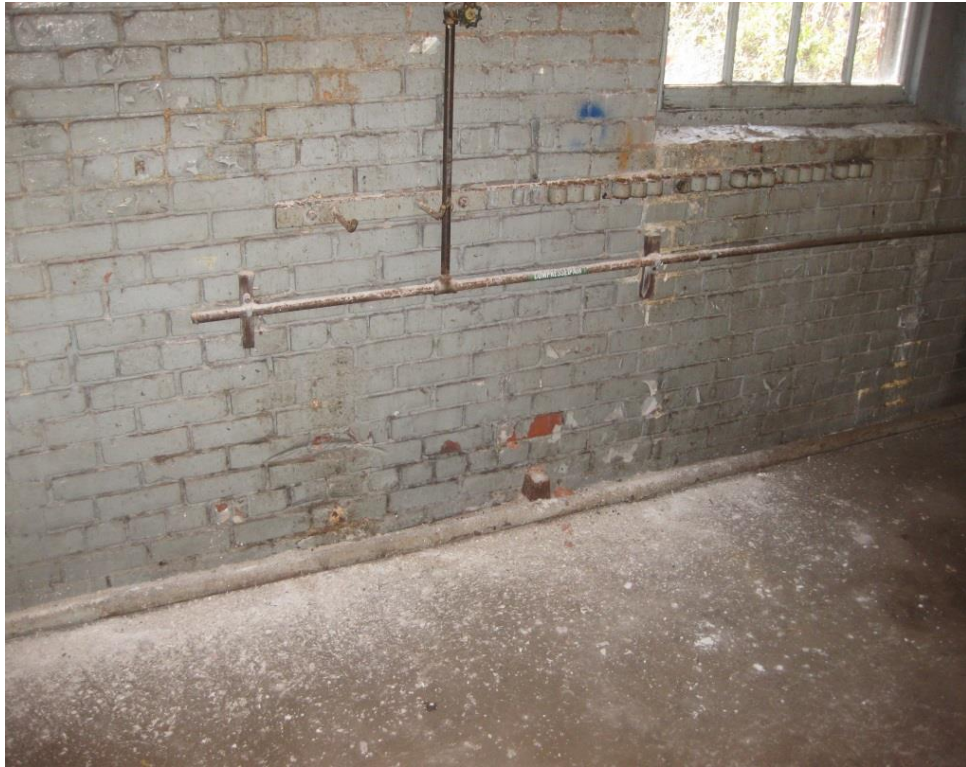
**Photo B-15 – Disintegrated mortar at inside face of exterior wall**

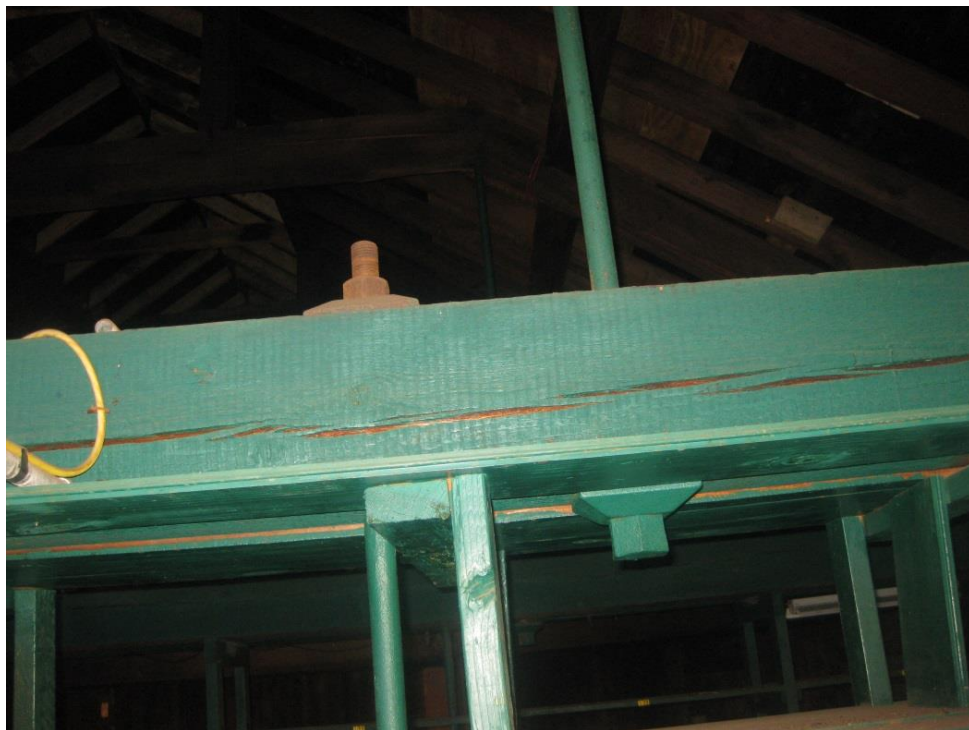
**Photo B-16 – Horizontal crack on the wood truss bottom chord (east side)**

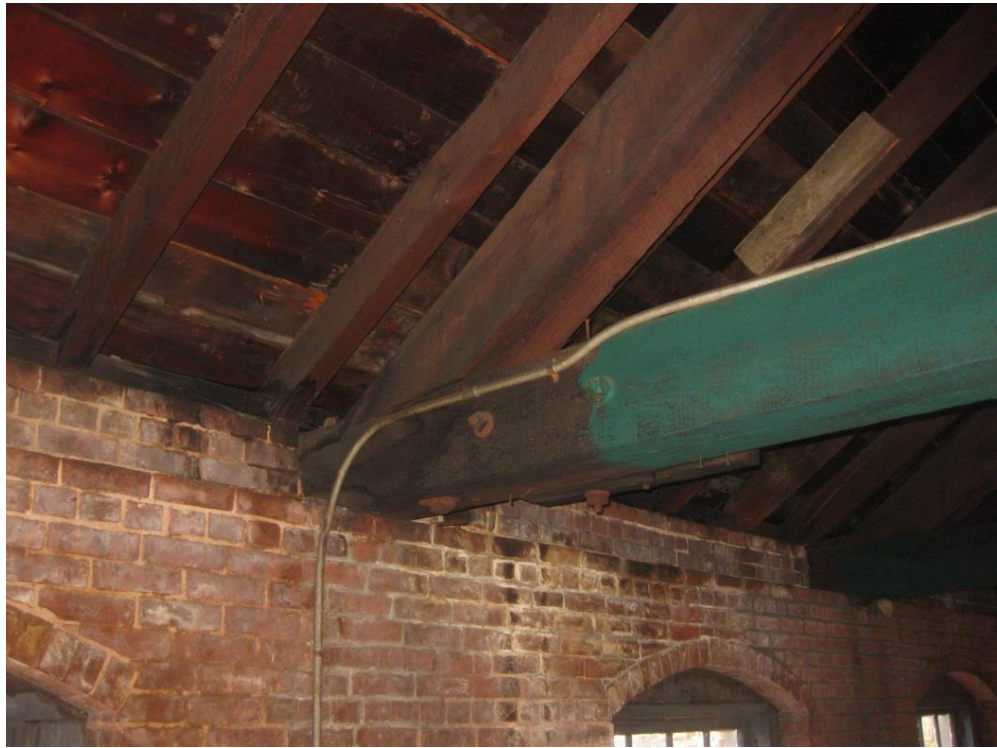
- The roof structure at section 1 can be observed from the mezzanine (see photo B-17). Some deteriorated truss members appear to be reinforced by sistered wood beams on each side. Several roof planks have also been replaced. Several truss members and rafters were found with significant cracks and evidence of water infiltration (see photos B-16 and B-17).

**Photo B-17 – Deteriorated and weathered wood truss at wall bearing (east side)**

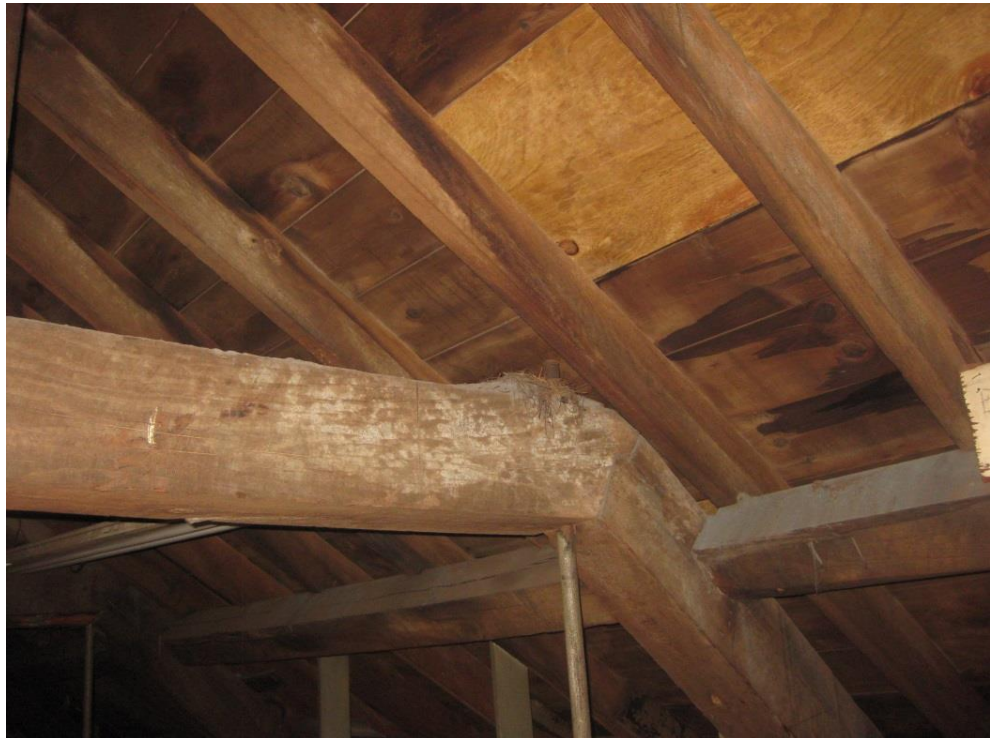
- From the mezzanine in section 2 of the building, the roof structure is visible, including the trusses, rafters and planks (see photo B-18). Some of the truss members and rafters have been reinforced with sistered members on each side, and deteriorated wooden planks have been replaced with newer planks and sections of plywood. There is evidence of water infiltration and deterioration on the wood framing (see photo B-18 & B-19), but overall the roof structure appears to be intact.

**Photo B-18 – Deteriorated and weathered wooden truss (west side)**

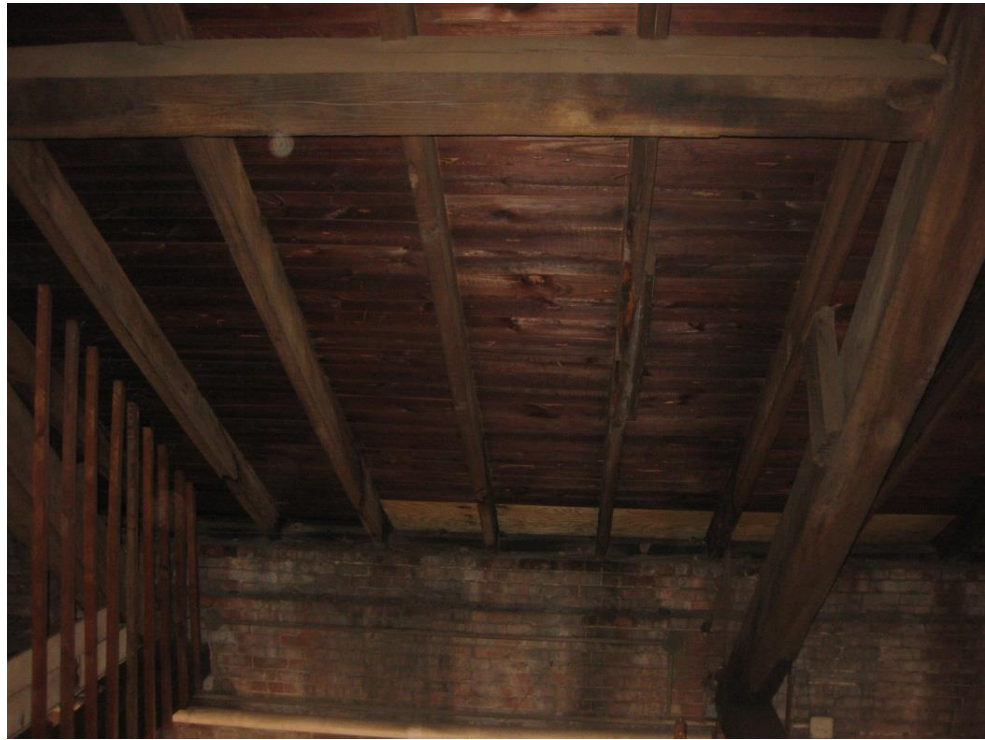
**Photo B-19 – Wood roof planks and framing**
