# REHABILITATION STUDY REPORT

State Project No. 40-141  
Bridge No. 01138 in East Haddam  
Route 82 over Connecticut River

State of Connecticut  
Department of Transportation  
Newington, Connecticut

*Submitted:* April 2017

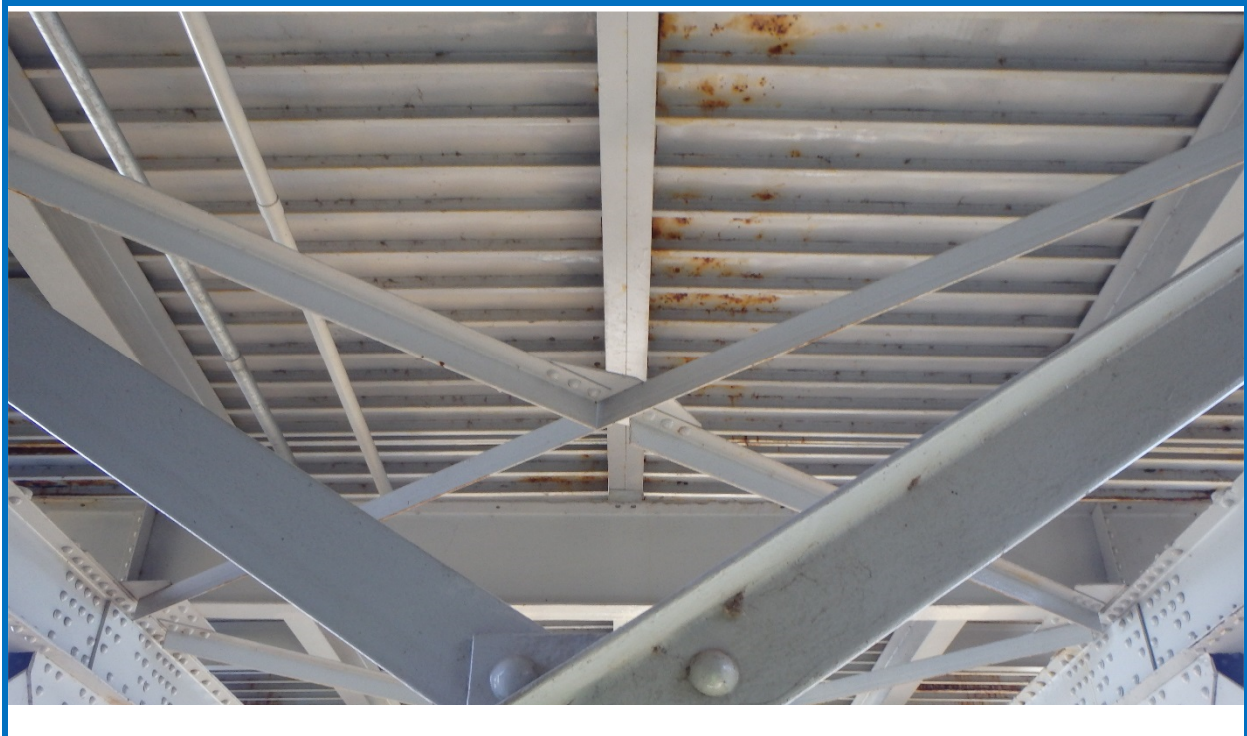
*Stay-in-place (SIP) forms cover the deck underside in Spans 1 and 2. Note there are areas of moderate rust on the SIPs.*

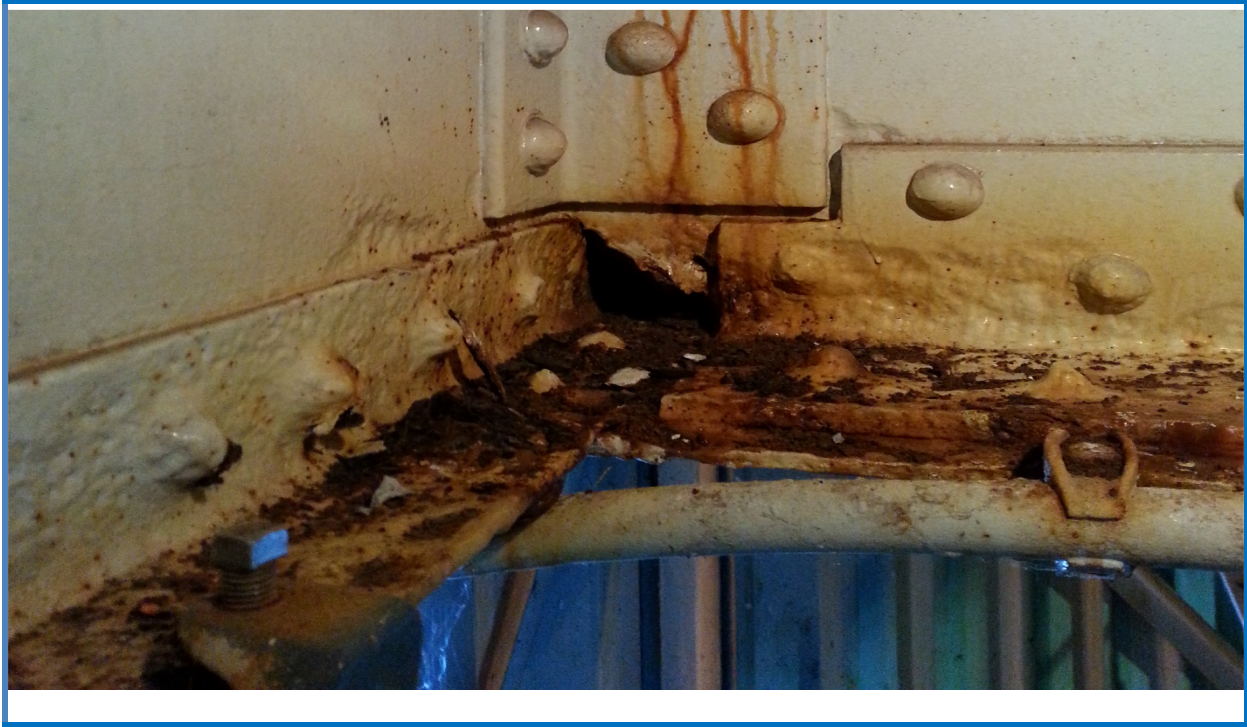
*Typical painted over pitting loss in floorbeams and truss members and evidence of additional corrosion.*

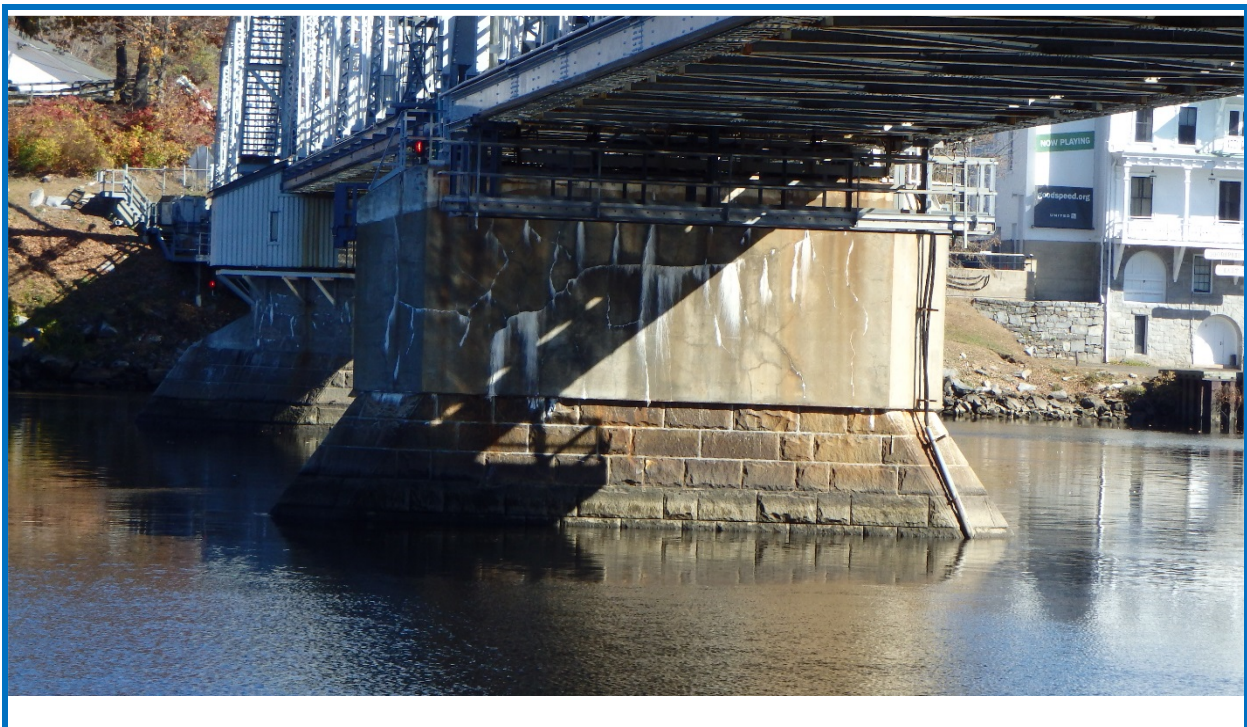
*Pier 2 West Elevation. There is extensive map cracking with efflorescence.*

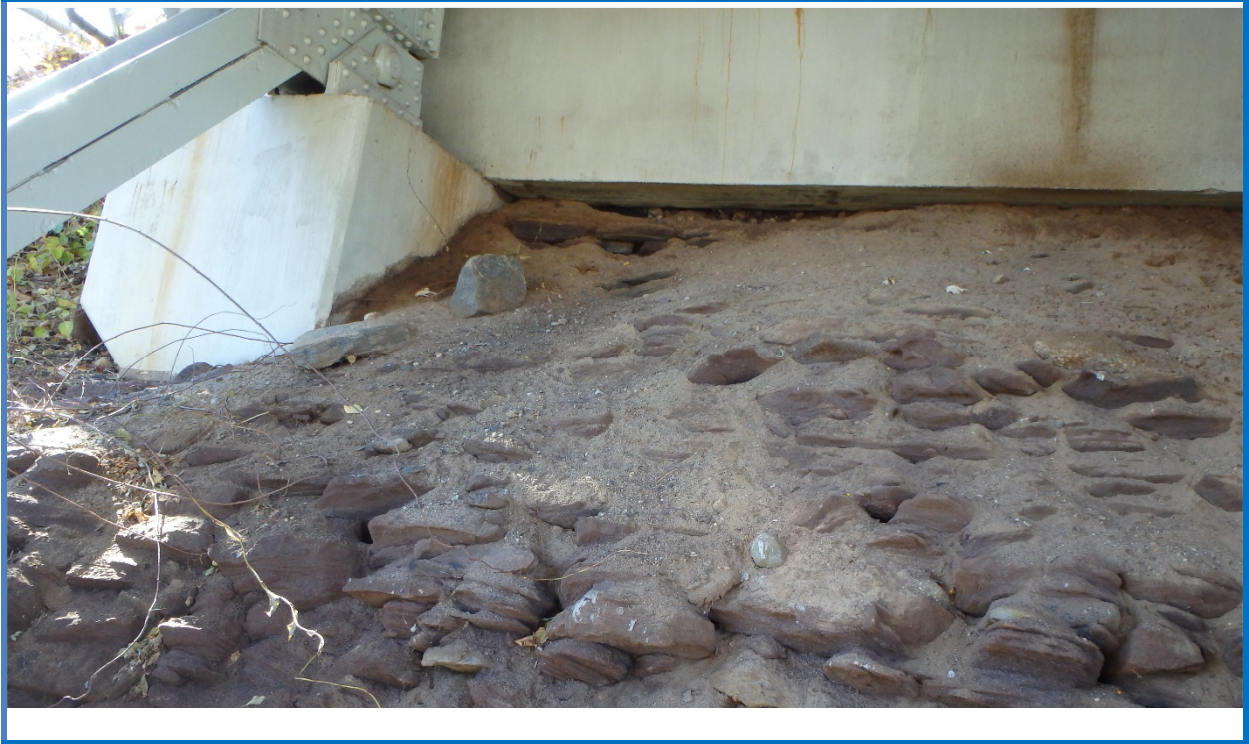
*West Abutment. Slope protection in front of spill through abutment and some evidence of erosion.*

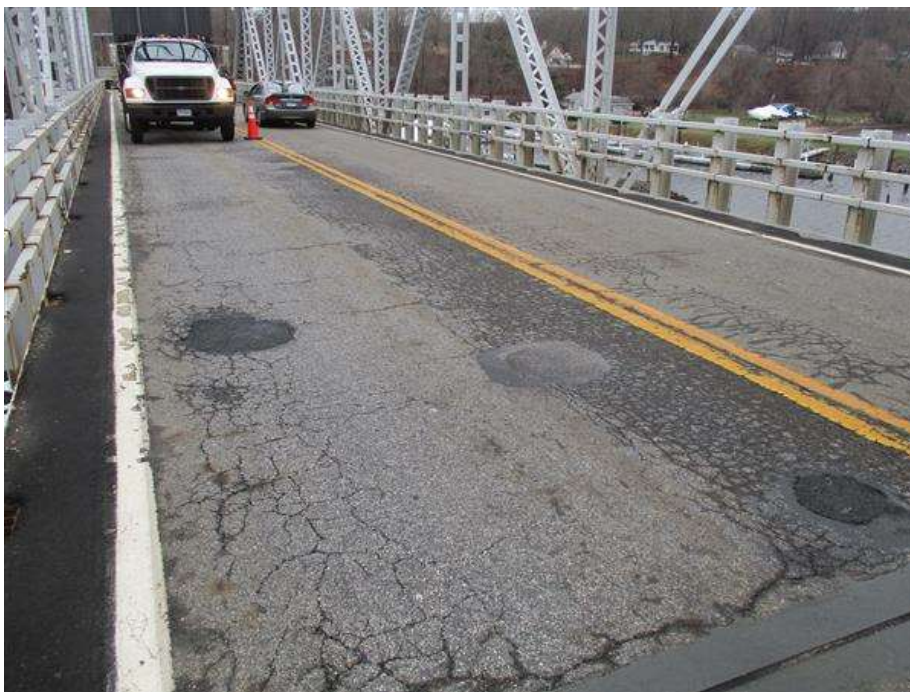
Photo Number: 6

Bituminous concrete bridge overlay in span 1. Note longitudinal and map cracks and bituminous patches in overlay.

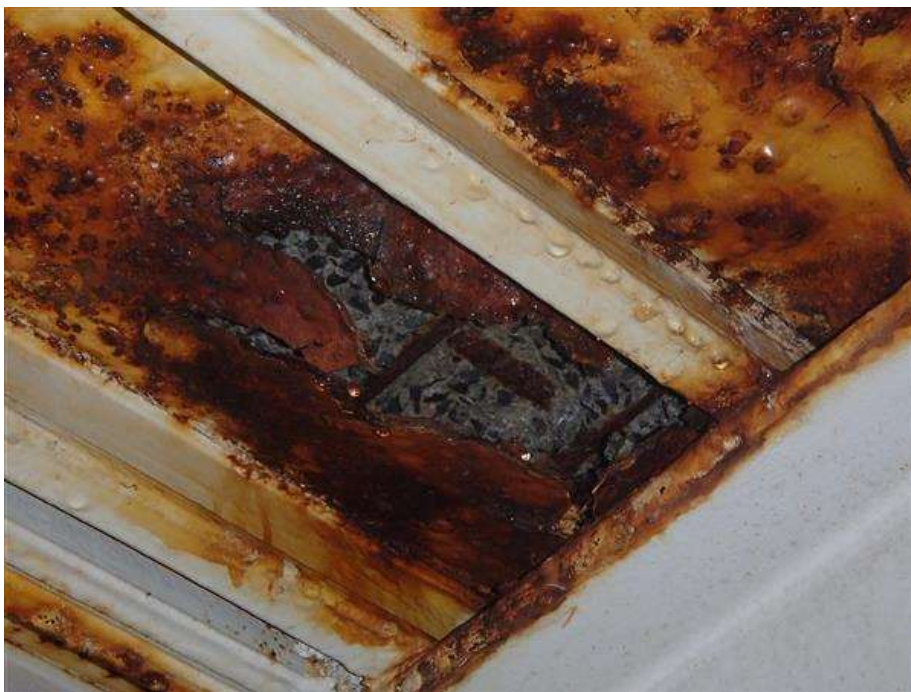
Photo Number: 14

Underside of SIP with light rust and active leakage in span 1 between S4 & S5, adjacent to floorbeam U0.

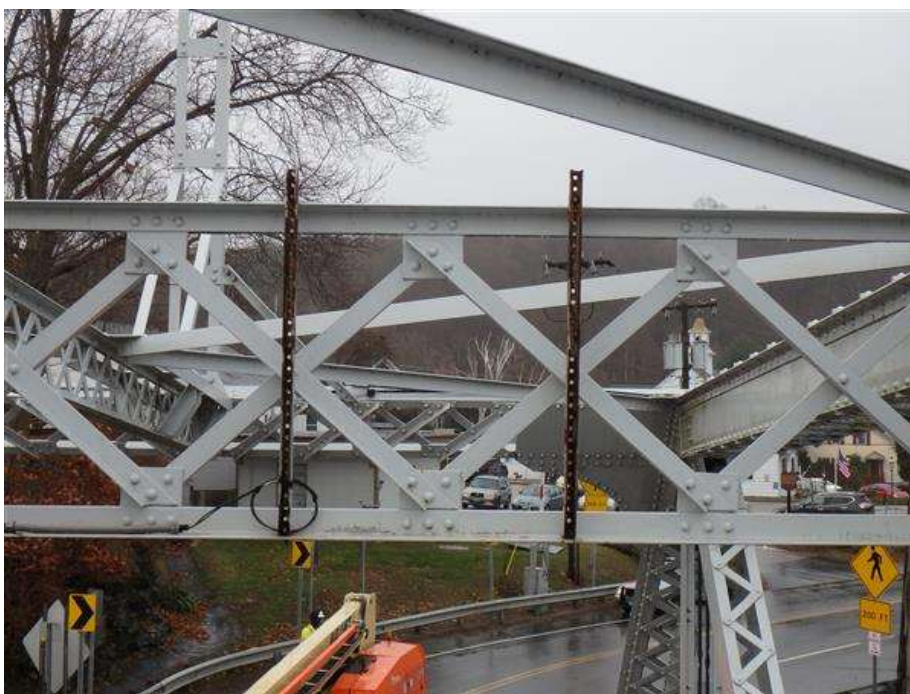
Photo Number: 24

Missing conduit access cover at panel point M9 in north truss of span 3

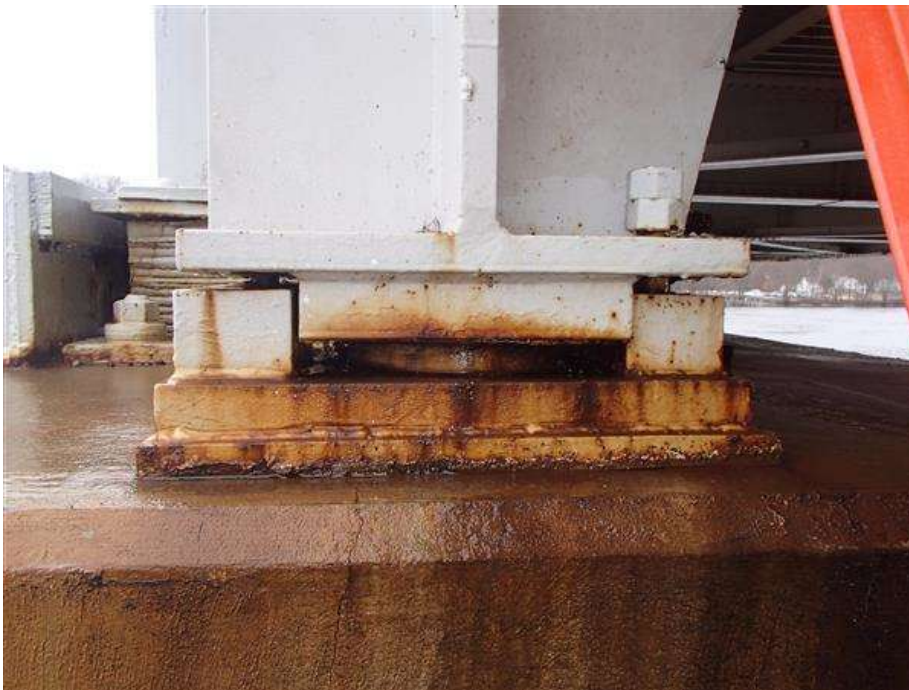
Photo Number: 36

Elastomeric expansion bearing for north truss at pier 1 in span 1. Note the painted over pitting loss on the bearing steel plate and pack rust under the north pin.

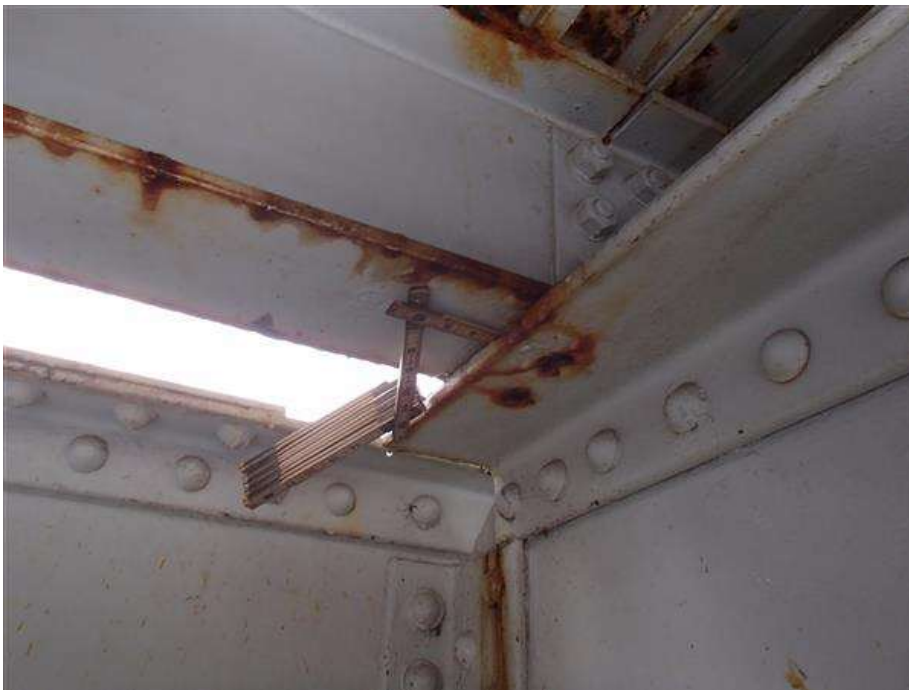
Photo Number: 42

Bearing for stringer S1 at west side of floorbeam FB9 in span 4. Note the missing filler plates with gap under the stringer.

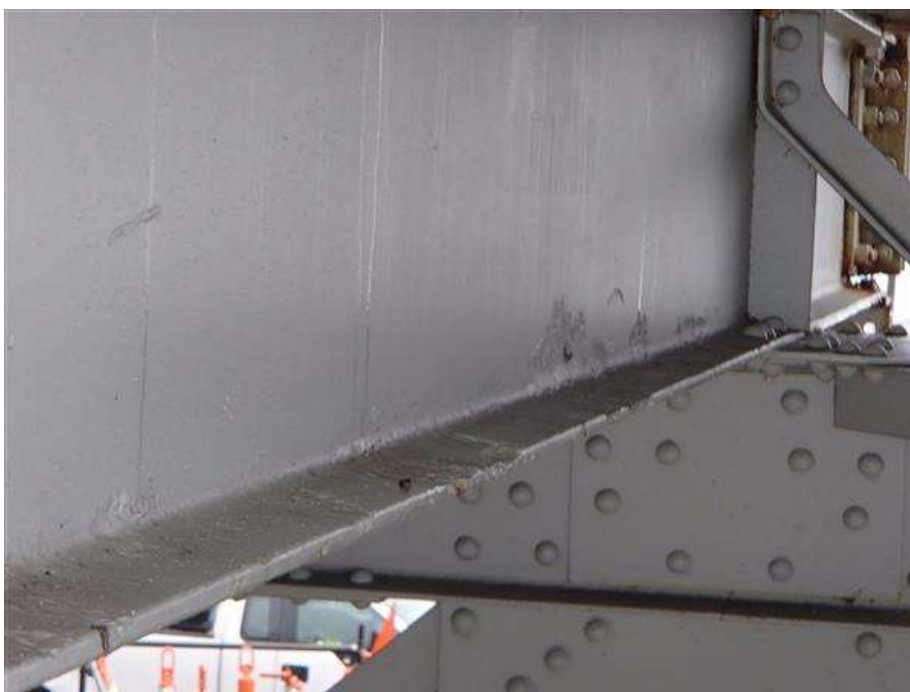
Photo Number: 44

South elevation of stringer S4 at floorbeam 17 in span 3. Note the missing and loose bolts in the splice connection.

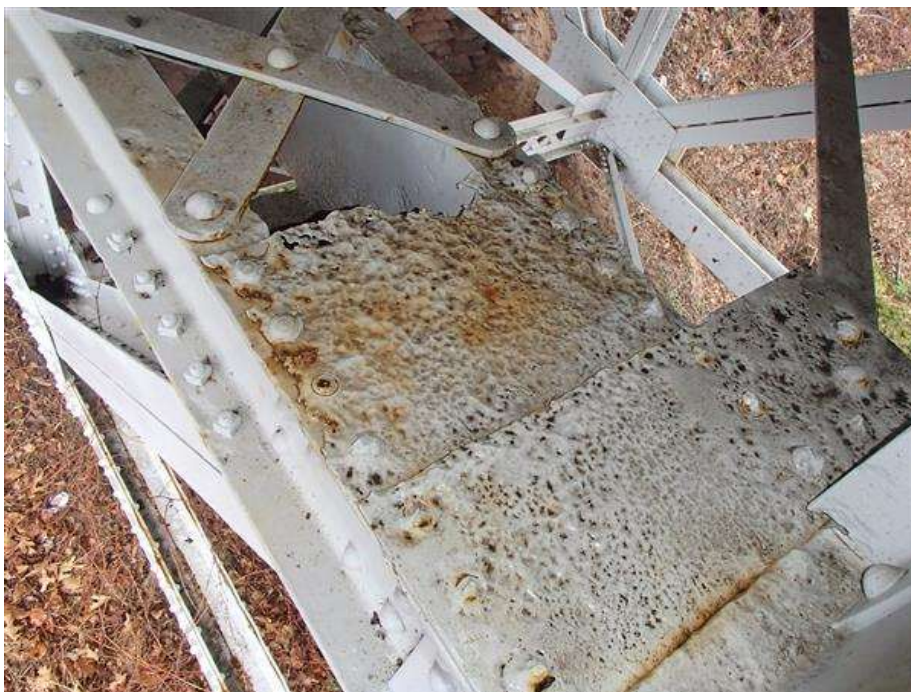
Photo Number: 56

East face of floorbeam FB10 (north end) in span 4. Note the missing fiberglass cover at the floorbeam top flange.

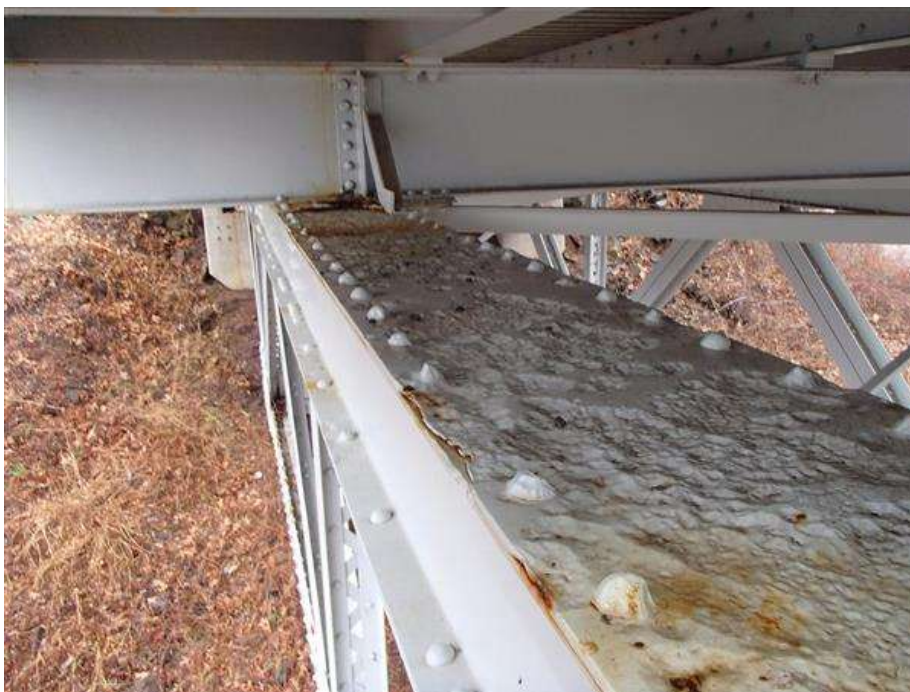
Photo Number: 58

Moderate to heavy rust with perforation in the horizontal gusset plate at panel point U3 in south truss, span 1.

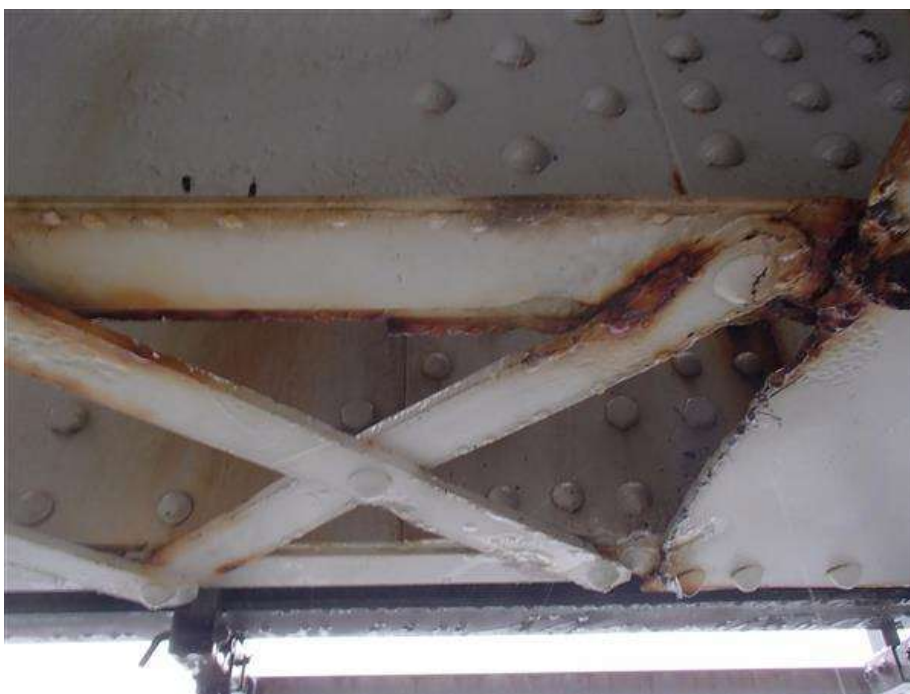
Photo Number: 66

Pack rust between the top chord plates at panel point U6 in north truss, span 2.

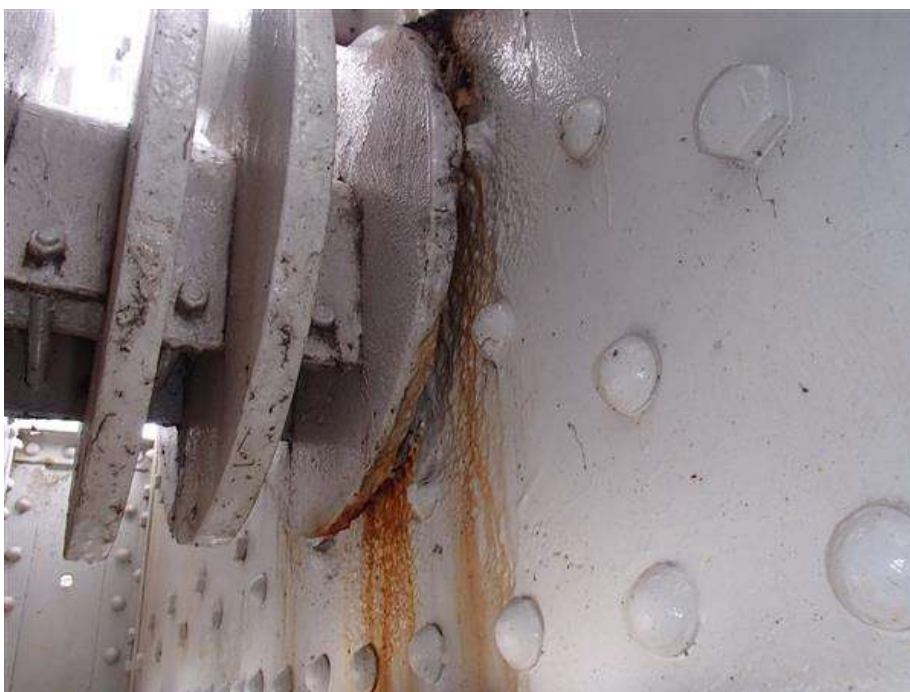
Photo Number: 92

Painted over section loss with pack rust between the eye bars at panel point U9' of south truss, span 4.

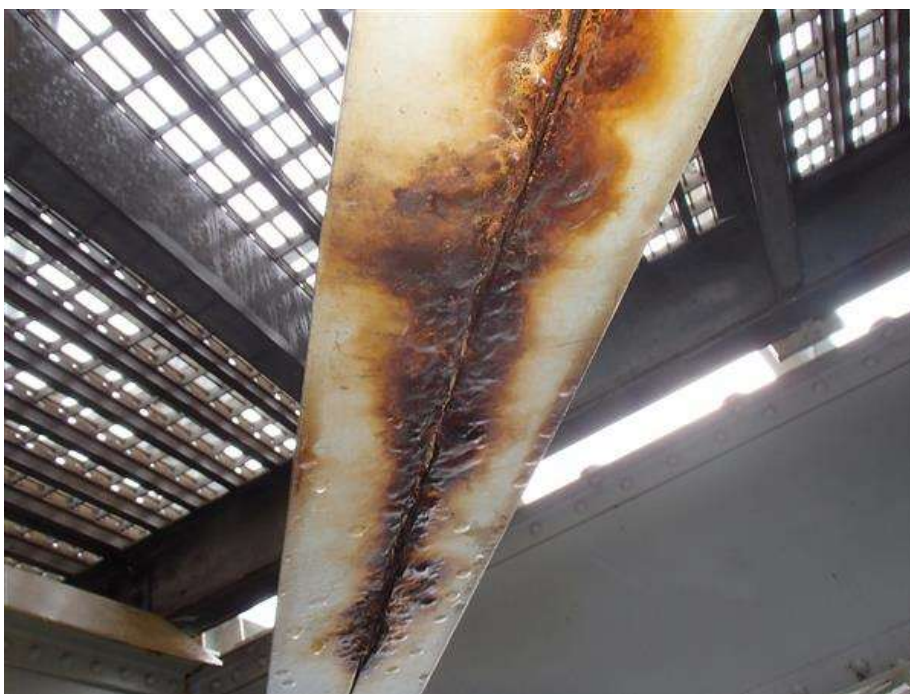
Photo Number: 100

Painted over pack rust with recurring rust between the bracing angles between floorbeams FB8 and FB9 in span 4.

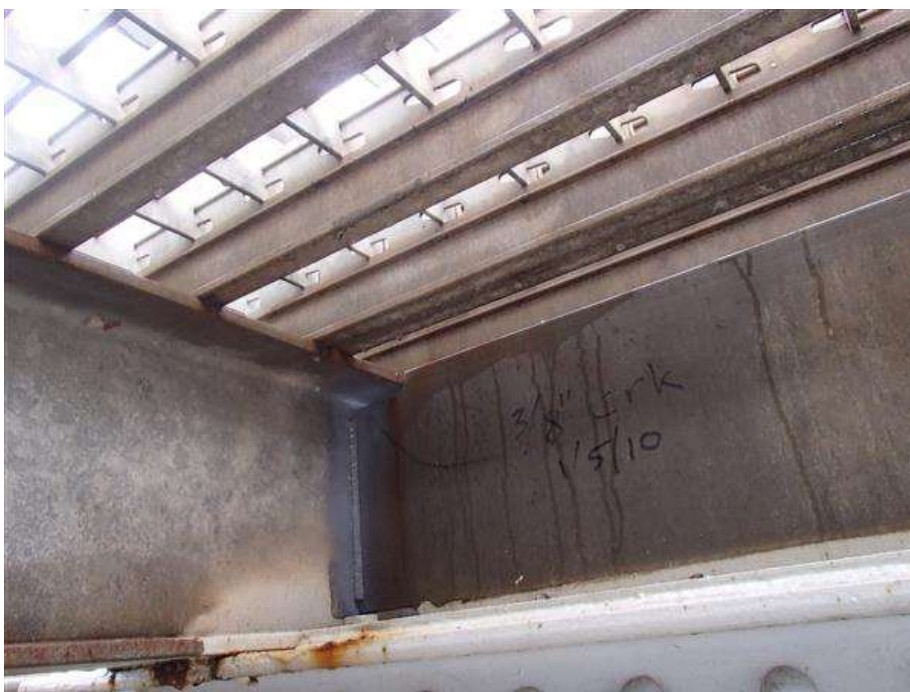
Photo Number: 106

North face of stringer S2 at pier 1 in span 1. Note the repaired crack with a stop hole and bolt since the last inspection.

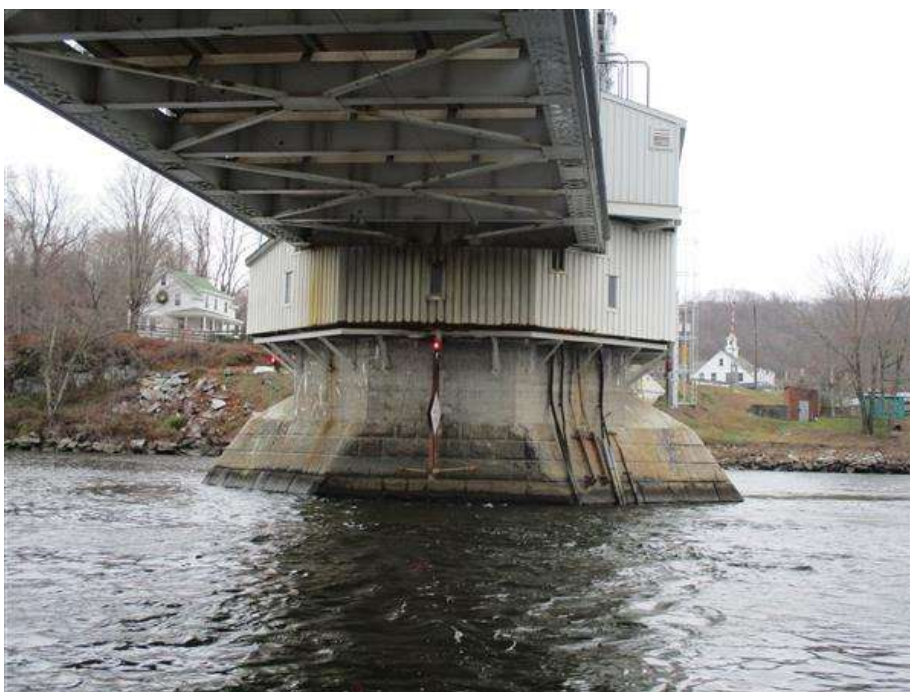
Photo Number: 114

West elevation of pier 2. Note map cracking with efflorescence to concrete cap.

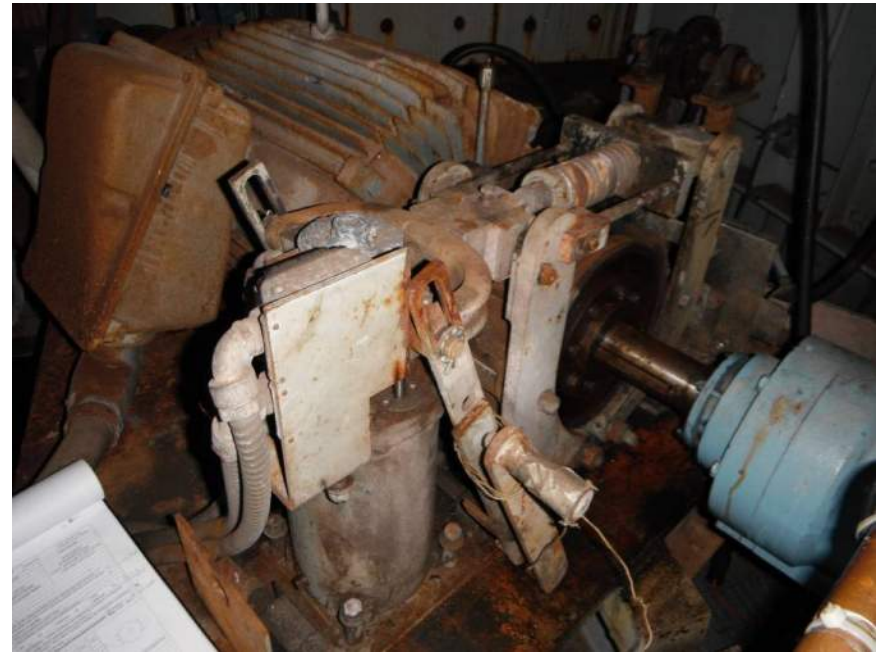
**Photo M05:** View of west motor rear extension shaft coupled to tachometer/overspeed switch assembly. Note lack of paint protection and light to moderate surface corrosion throughout.

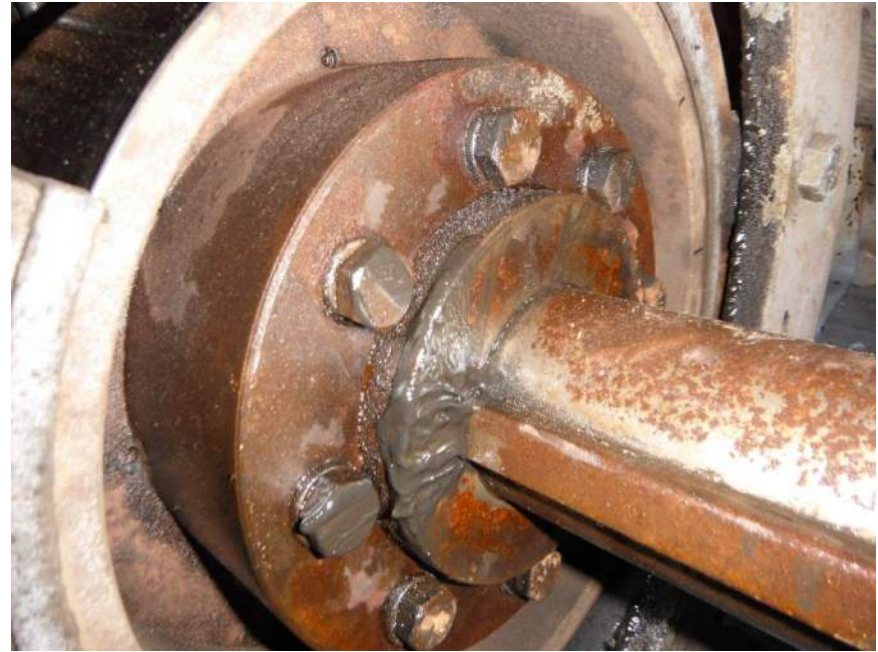
**Photo M09:** Close-up of purge plugs on west main pinion shaft coupling – plugs show signs of recent movement from maintenance activities.

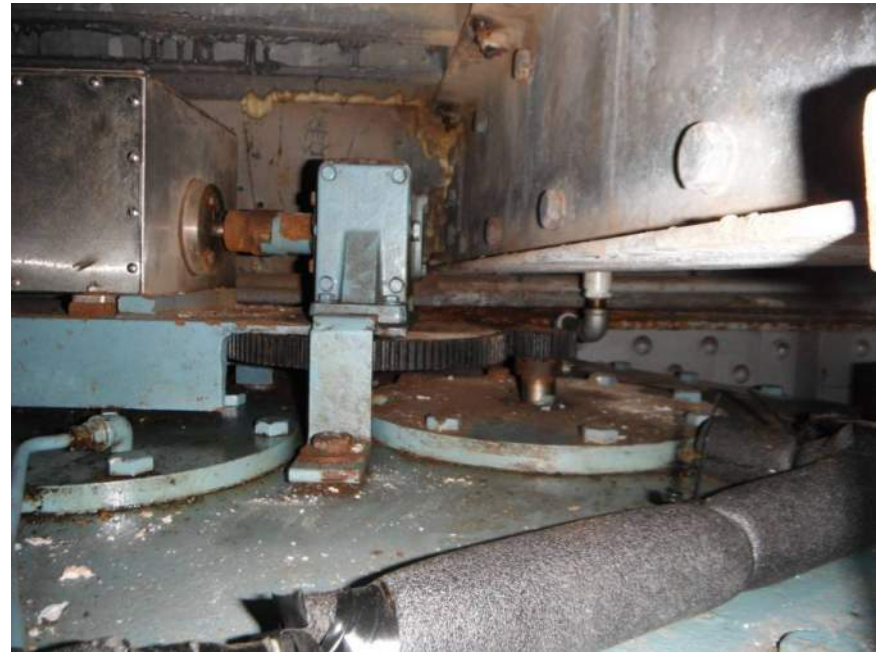
**Photo M17:** View of east span drive reducer desiccant breather requiring replacement.

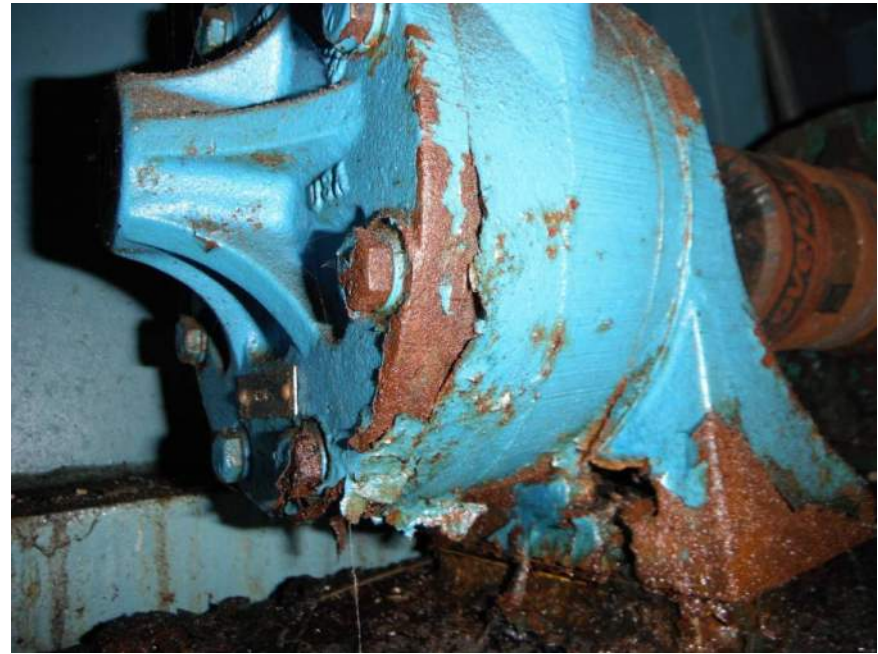
**Photo M19:** View of possible light oil seepage from east enclosed speed reducer output shaft bearing.

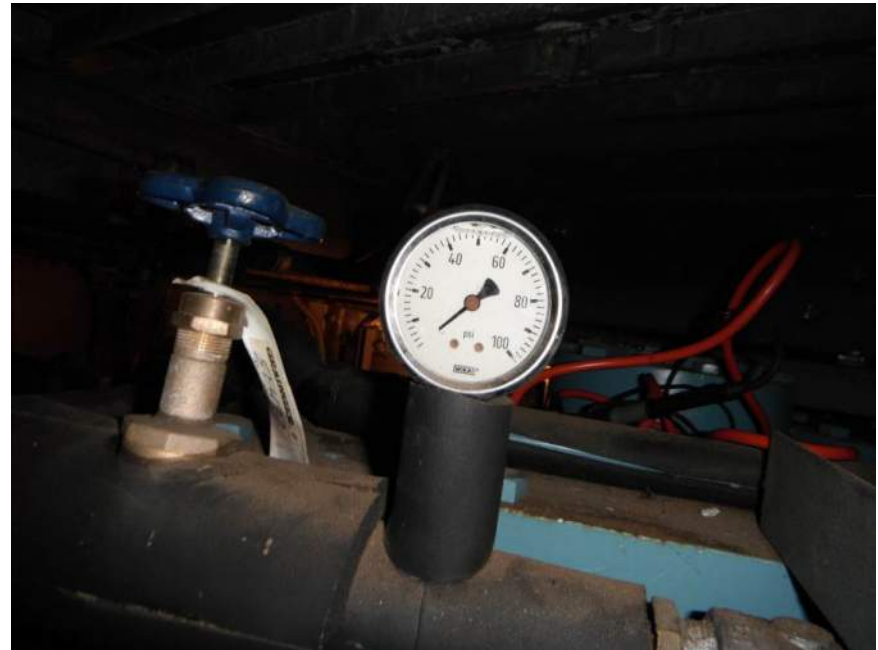
**Photo M21:** East circulating pump oil gauge with coagulated oil

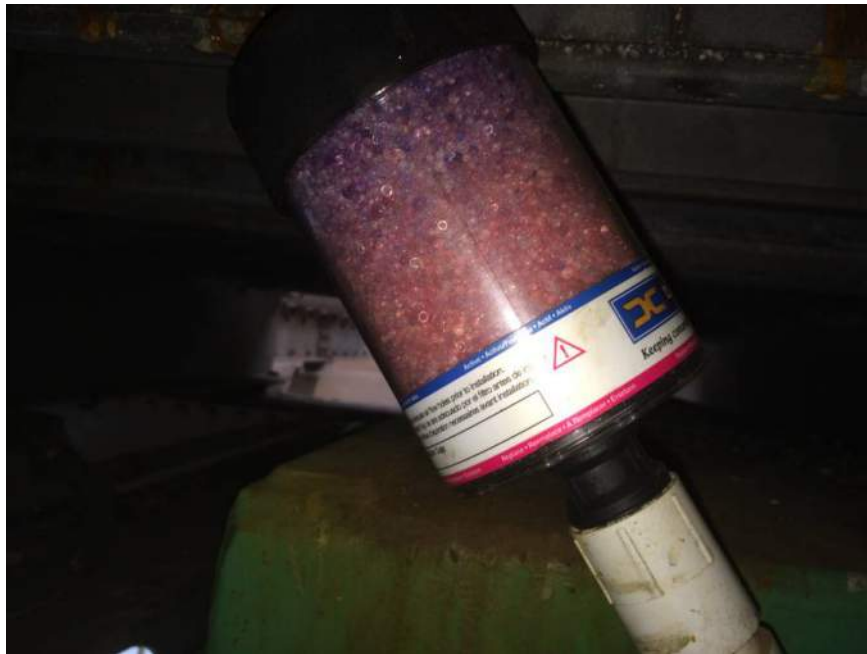
**Photo M41:** View of west end wedge gear reducer desiccant breather. Note almost all desiccant has changed color to pink, indicating the breather requires replacement.

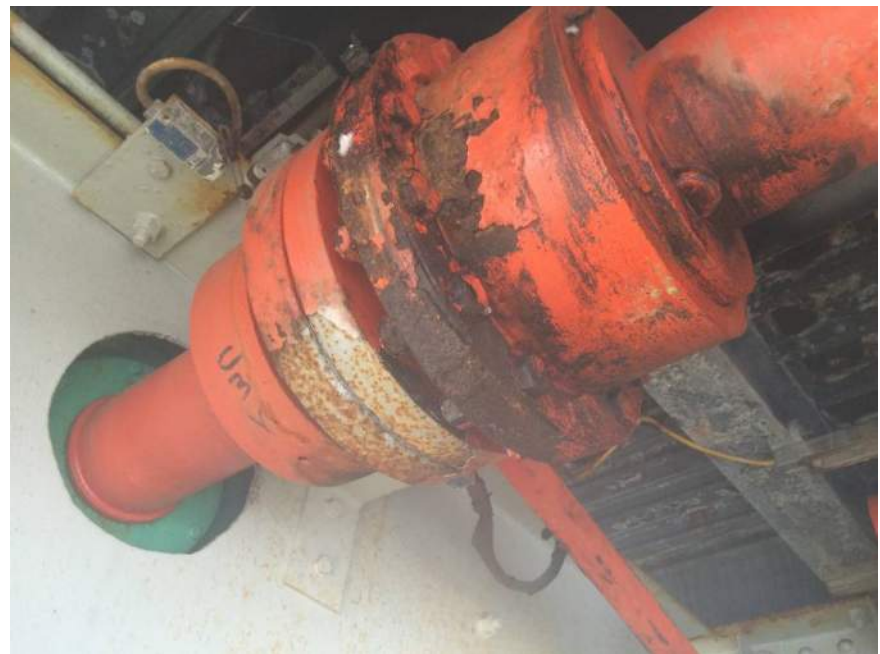
**Photo M42:** View of west end wedge C2 single engagement gear coupling. Note moderate paint failure and surface corrosion.

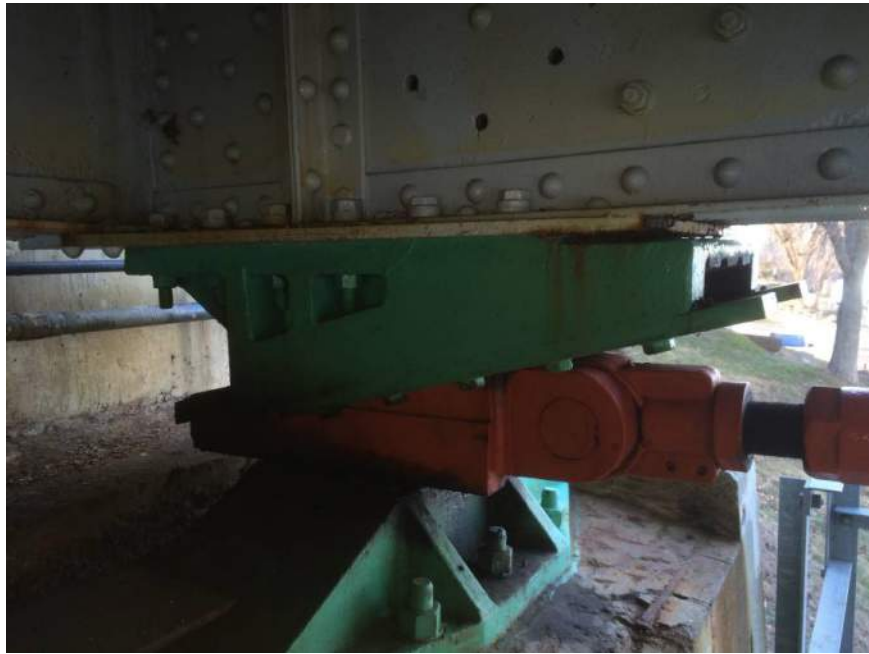
**Photo M43:** View looking south at SE end wedge assembly. Note corrosion between top shim plate and top shoe.

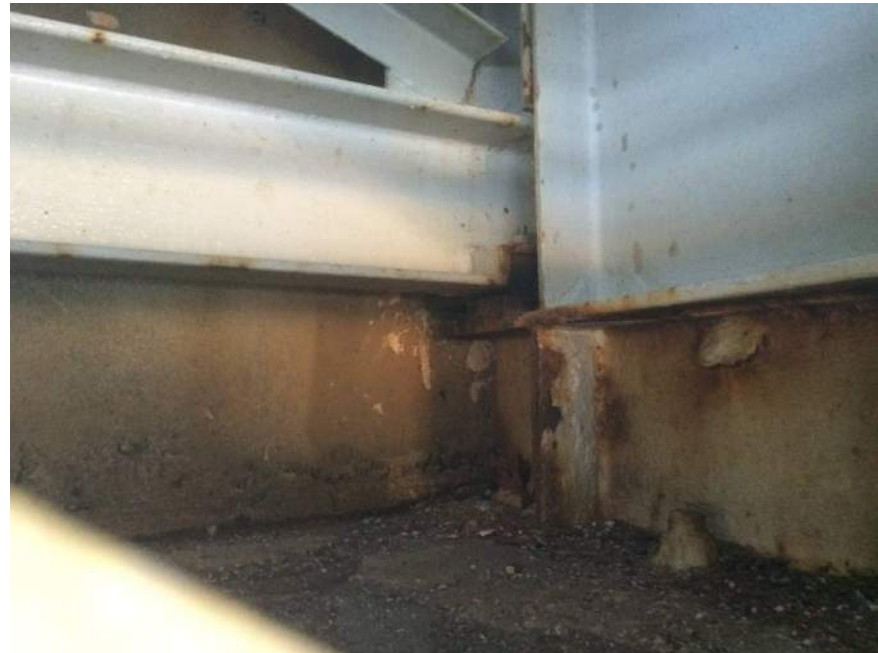
**Photo M48:** View looking at east barrier gate bottom live load shoe with gap.

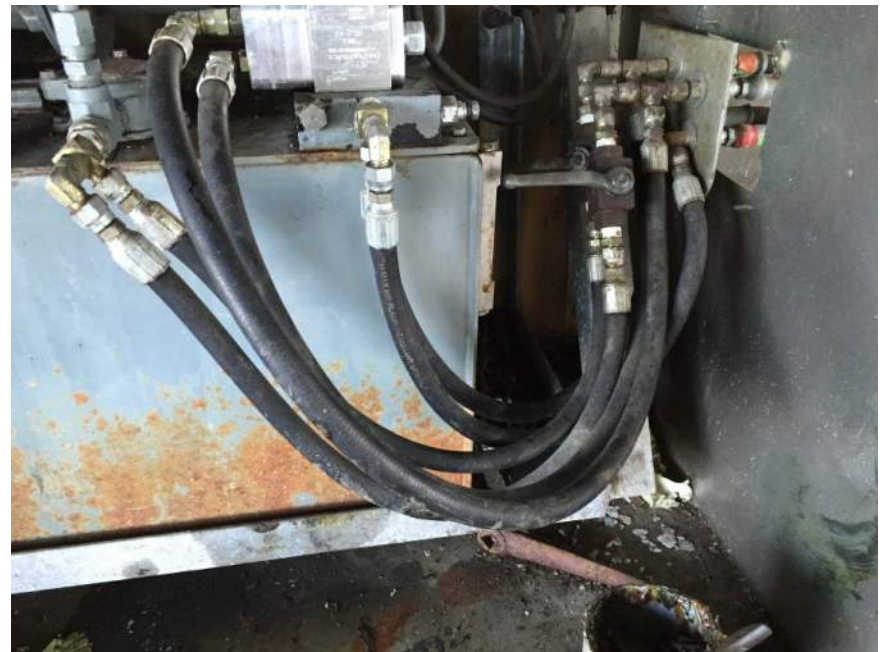
**Photo M46:** View of W barrier gate hydraulic equipment. Note broken temperature gauge.

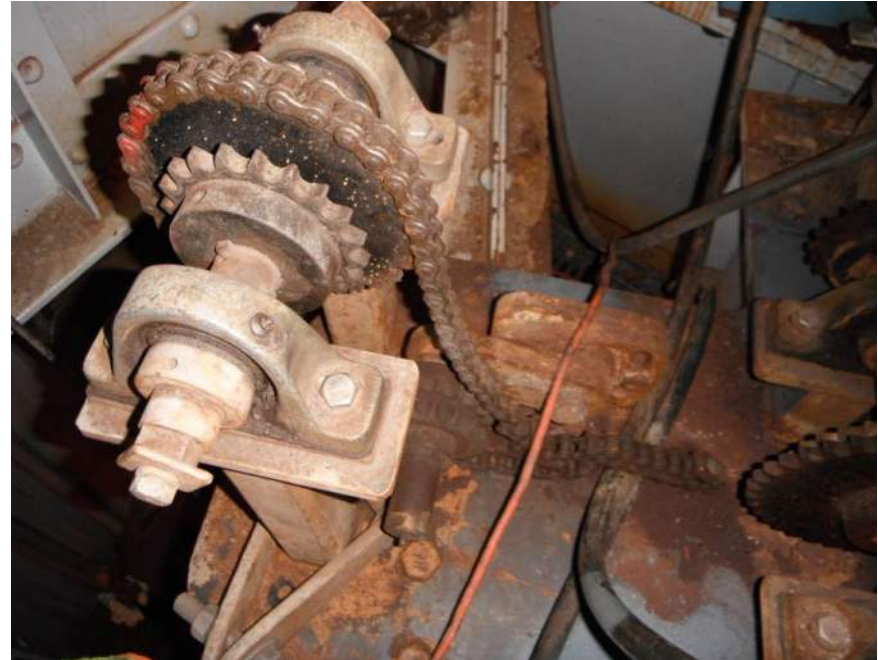
**Photo M52:** View of west auxiliary drive chain and sprocket attachment. Note light to moderate surface corrosion throughout the components and less than optimal storage conditions for the chain.

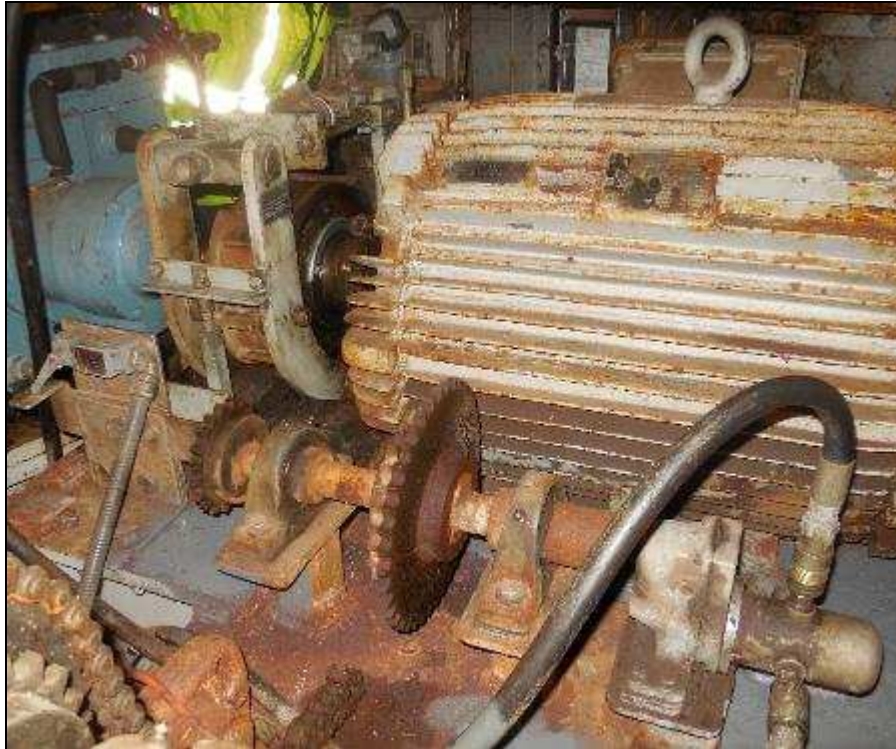
Photo E 1 Typical Span Motor Condition

Note exterior corrosion and paint failure.  
Note corrosion on motor nameplate.

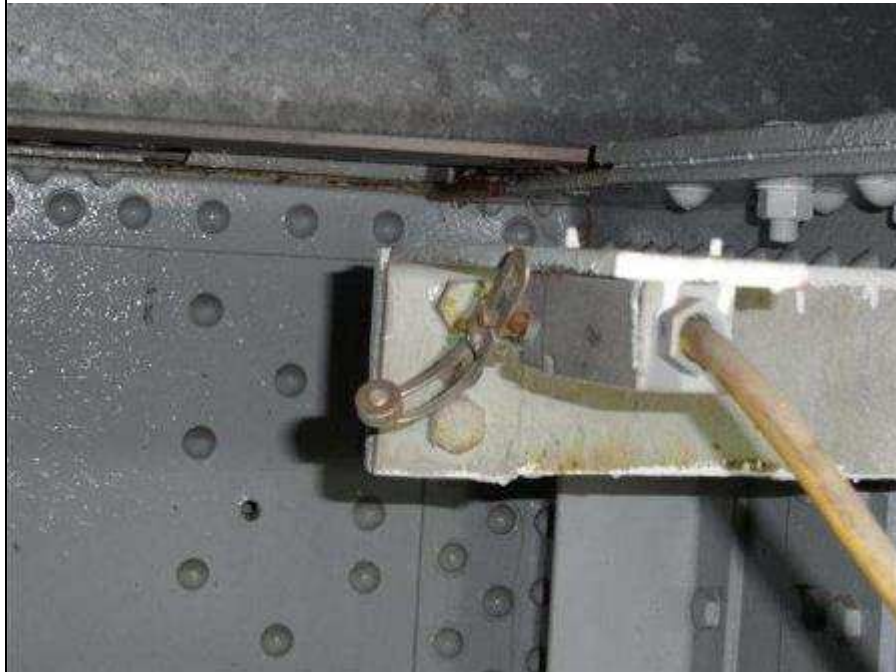
Photo E 3 North Center Wedge Limit Switch  
Note that the switch arm is bent.

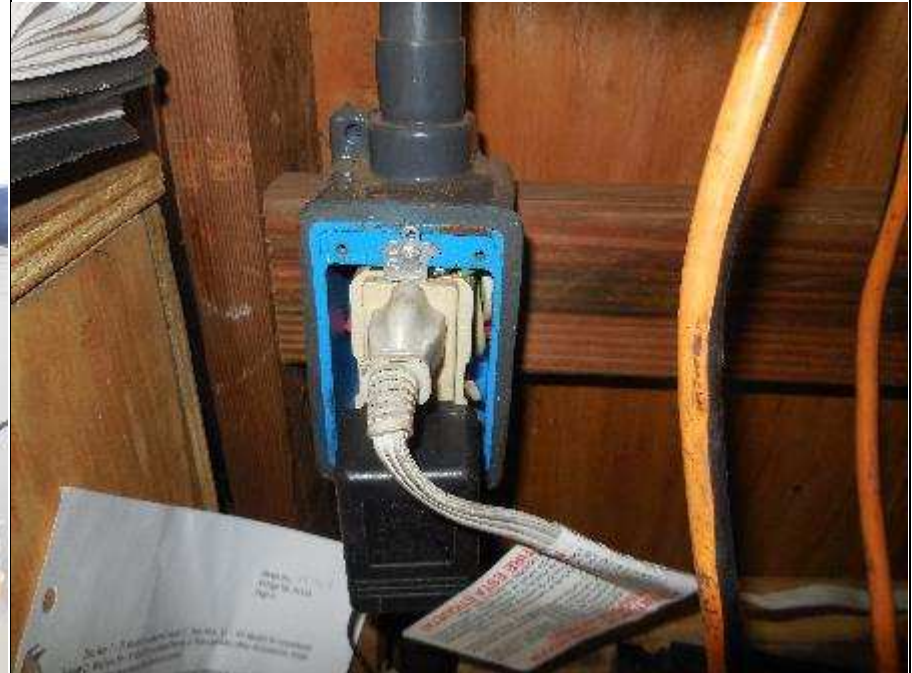
Photo E 12 Receptacle Within Electrical Room  
Note missing cover plate.

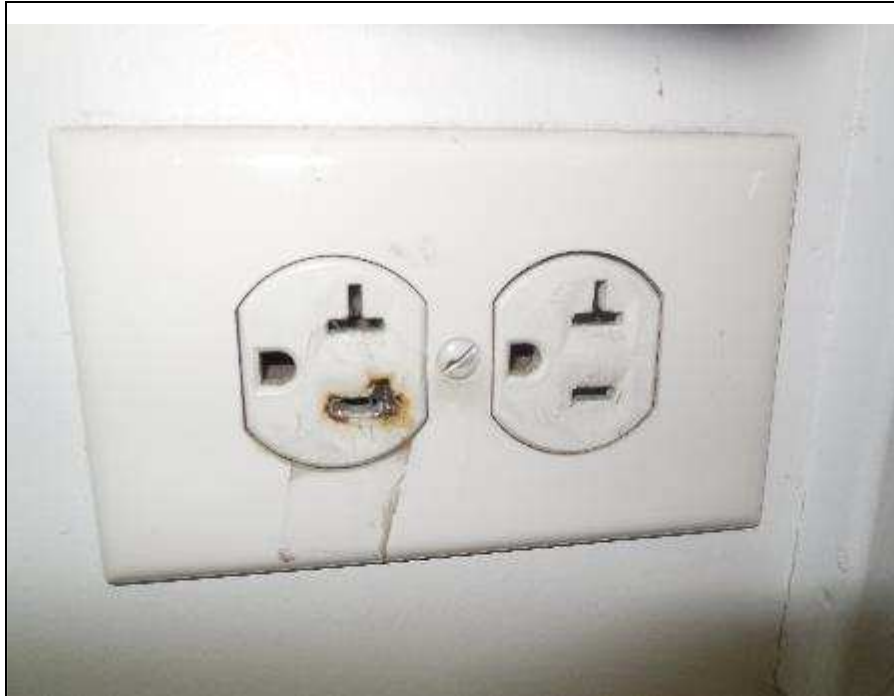
Photo E 13 Receptacle Within Control House  
Note signs of arcing and overheating.

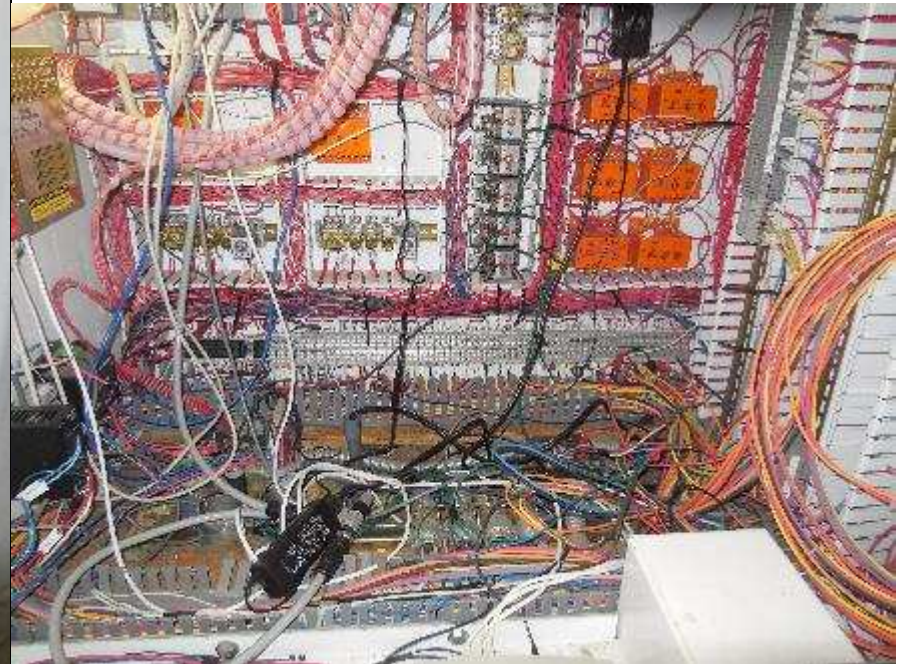
Photo E 14 Below Control Console  
Note disorganized wires, missing termination covers and power supply on wire bundle..

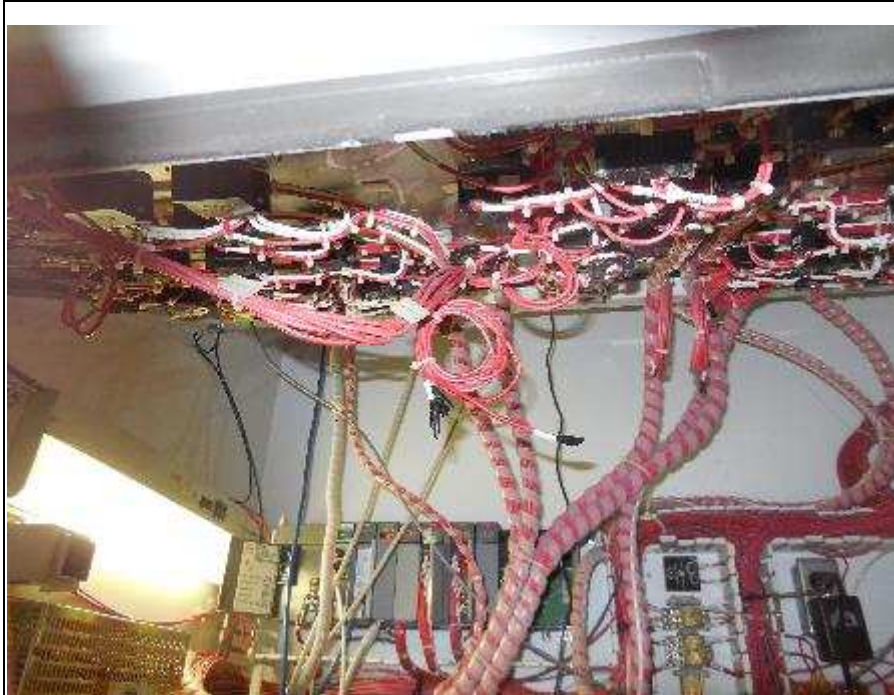
Photo E 15 Below Control Console  
Note improperly terminated wires
