# REHABILITATION STUDY REPORT

State Project No. 40-141  
Bridge No. 01138 in East Haddam  
Route 82 over Connecticut River

State of Connecticut  
Department of Transportation  
Newington, Connecticut

*Submitted:* April 2017

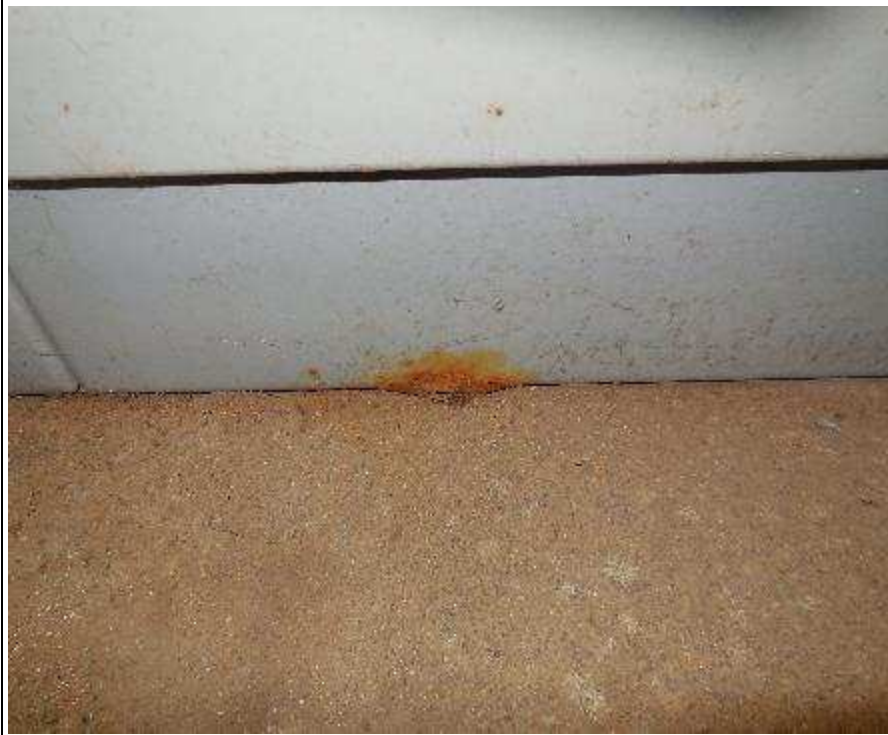
Photo E 19: Bottom of MCC  
Note corrosion starting to form.

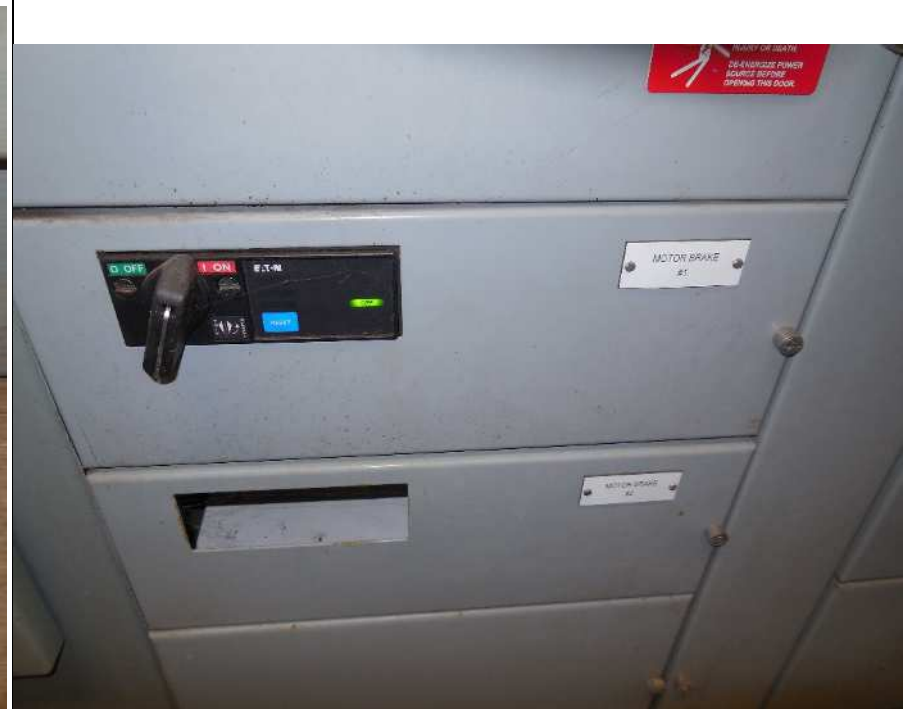
Photo E 20: MCC  
Note that the motor brake #2 controller is missing.
