TOWN OF HADDAM

FACILITY ASESMENT REPORT

Six Town Buildings

April 1, 2024

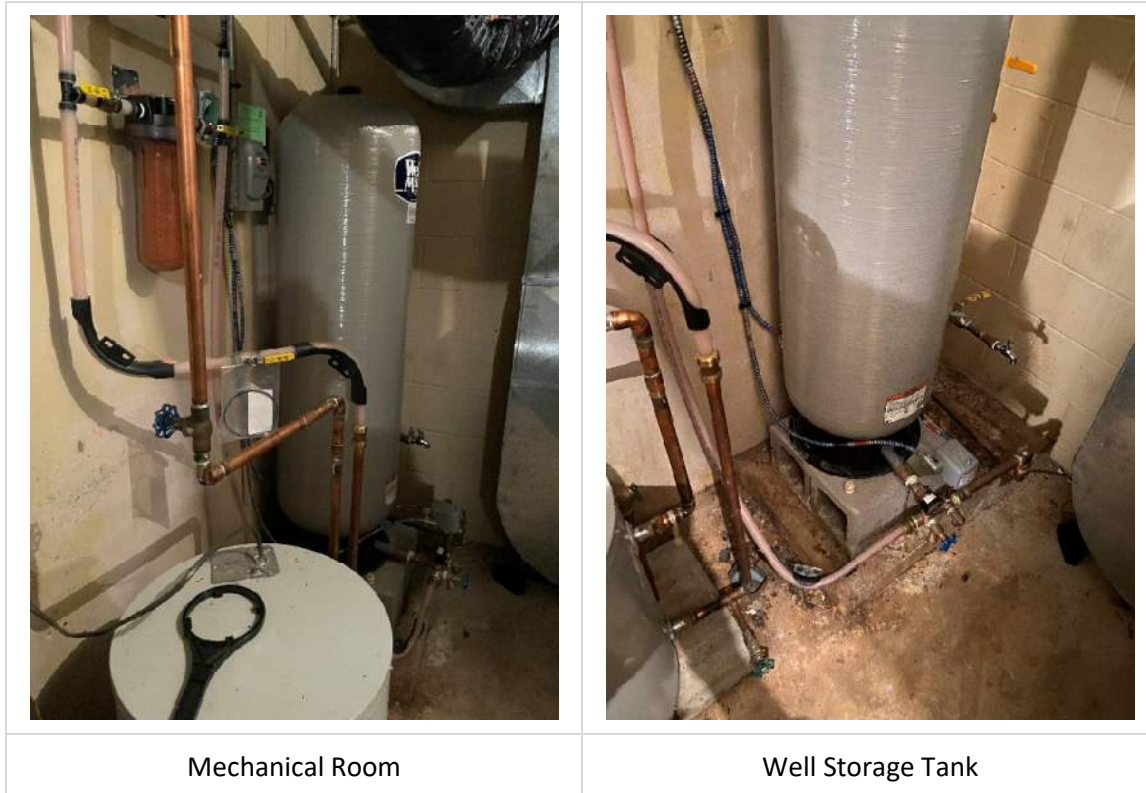
The buildings domestic water is supplied from an on-site well water system. There is a 40-gallon well storage tank located inside the building mechanical room. Domestic cold water piping is mostly copper with soldered fittings. Piping is currently un-insulated. Recommend installing low flow plumbing fixtures to reduce water consumption.

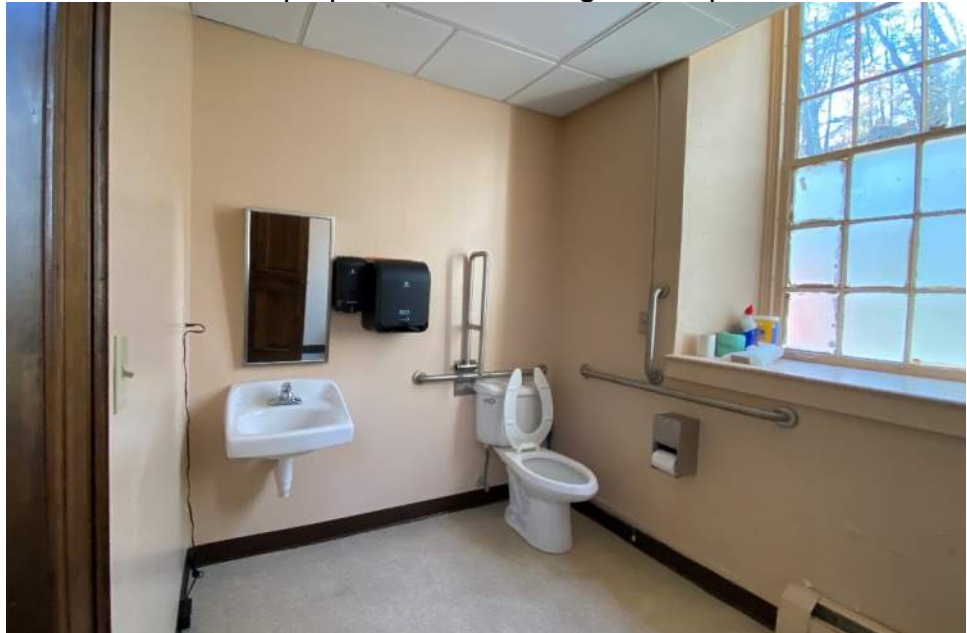
The Toilet Room on the 1st Floor can be found near the North entry to the Old Town Hall. Fixtures and finishes are in good condition and are ADA accessible with proper clearances and grab bars provided.

1st Floor toilet room

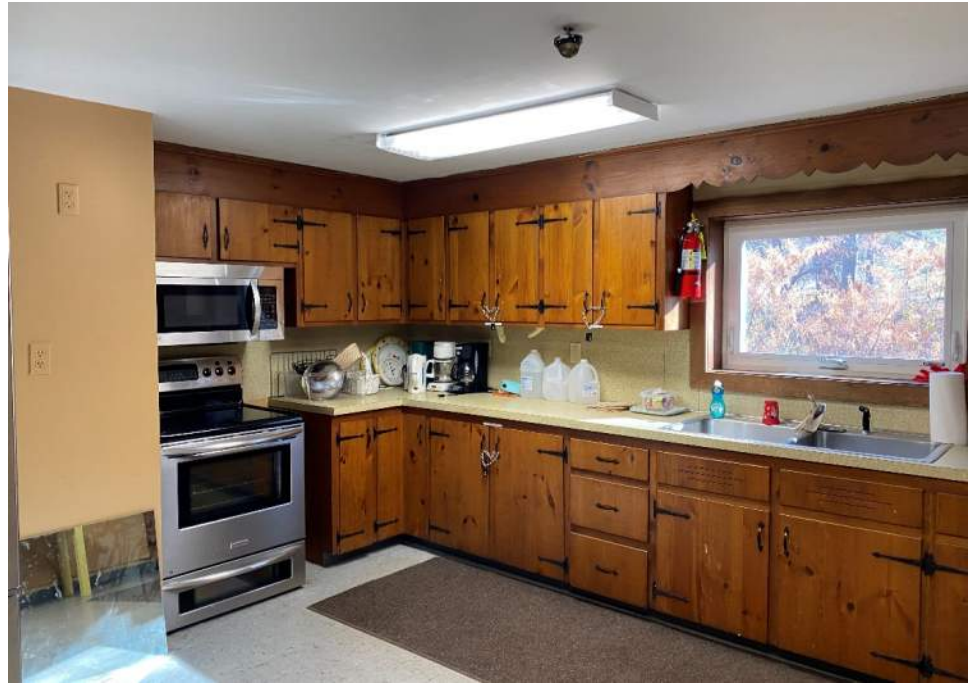
Kitchen cabinets, countertops, and fixtures all appear to be in good condition, however they are not ADA compliant and dated. Cabinets are not the proper height, nor do they provide knee space at the sink for wheelchair access. Upper cabinets are also out of the required 48” reach zone.

Kitchen

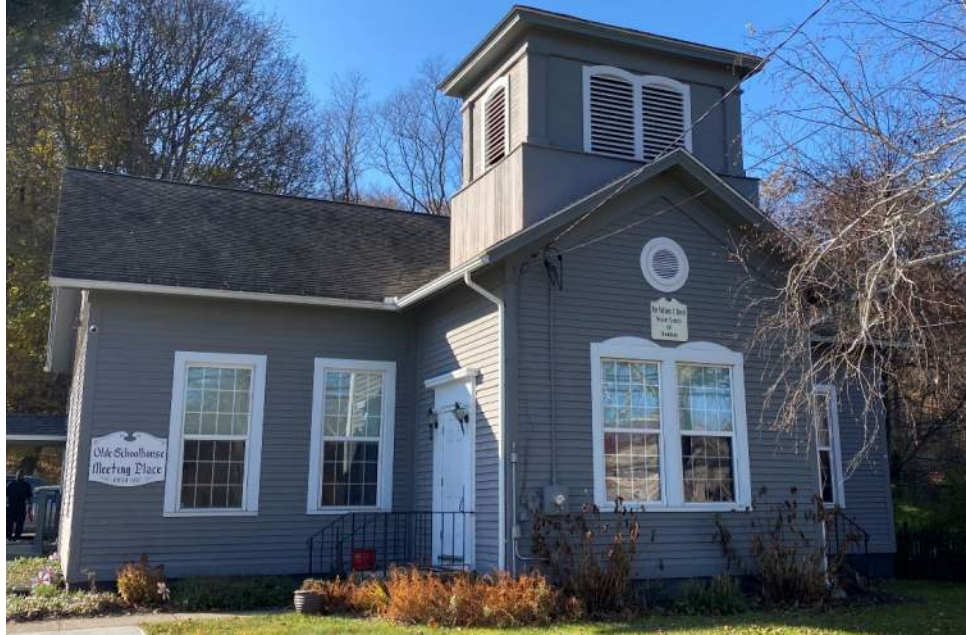
The windows along the front and sides of the Senior Center are simulated divided lite, 12 over 12, vinyl, double hung windows. They appear to be newer and insulated, and are in good condition.

Double hung windows at front and sides

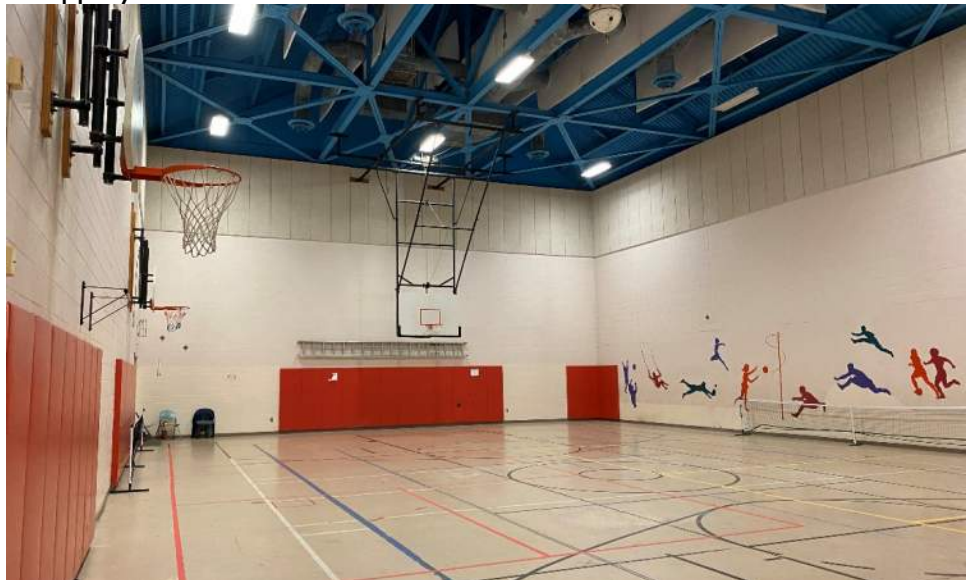
Gymnasium

The Gymnasium, located in the lower level of the east wing was part of the last addition to the school. Overall the space is in very good condition, however the floor is cracked, striping is worn, and the surface is slippery.

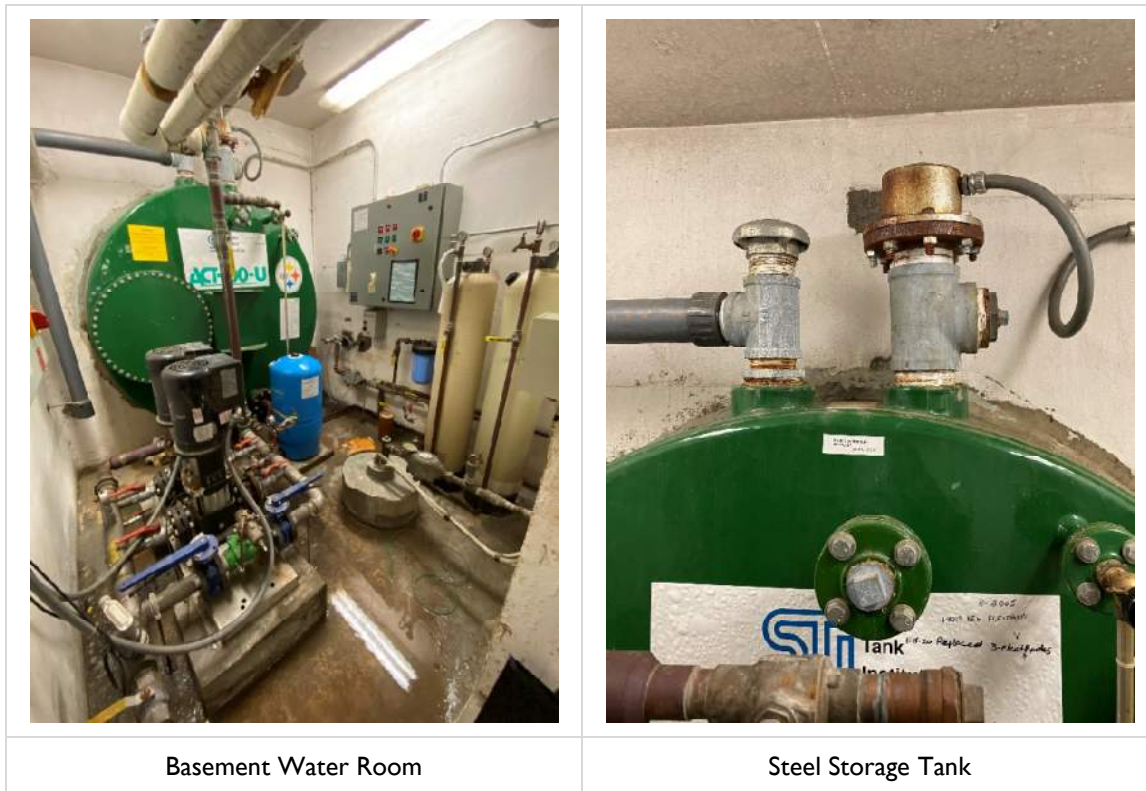
Basement Water Room

The buildings domestic water appears to be supplied from two (2) on-site well water systems, one (1) old and one (1) new, each with their own neutralizer. Water is stored in a large semi-underground steel tank that is partially underground and partially into the basement. The storage tank appears to be from 2005 and had 3 electrodes replaced on 01-15-2020. The water system is equipped with a skid mounted duplex booster pump system with control panel and hydro tank.
