Phase I Environmental Site Assessment

Scovil Hoe Mill

11 Candlewood Hill Road
Higganum, CT

February 2018

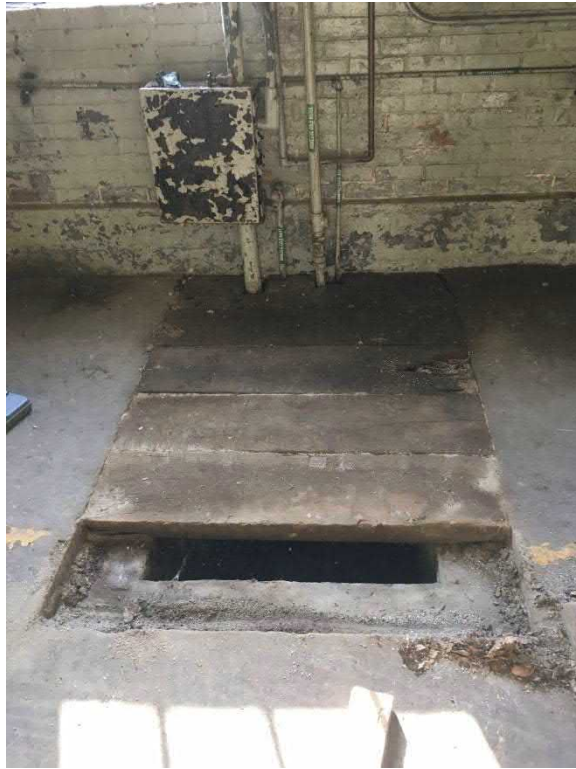
- Tunnel/Utility Trench – On the south wall in the central portion of the building is an approximate four feet rectangular opening in the concrete floor covered by 6-inch wide wooden boards. During the site visit two of the boards were removed to reveal an approximate four feet deep rectangular vault with concrete and stone sidewalls. Hardpacked dirt and small concrete and stone fragments were present at the bottom. There was no odor or staining observed in the material at the bottom. Approximately 1-inch diameter metal water pipe and 1/2-inch metal compressor piping were observed in the trench vertically extending out of the vault up the side of the wall of the building. At the bottom of the vault an approximate 6-inch diameter open pipe appeared to extend to the east parallel to the wall of the building. What appeared to be 1-inch diameter water pipe also extended in both directions parallel to the wall of the building. The concrete and stone comprising the southern wall of the vault appeared to be constructed after the original structure was built and appeared to be “blocking” additional access beyond what could be observed. Reportedly, a tunnel or trench extended between the two buildings. There currently is no evidence of a tunnel between the two buildings because of the blocked access to the south wall, however, it appears that the water lines may extend south beyond the wall to Building 81-106.

Utility Tunnel Building 81-115

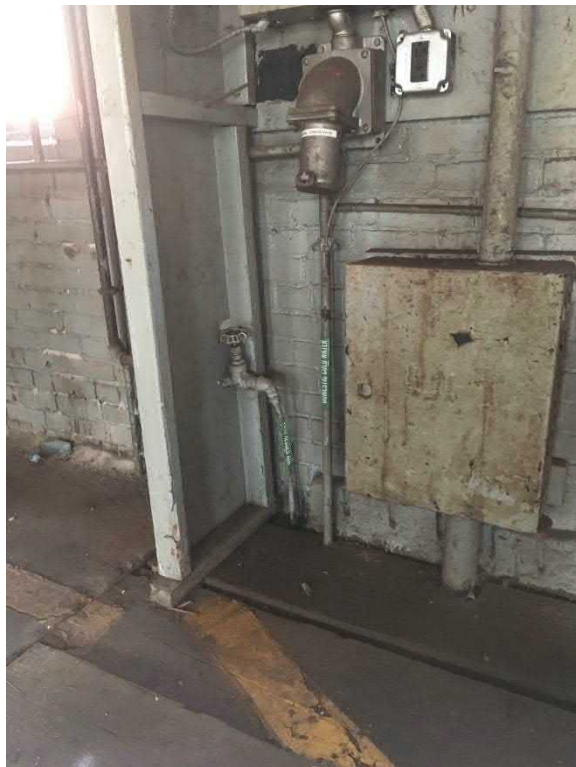
- Tunnel/Utility Trench – On the north wall in the central portion of the building is an approximate four feet rectangular opening in the concrete floor covered by 6-inch wide wooden boards. During the site visit two of the boards were removed to reveal an approximate four feet deep rectangular vault with concrete and stone sidewalls. Hardpacked dirt and small concrete and stone fragments were present at the bottom. There was no odor or staining observed in the material at the bottom. The 1-inch diameter metal water pipe referenced for the well above was observed to extend up through the floor slab adjacent to this location to a shutoff valve mounted on the building wall. From the shutoff valve the pipe extended down the wall into the vault and at the bottom of the vault the piping turned 90 degrees directly to the north through the wall toward Building 81-115. Similar to the configuration of the vault described for Building 81-115, the northern wall of the vault for Building 81-106 appeared to have been constructed to “block” access to some sort of conduit, tunnel, or pipe discharge between the two buildings. The original use of this conduit between the two buildings may have been for drainage or process water flow, but appears at some point in time to have been converted to serve as a utility conduit for the water pipe from the supply well north of Building 81-106 to serve both buildings.

Utility Tunnel Building 81-106

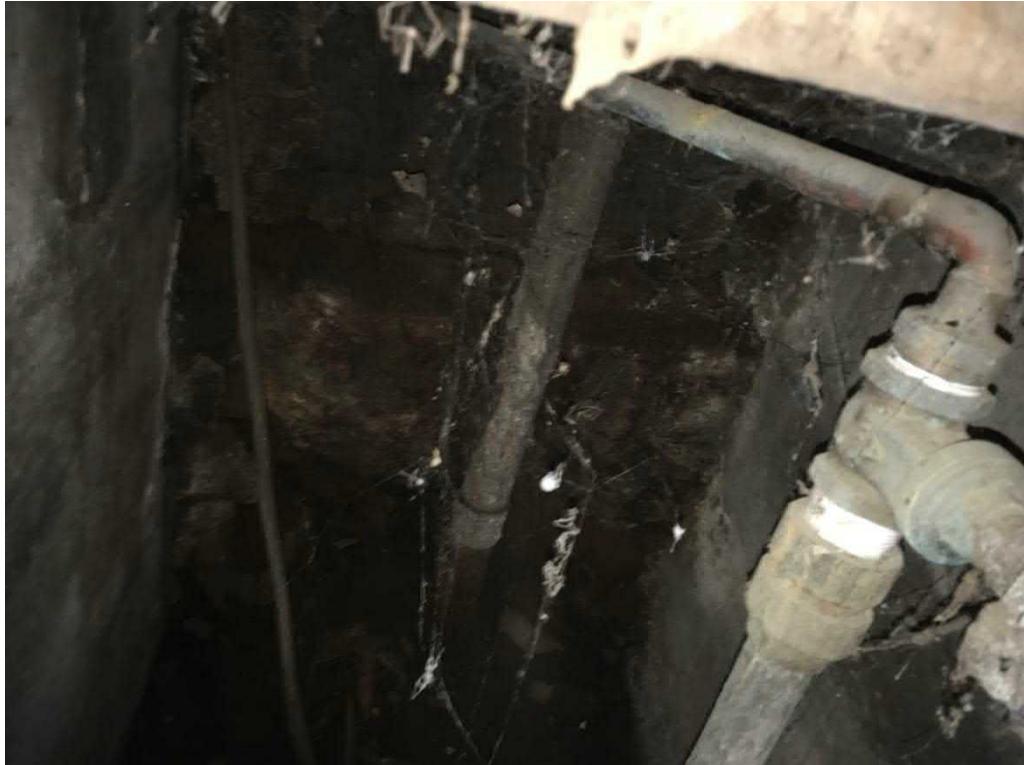
Interior of Tunnel Building 81-106
Note Blocked Access and Water Line Extending to Building 81-115

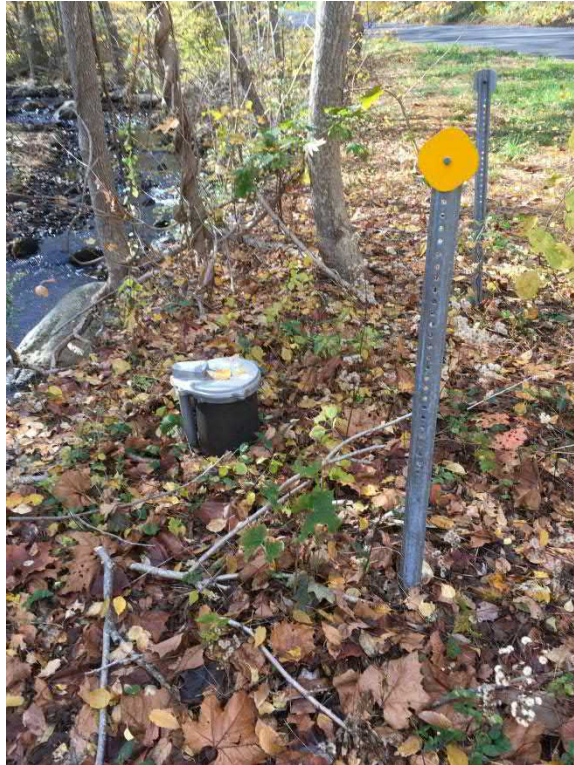
Water Supply Well With Water Line Extending to Bld. 81-115
Note Water Line to Water Pressure Tank in Bld. 81-115 Cut & Capped

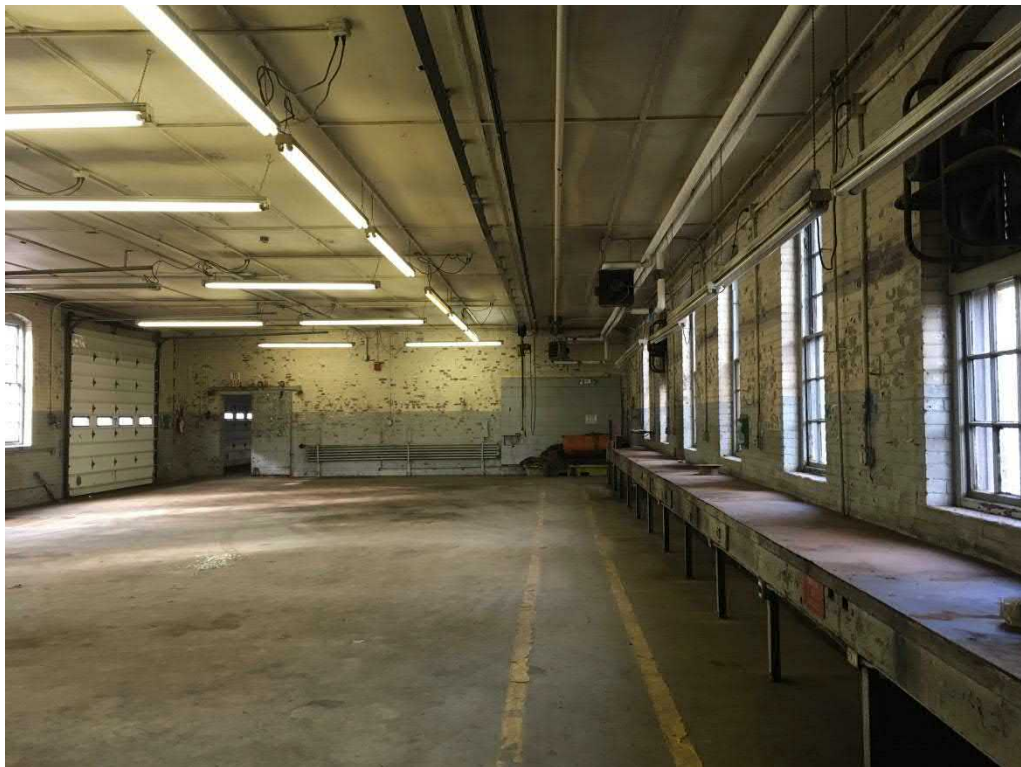
- Generators/Fire Pumps/Compressors – A diesel generator is found in the northwest corner of one of the central garage bays. Minor staining around the generator is evident. Evidence of a former compressor is found in the same garage bay, just west of the supposed utility trench.
- Furnace – The furnace is located in eastern portion of the building adjacent to the former heating oil tank (REC-13). Peeling paint from the walls and ceiling was observed on the concrete floor. The furnace appeared to be in generally good condition with no cracks or oil staining evident on the floor.

Interior of Bld 81-115 with Diesel Fuel AST for Generator on Secondary Containment

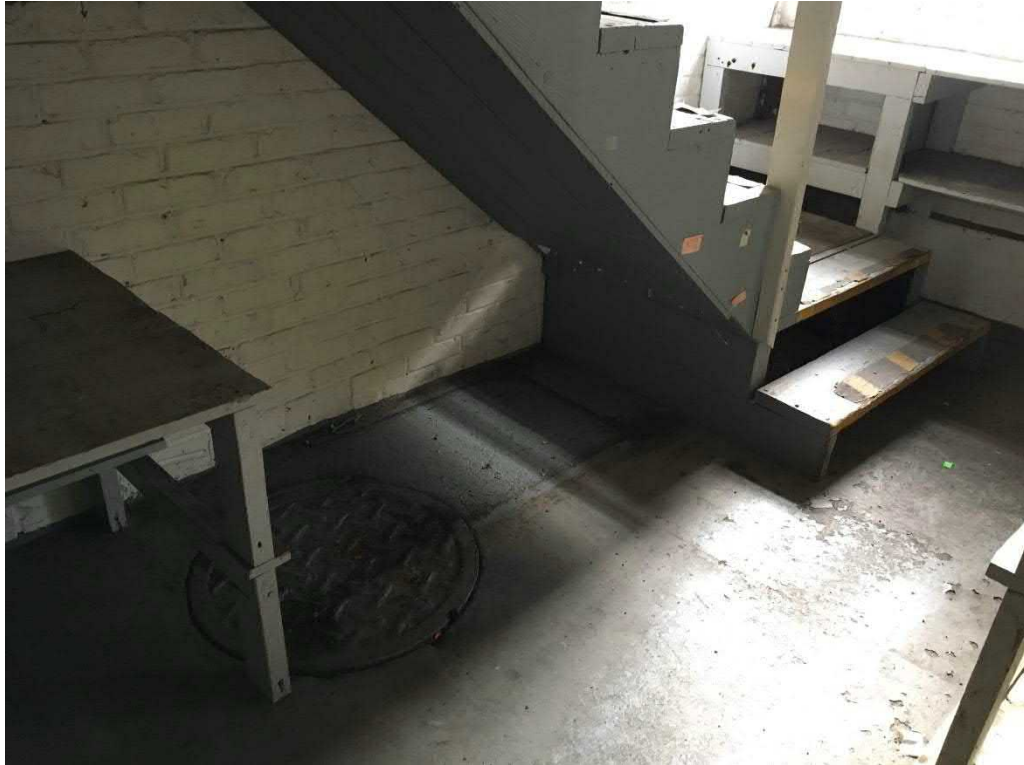
Manhole Access for Stormwater Line Extending Below Building 81-115

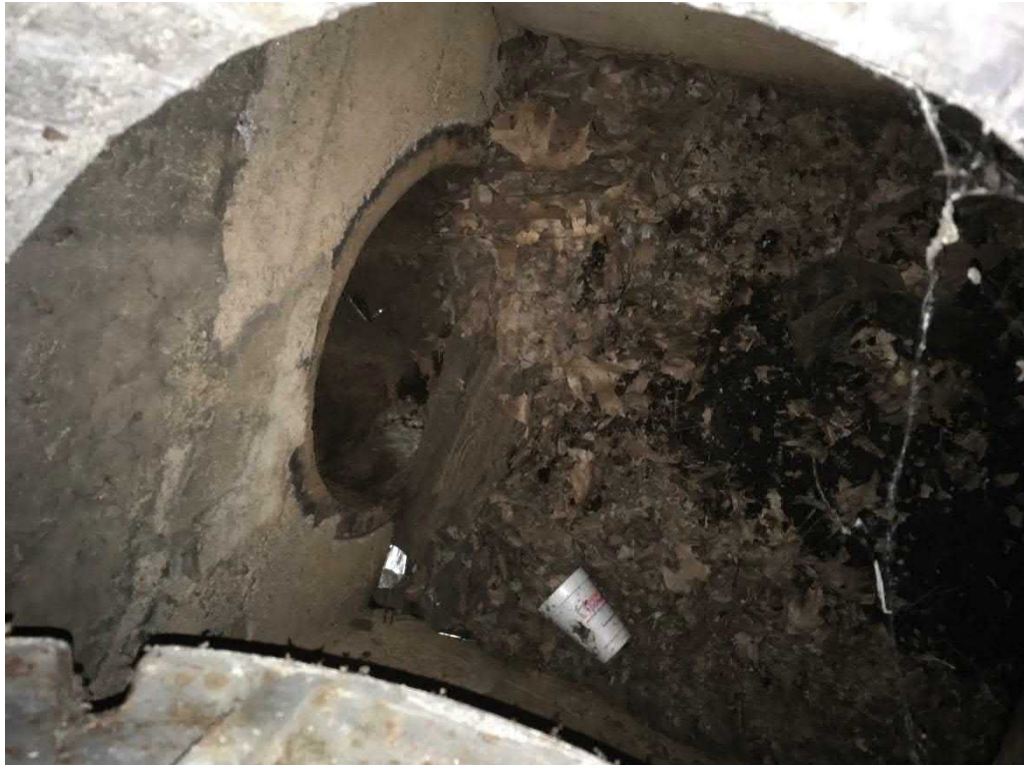
structure suggests that there may formerly have been a pipe extending in an easterly direction as well. The stormwater pipe extends below Building 81-115 southeast to a catch basin located north of the northeast corner of Building 81-106. A stormwater discharge pipe to Candlewood Hill Brook was observed in the bank east of the southeast corner of Building 81-106 (*Figure 2*).

Interior of Stormwater Line Below Building 81-115 at Access Manhole

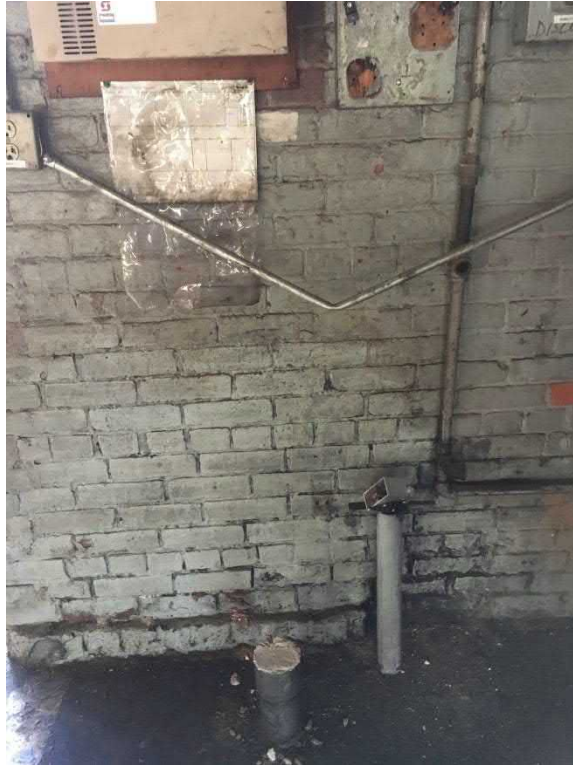
Waste Oil Drain Line to Former Waste Oil Tank (Rec-14) Bld 81-106

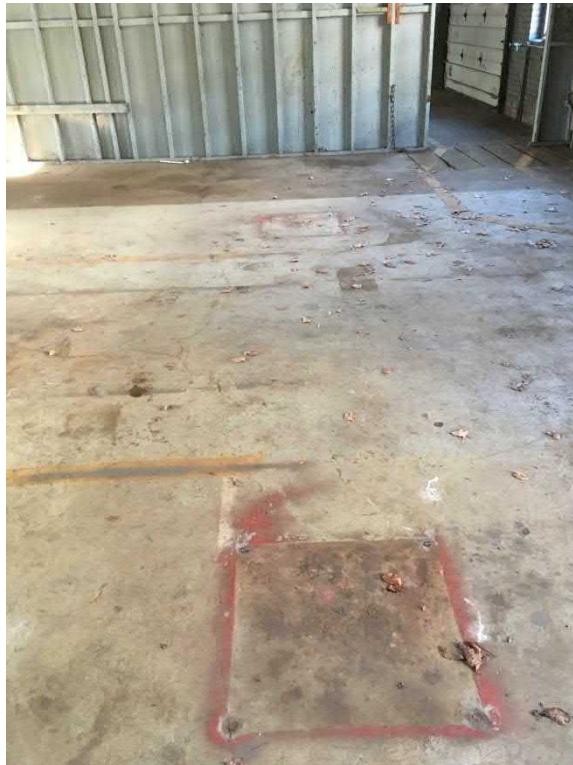
- Patched Flooring for Former Below Grade Vehicle Lift– An approximate 15 feet wide by 30 feet long poured slab, which is not the originally floor, is located in the central repair bay of Building 81-106. The floor slab contains markings and bolt patterns indicative of a former support for an above ground vehicle lift. The concrete floor appeared to be in good condition with no cracks or oil staining observed. Previous reports indicate that the former above ground vehicle lift is in the same location as a former underground vehicle lift where as described in *Section 4.1* 70 gallons of hydraulic oil had been released.

Markings of Former Above Ground Vehicle Lift At Building 81-106
(Note that this is a poured floor above a former below ground vehicle lift (REC 16))

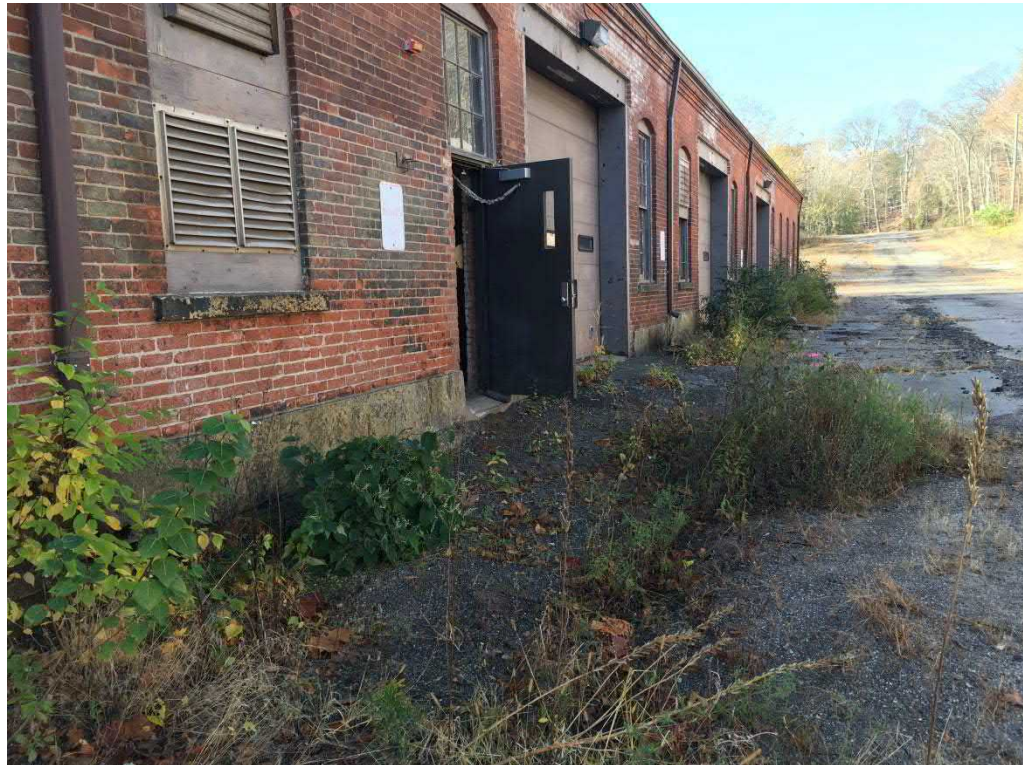
View of north side of Building 81-106 and former Waste Oil UST (REC-14)

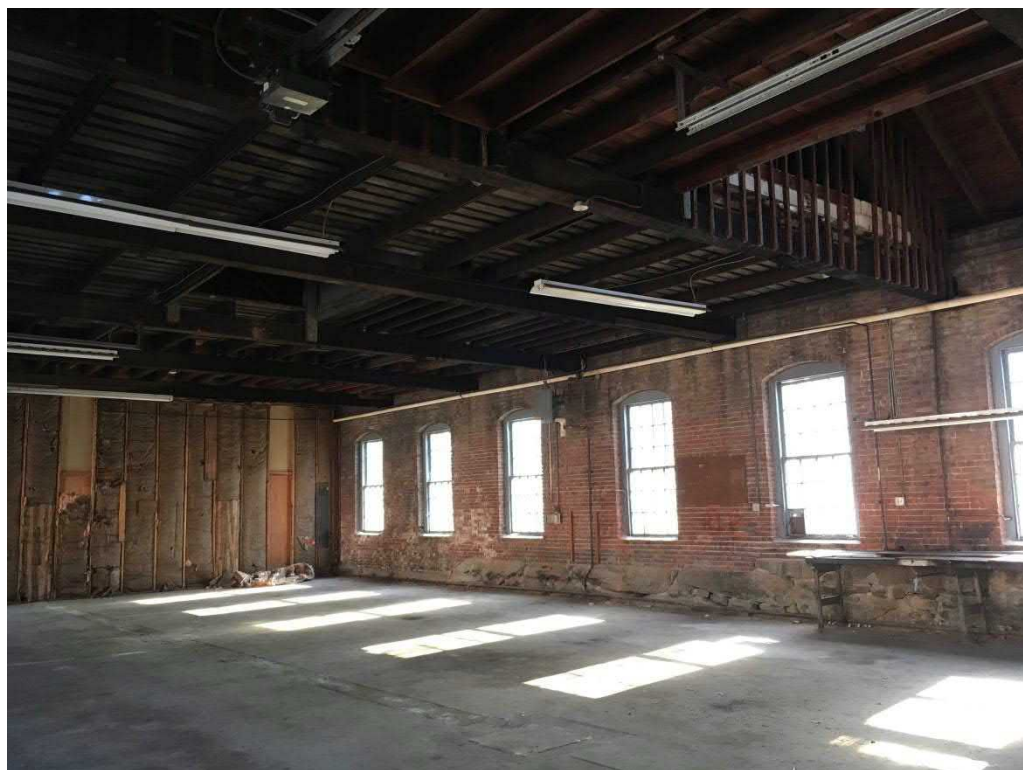
View of western third of Building 81-106
(Note floor cut out of below grade sumps and drainage trenches
previously filled with concrete (REC-15))

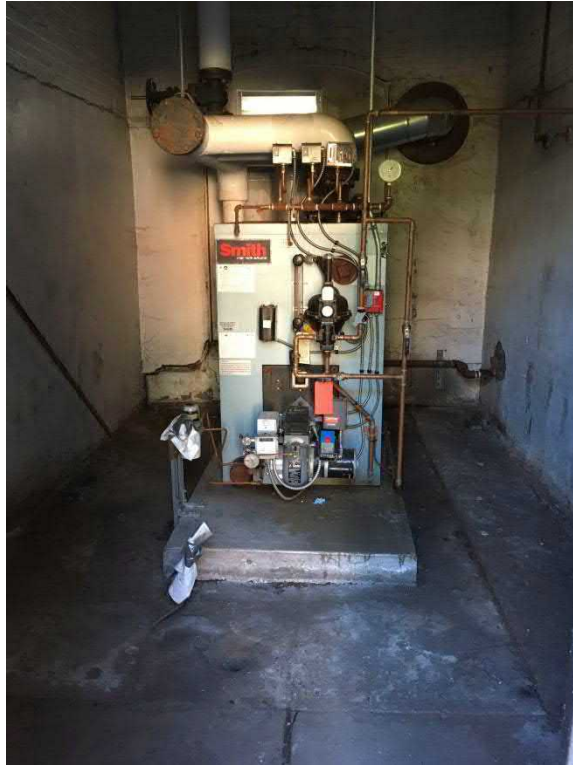
Furnace in Utility Room Extending From East End of Bld 81-106
(Note feed and return lines from Former USTs (REC-9) cut & capped, but remain in place)

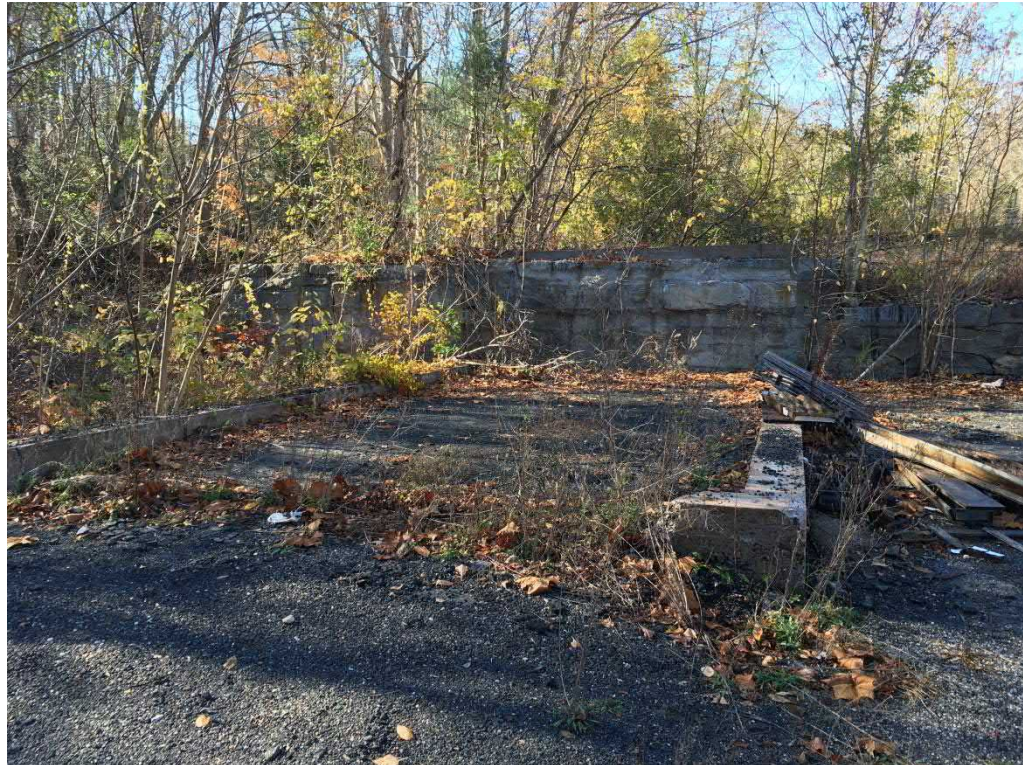
- Stone Foundations and Retaining Walls – Several stone walls and foundations were observed in the western portion of the Site west of Building 81-106. A former shed foundation was observed in this area. The purpose of the shed is unknown, although one of the maps prepared by DTC during their 2007 investigation indicated a drum storage area adjacent to the foundation (REC-3). Two retaining walls are located on the western portion of the Site, at least one of which may have been part of a larger spillway dam for the former Spar Mill Pond. As described above, the dam historically diverted water from Candlewood Hill Brook through a flume that extended along the southern bank, through a steel penstock that crossed the brook just south of the former wooden mill building, and to a turbine and tail race for energy production during the time that the mill occupied the Site. Remnants of the flagstone dam on the southeastern portion of the Site, of the retaining walls on the northern bank of the brook, and of the tail race on the southeastern portion of the Site still remain.

Remnants of Former Shed Previously Used by DOT to Store Drums (REC-3)

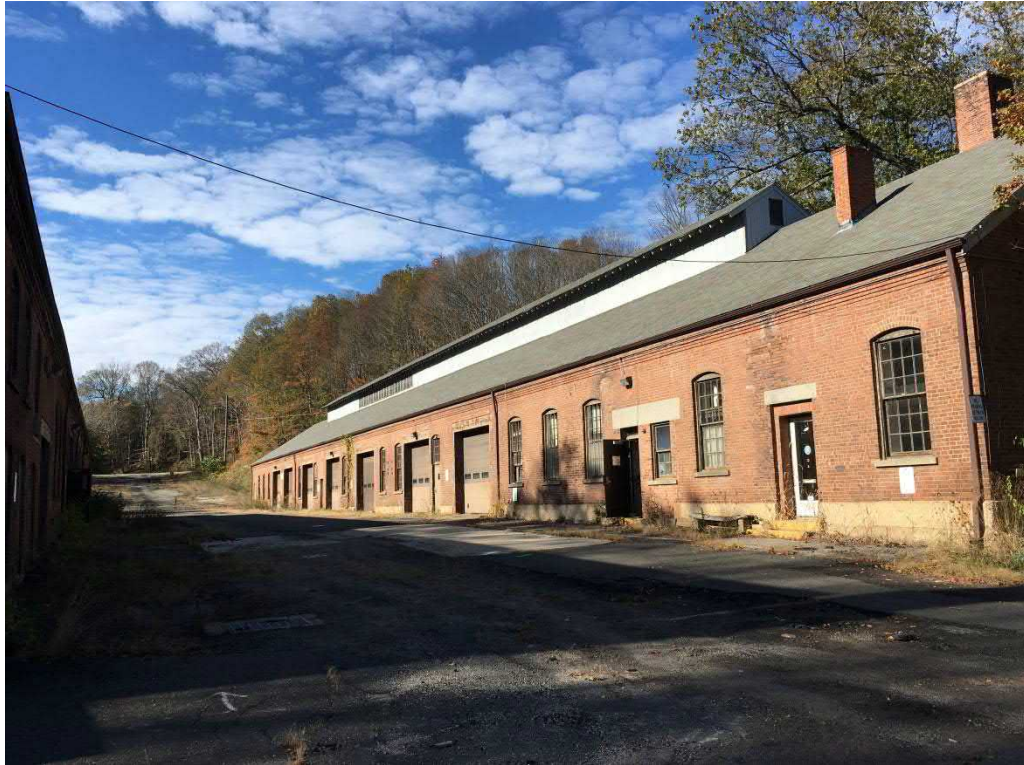
View of South Side of Building 81-115 and Former Pump Islands (REC-6)

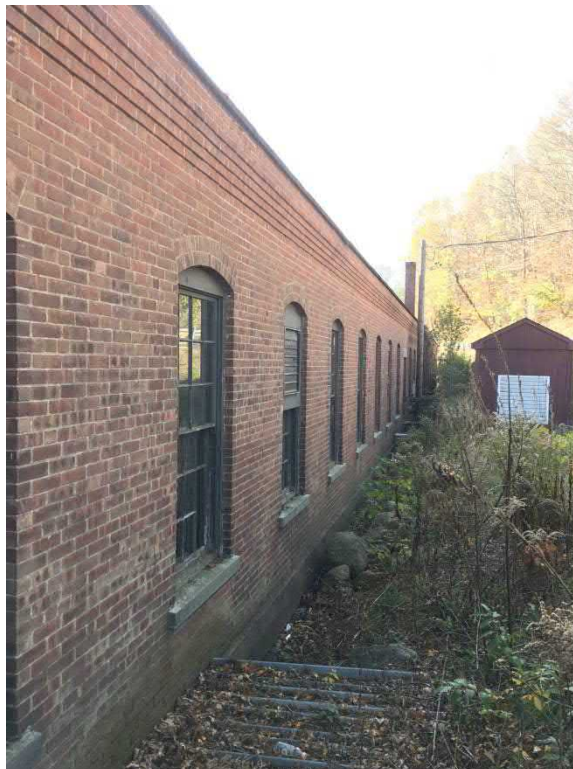
View of North Side of Building 81-115
(Stormwater Collection Catch Basin Visible in Foreground)
(Shed for Generator Visible in Background)

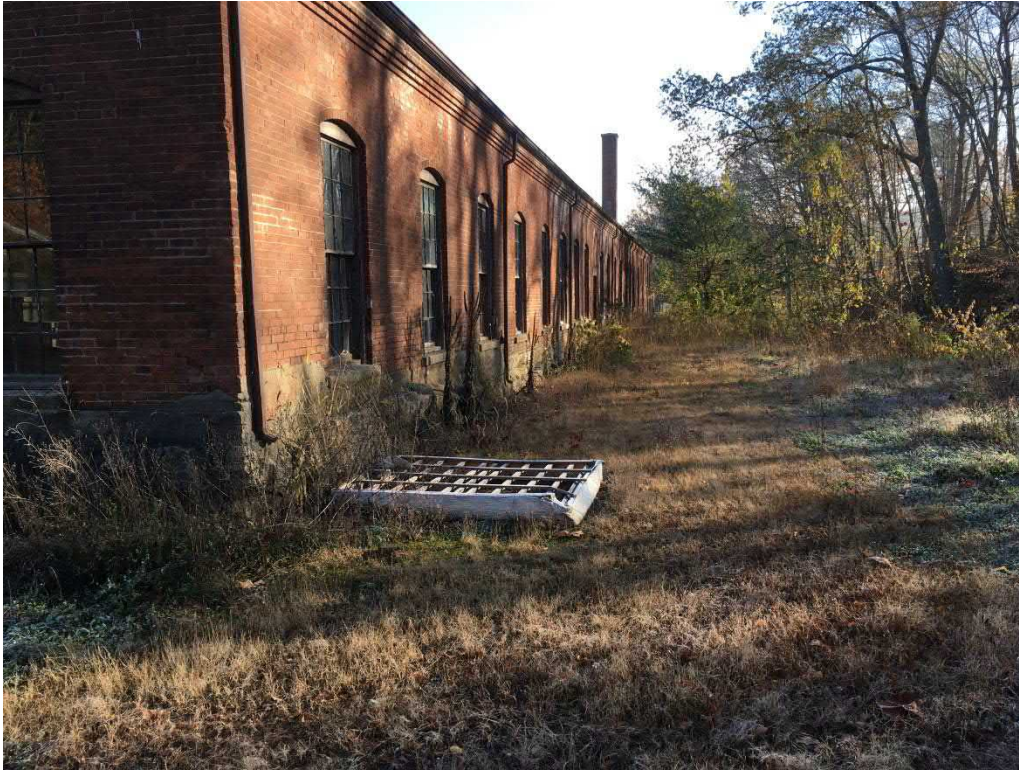
View of South Side of Building 81-106 and RECs 4 & 12. Candlewood Hill Brook Right of Picture

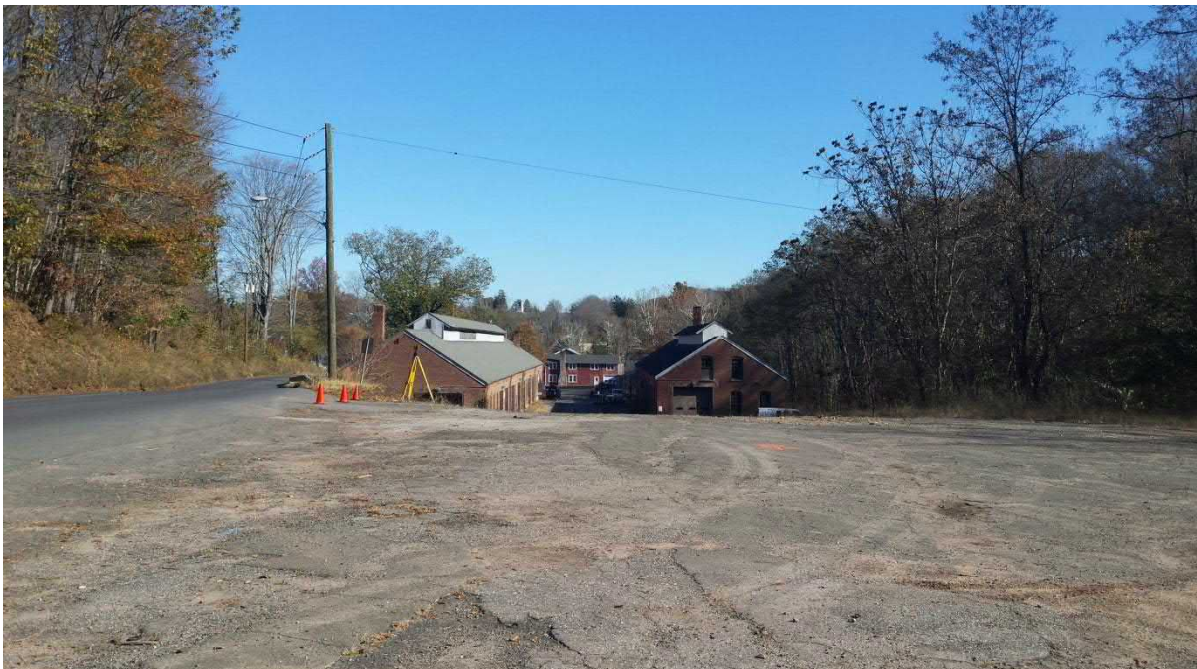
A pond appears to have occupied the western portion of the Site from at least 1881 through 1941. In the 1941 and 1950 aerial photos, it appears as though the pond was being filled. By the 1957 photo, the pond had been entirely filled in. Subsequent, environmental sampling of the fill indicated that it had been filled with a variety of polluted soil and construction materials as further described on *Table 1* as REC-1. The aerial photographs from the 1970's indicate a cone-shaped pile, which could be a sand or salt pile on the former pond area.

View of the Site from the West Limit with former Spar Mill Pond Area foreground (REC-1)
