Hazardous Building Materials Inspection

Former Scovil Hoe Mill

11 Candlewood Hill Road

Town of Haddam

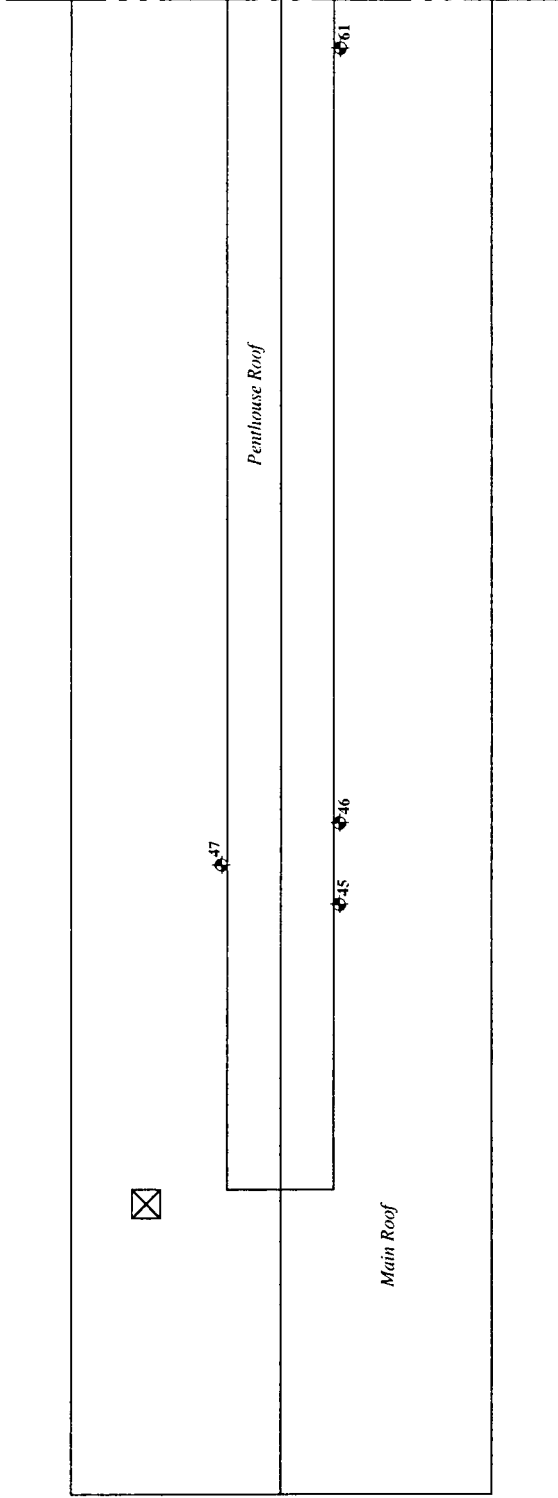
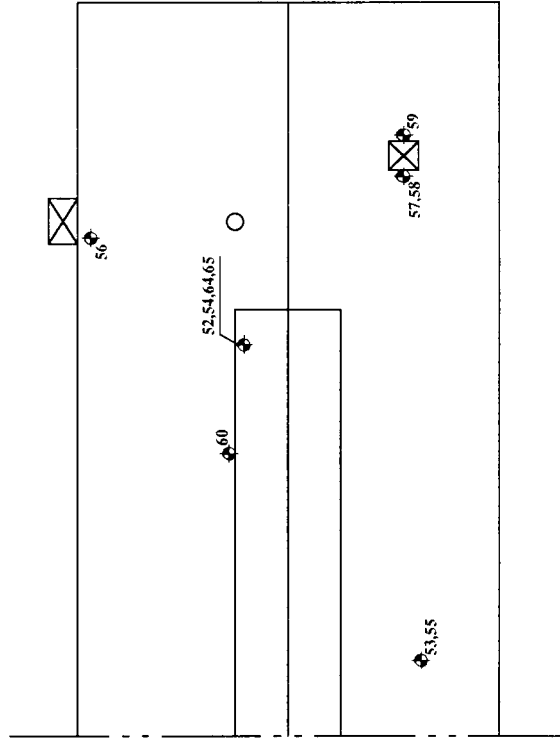
There is approximately 1,900 square feet of transite roof tile located underneath red/green asphalt roof shingles on this roof. The transite roof tile was found to contain 25-30 percent asbestos. The red/green asphalt roof shingle was found to contain no asbestos.

There is approximately 405 square feet of gray flashing cement located along the base of penthouse and around the vent tube on this roof. This material was found to contain 20 percent asbestos.

There is approximately 30 square feet of gray flashing cement over gray flashing paper located at the base of three chimneys on this roof. The gray flashing cement was found to contain 20 percent asbestos. The gray flashing paper was found to contain 35 percent asbestos.

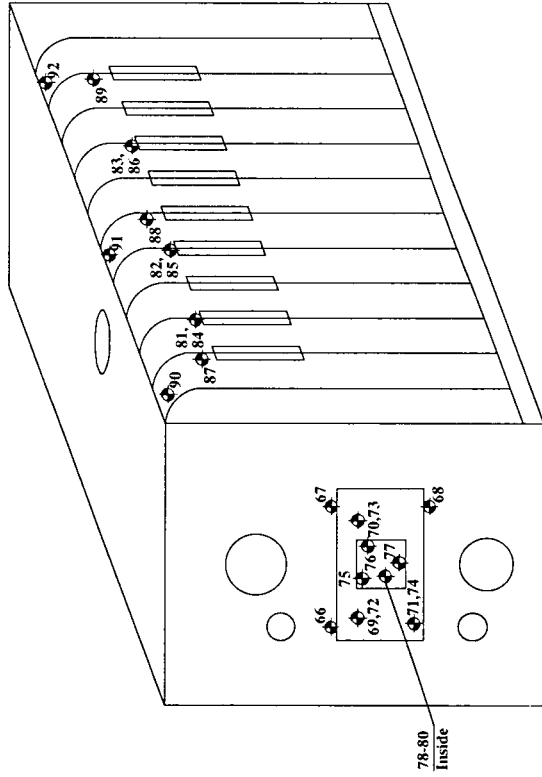
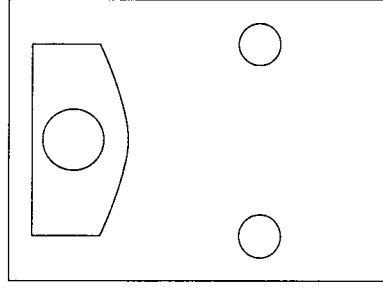
There is approximately 1 square foot of inspection door rope gasket located on the front door of the boiler in this room. This material was found to contain 80 percent asbestos.

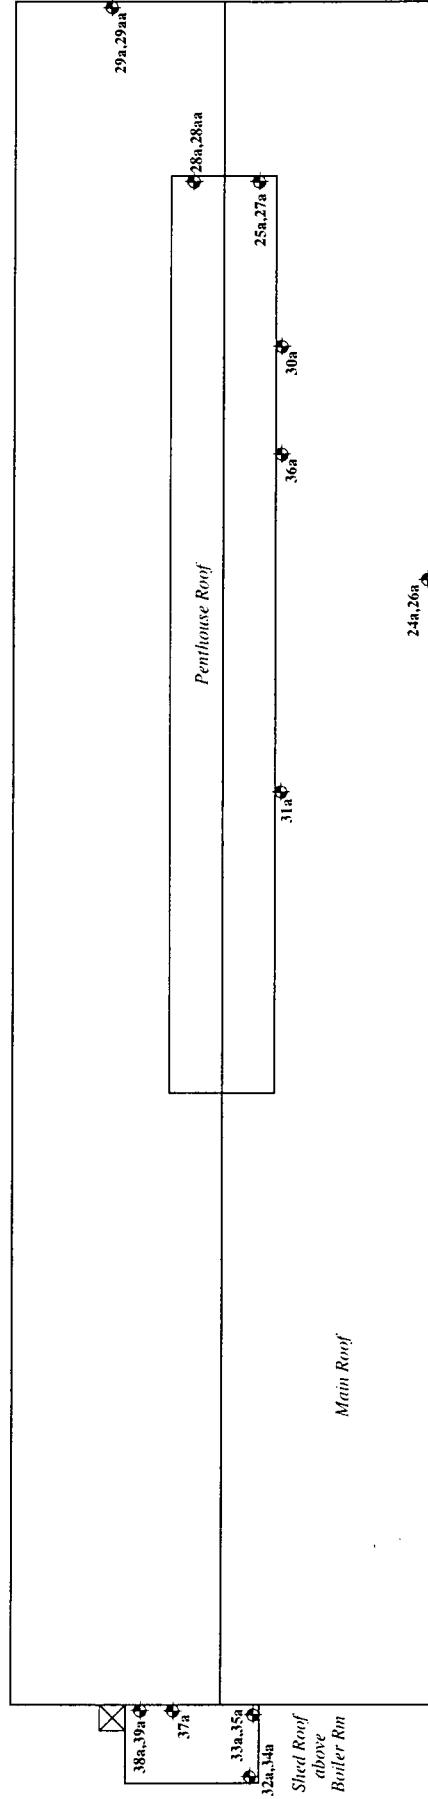
There is approximately 150 square feet of black roll roofing with underlying adhesive applied on this roof. The black roll roofing was found to contain 35-40 percent asbestos. The adhesive was found to contain 15 percent asbestos.

There is approximately 80 square feet of gray flashing cement located along the perimeter of this roof and on the wall below the main roof and on the chimney. This material was found to contain 20 percent asbestos.

There is approximately 250 square feet of gray flashing cement located along the base of penthouse on this roof. This material was found to contain 20 percent asbestos.

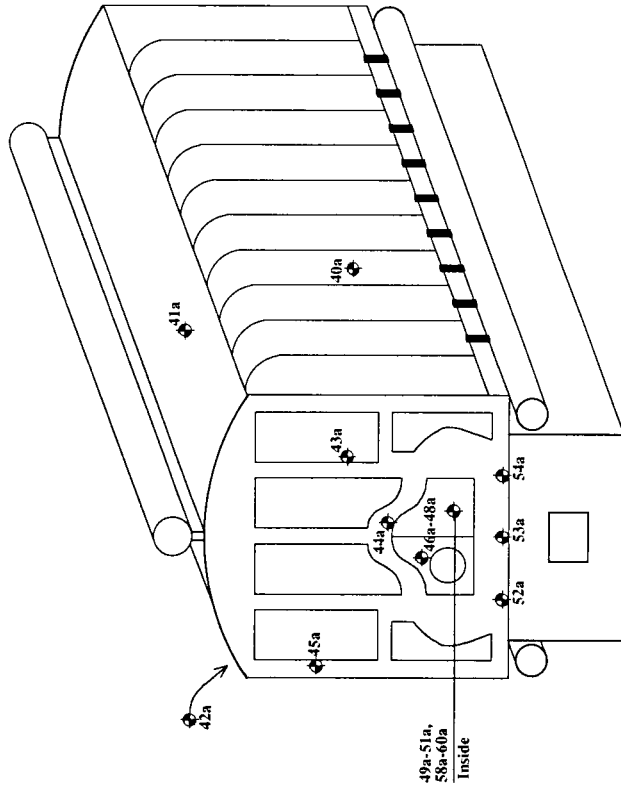
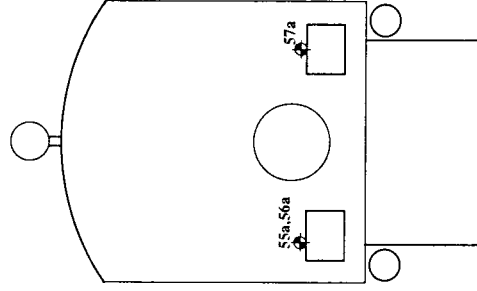
There is approximately 3 square feet of chimney breeching cement located in this room. This material was found to contain 65 percent asbestos.

There is approximately 5 linear feet of old fire chamber plate sealant located in the front of the boiler in this room. This material was found to contain 10 percent asbestos.

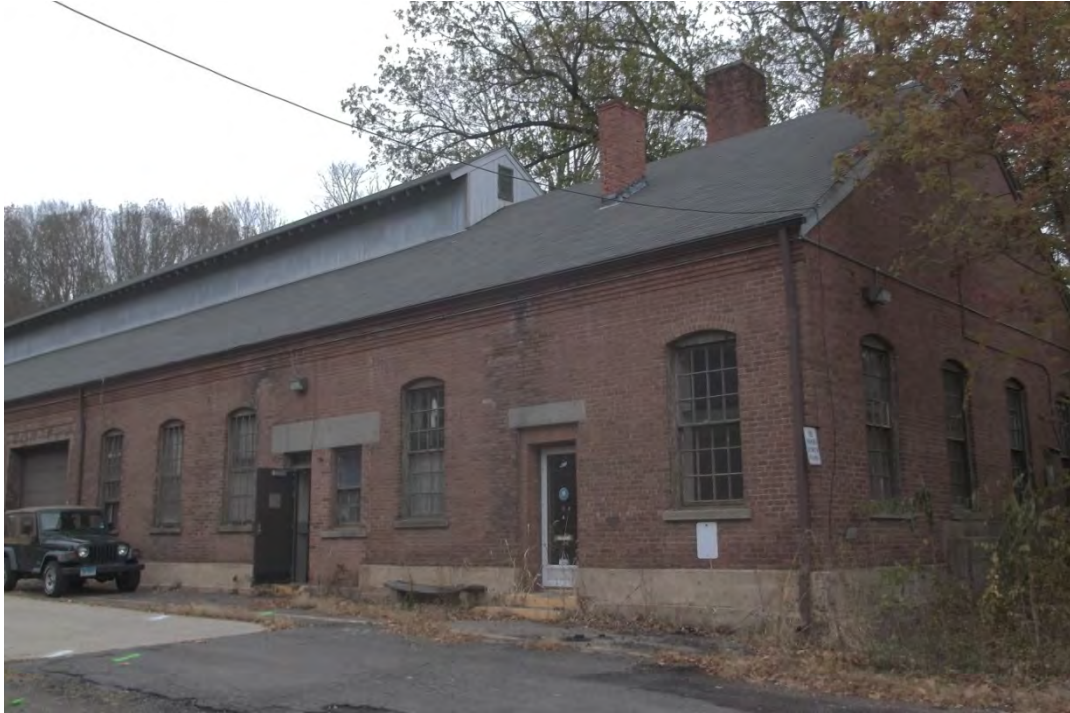
Exterior North Building – Building A

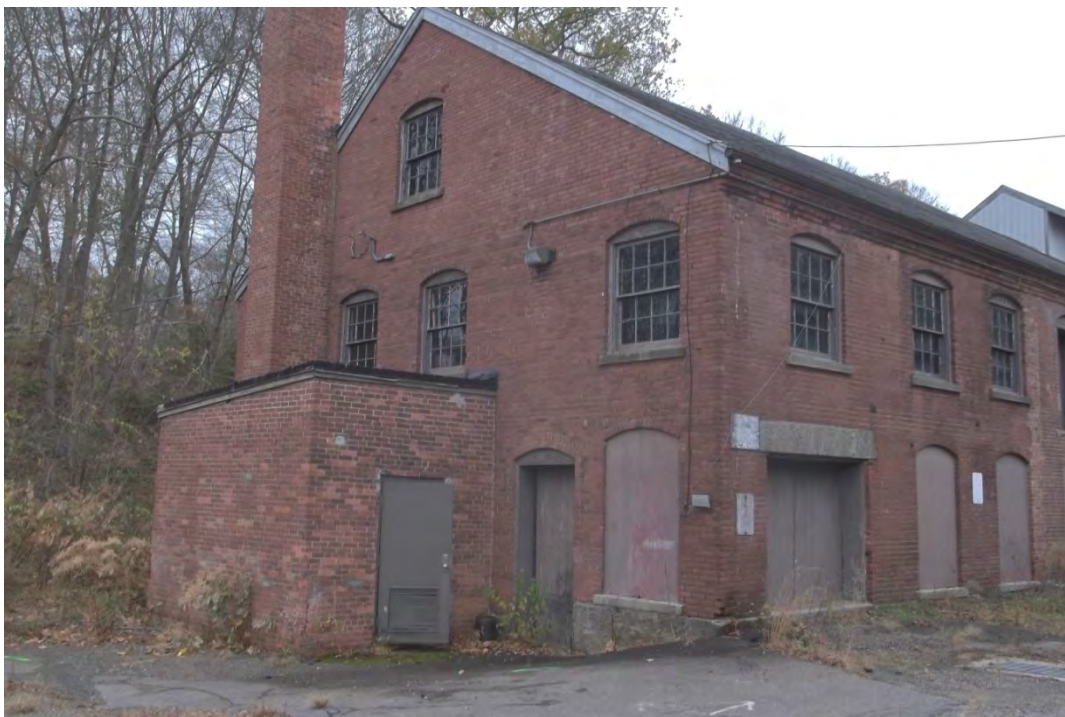
Exterior of South Building – Building B
