TOWN OF HADDAM

FACILITY ASESMENT REPORT

Six Town Buildings

April 1, 2024

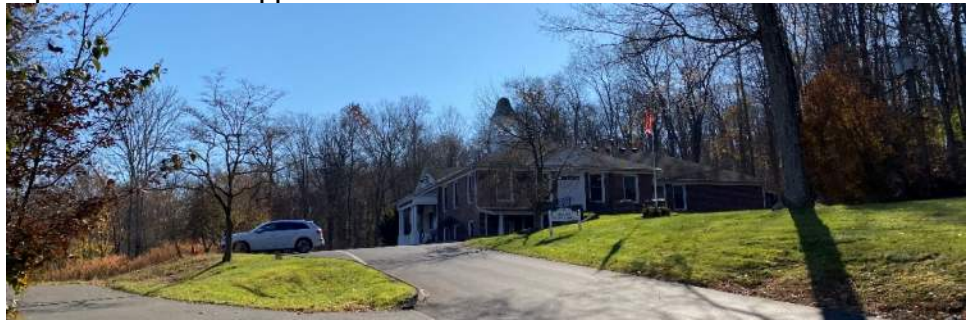
There are two parking lots for the Town Office Building; a lower lot at the main building entrance, and an upper lot, to the south of the building. The lower parking lot provides 7 spaces. The upper parking lot provides 18 spaces, of which, two are ADA accessible. Spaces are clearly indicated with signage and striping, however there is no indication that ADA access is provided at the upper lot.

Entrance to lower parking lot

1. Site
 - a. Clean & repoint stone retaining wall
 - b. Provide signage indicating upper lot allows for ADA access
2. Exterior
 - a. Clean vinyl clapboard siding in gable ends
 - b. Repair, re-point, replace damaged masonry
 - c. Clean and re-seal brick veneer
 - d. New 30-year architectural asphalt shingles
3. Doors
 - a. Update door hardware to ADA standards at all doors, interior and exterior
4. Windows
 - a. Clean lintels of all rust. Paint.
5. Ceilings
 - a. Verify areas of possible water leaks for pipe damage. Repair any damaged plumbing and repair damaged sheetrock ceiling.
6. Kitchen
 - a. Provide kitchen cabinets, fixtures, and appliances that are ADA compliant

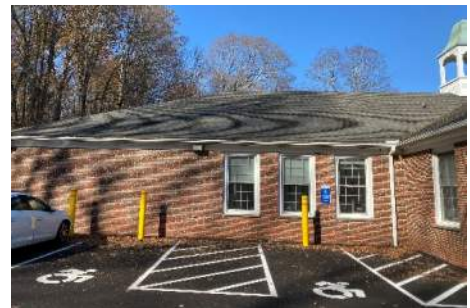
ADA accessible parking

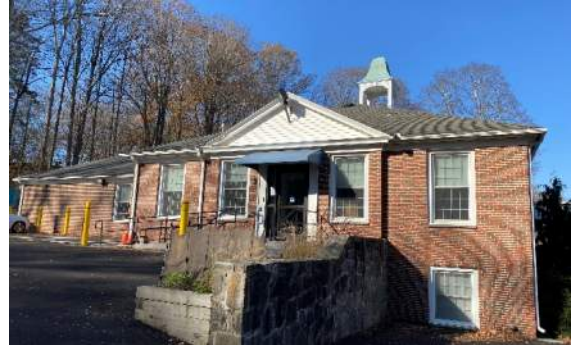
Landscaping at the Town Office Building consists mostly of several shrubs, flowers and a moderate sized conifer along the east elevation of the building. Stone retaining walls at the south and north side of the structure hold back the sloping grade. Walls and plantings appear to be in good condition, however there were some areas of missing mortar at the stone walls, as well as some staining. This missing mortar can become a hazard with water infiltration and should be repaired.

Retaining wall at South Elevation

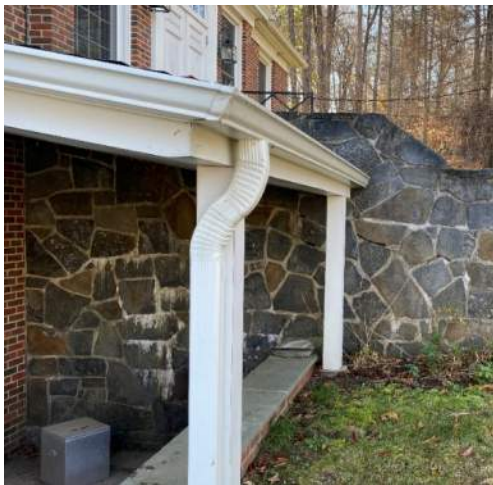
Retaining wall at North Elevation

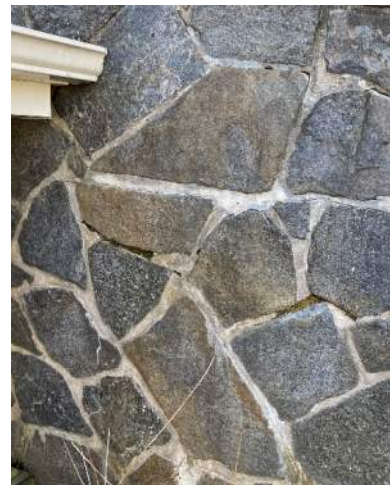
Missing mortar

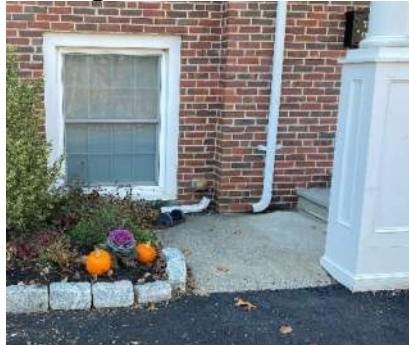
The exterior walls of the Town Office Building are brick masonry and appear to be in good condition. Although there was no major cracking, spalling, or issues with mortar joints, there were several areas where some minor cracking is occurring in the masonry. This is typically near downspout locations.

Cracking at masonry near down spout

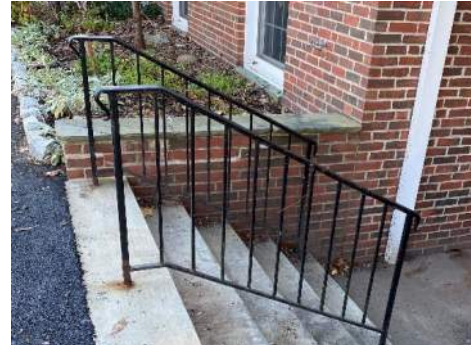
Staining was observed at retaining wall near the north entrance.

Staining on masonry

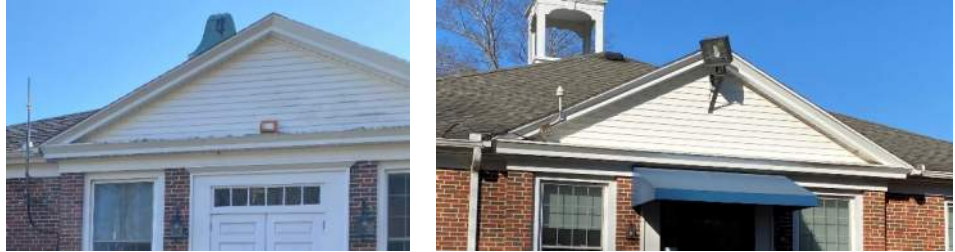
Gabled ends over the primary entrances are vinyl clad appear to be in good condition, however, require cleaning.

Vinyl sided gabled ends

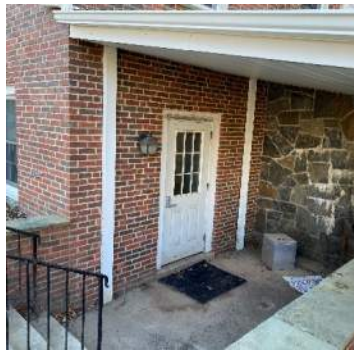
The north entrance to the lower level provides direct entry to the Building Department. It is necessary to navigate several steps from grade down to this entry point. Stair railings are lacking handrail extensions.

North entrance to lower-level

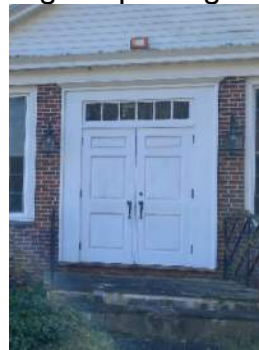
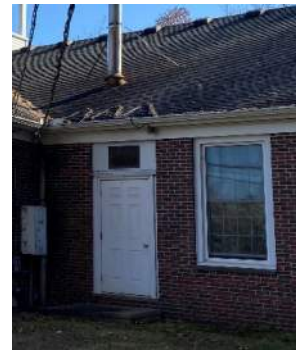
Two more sets of exterior doors can be found at the west elevation. The 3-panel, steel clad, double doors located off the main corridor provide a second form of egress from the 1st floor. And a single 6-panel door allows access to the Furnace Room. Both doors are in fair condition, however, neither is provided with ADA compliant hardware and both are in need of cleaning and painting.

West entrances to 1st Floor

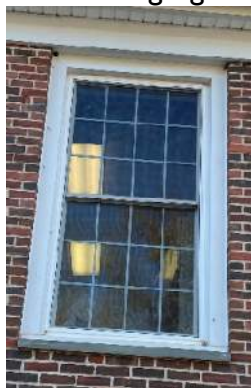
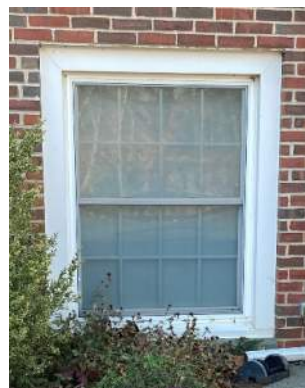
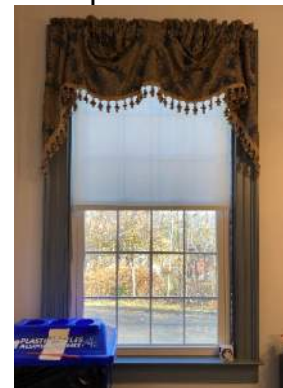
The windows at the Town Office Building are vinyl, double-hung, with insulated glass and simulated divided lites. The larger windows of the 1st Floor are typically 12 lites over 12, while the smaller lower level windows are 8 lites over 8. The age windows of the windows could not be determined, however, they appear to be in good condition with no obvious broken glass, cracks, or defects. Steel lintels above the windows are showing signs of rust and should be cleaned and re-painted.

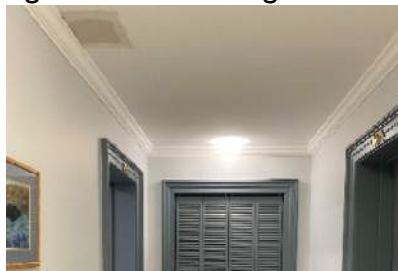
The ceilings throughout are gypsum board and are overall in good condition, however there are several areas on the lower floor that show signs of water damage and cracking.

Basement corridor ceiling with water stains

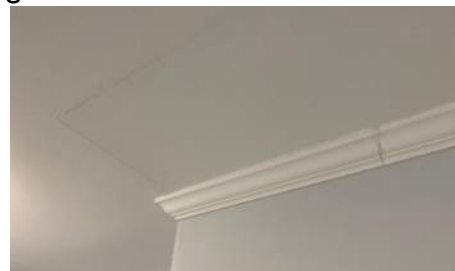
Cracking corridor ceiling

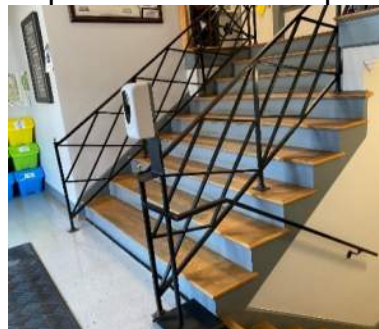
The primary stair in the Town Office Building can be found at the main entrance providing access to the lower basement level and the upper 1st Floor. Treads, risers, and railings are in good condition. The risers are 7 ½", per current Building Code, they should be 7". Wood treads should be provided with non-slip tread surface.

Stairs to 1st Floor

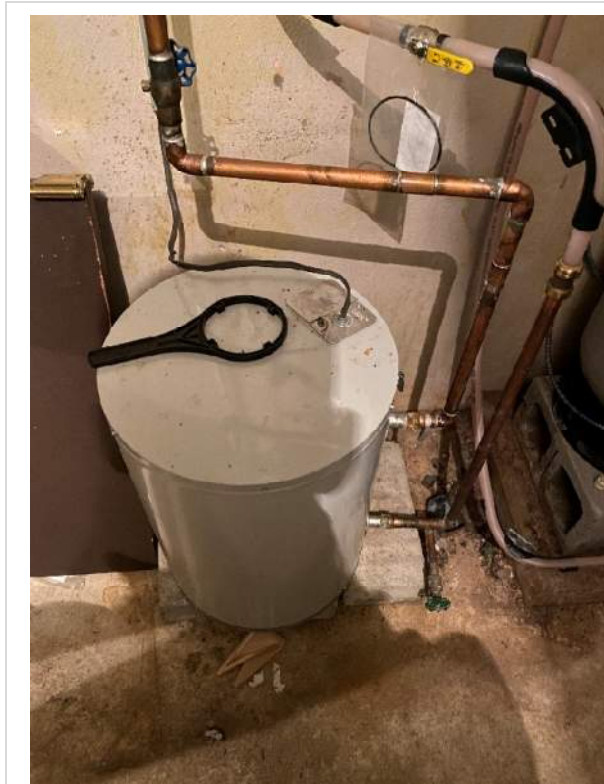
The buildings domestic hot water is generated by a 19-gallon electric storage tank water heater. Domestic hot water piping is copper with soldered fittings. Piping is currently un-insulated. Inlet/outlet piping connections to the water heater are corroding. Recommend replacing the existing water heater. Recommend insulating all domestic hot and cold water to reduce heat loss and energy loss.

Water Heater

3. Replace existing domestic water heater.
4. Ensure programmable thermostats are set for night set back and set back for unoccupied hours.
5. Provide insulation at existing heating hot water piping throughout the building.

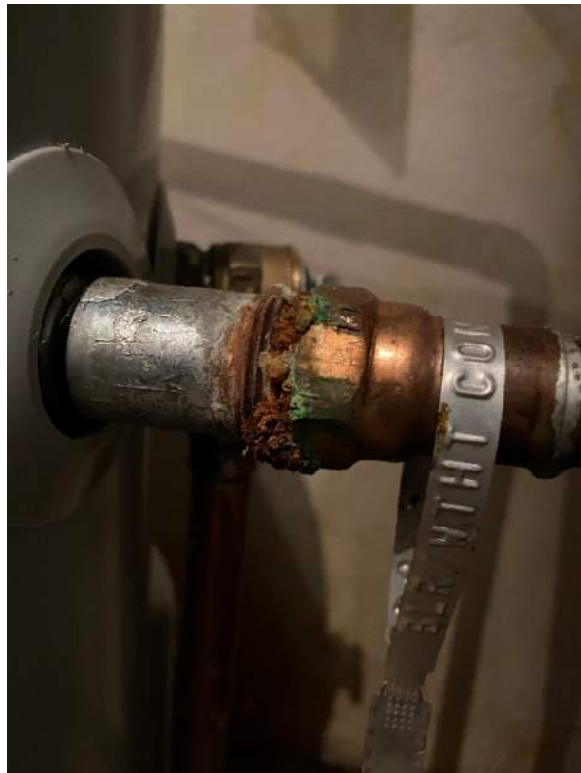
Water Heater Outlet Connection

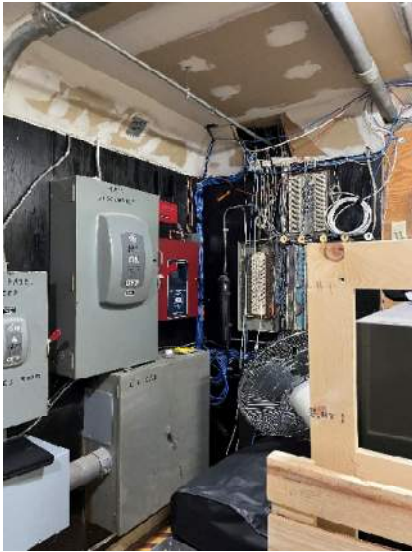
The room housing the main electrical distribution equipment is currently being used as storage. Boxes were observed partially blocking equipment and working clearances.

Main electrical service equipment

10. Removing the items located in front of electrical equipment in the main utility closet is recommended. Its current condition represents a code violation.

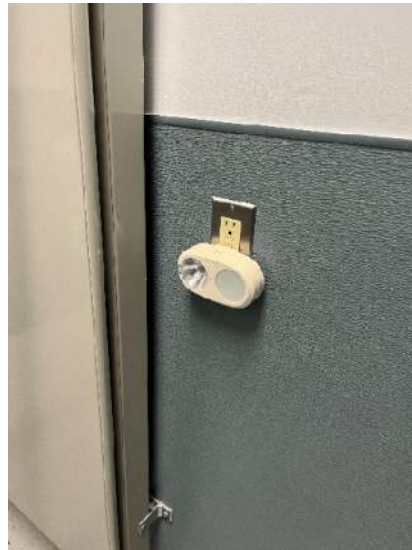
Emergency lighting consists of combination exit sign or stand-alone self-contained battery units. Code compliant coverage was observed in the corridors. Emergency lighting in the public bathrooms consists of units plugged into a power receptacle. This method of coverage is not recommended.

Plug in emergency light

1. Retrofitting existing lamps to LED and installation of localized standalone vacancy/occupancy sensors is recommended for additional energy savings in areas lacking these devices.
2. Replacing the plug-in emergency light device in one of the bathrooms is recommended.
3. Removing the items located in front of electrical equipment in the main utility closet is recommended. Its current condition represents a code violation.

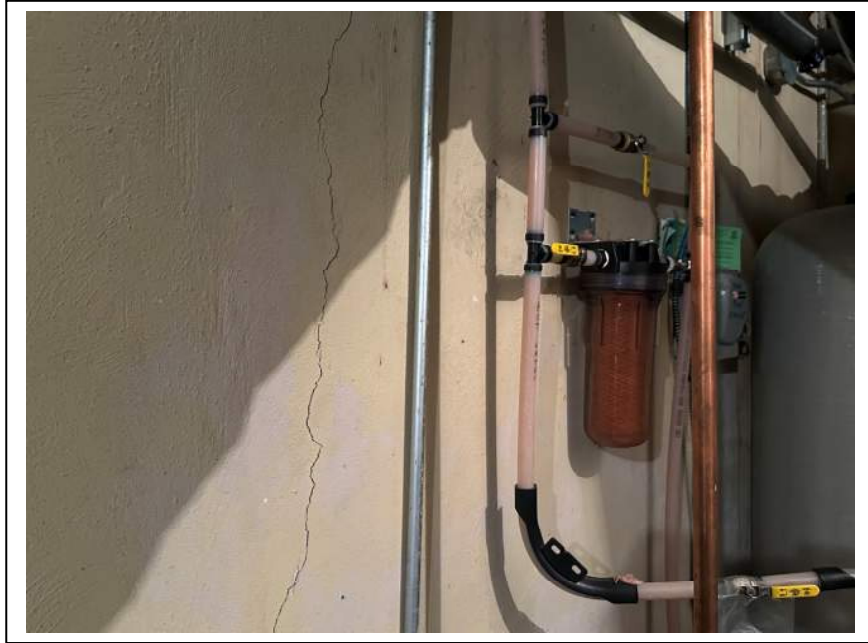
Exhibit 3

The interior walls at the lower level consist of concrete masonry units (CMU). Some portions of the CMU walls are exposed, while other areas are concealed by in place finishes. Cracking of the exposed masonry was observed in some locations as well as in the finishes of the finished partitions. The cracks appear to be minor in nature and do not represent a structural concern at this time. Should the cracking continue or appear in additional areas, further investigation will be required. Please refer to Photograph Exhibits #3 and #4.

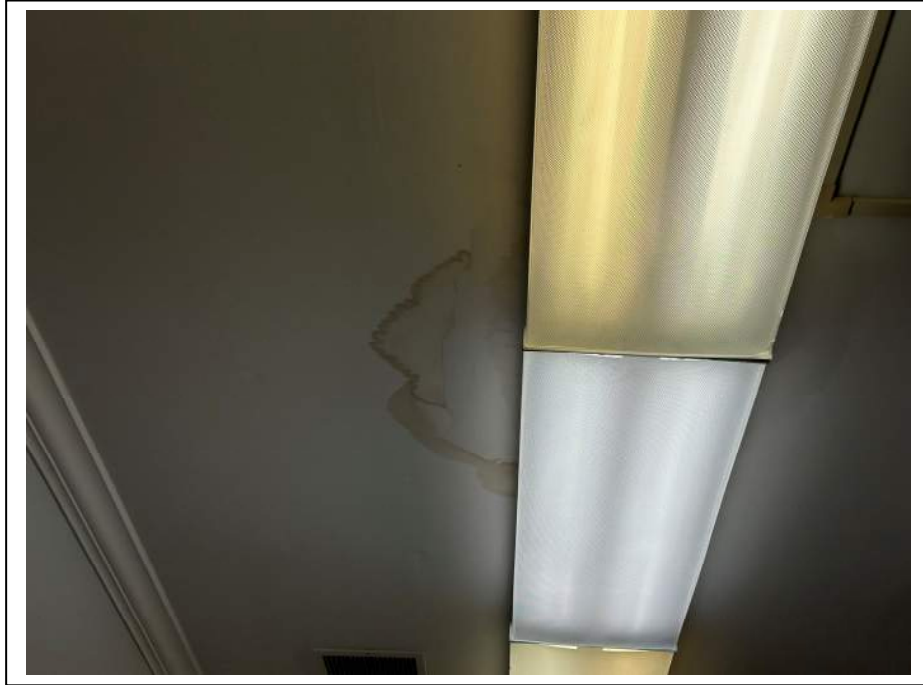
Exhibit 5

The wood framing of the supported floors is concealed by in place finishes and could not be observed. Some cracking of the finishes was observed, however, the cracks appear to be cosmetic in nature and do not represent a structural concern at this time. Should the cracking continue or appear in additional areas, further investigation will be required. Please refer to Photograph Exhibit #5,6. Some water staining was observed in the ceilings. The source of the water staining could not be determined. It also could

not be determined if the leaks were active. Further investigation should be carried out to determine both of the above.

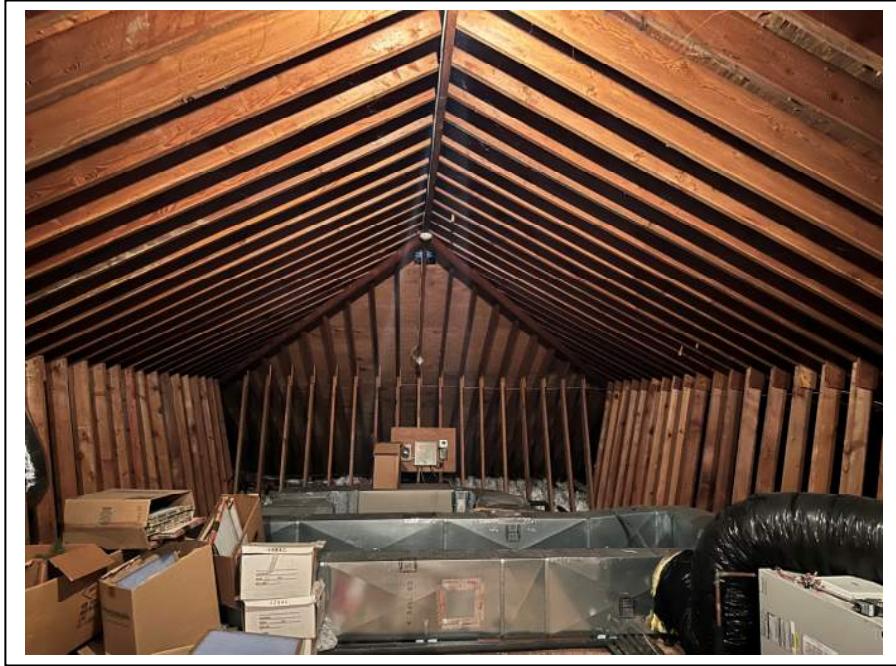
Exhibit 7

The roof framing was visible from within the attic space. The roof structure is a conventional wood framed system. Areas of previous repair work were observed and appeared to be weather tight at the time of the site visit. Please refer to Photograph Exhibits #7 and #8.

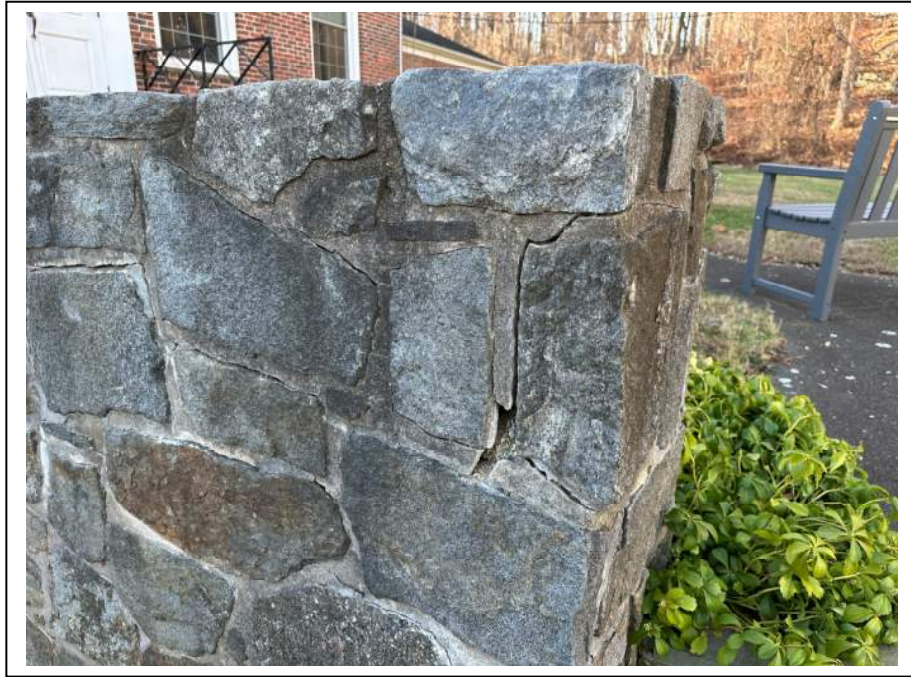
Exhibit 9

A stone site retaining wall, located on the north side of the building is in need of remedial work. The mortar joints between the stones are failing and require repointing. The bluestone caps are also in need of repointing. Water infiltration and freeze/thaw cycles will cause these deficiencies to worsen and therefore should be repaired before more significant repairs or replacement is required. Please refer to Photograph Exhibits #9 and #10.

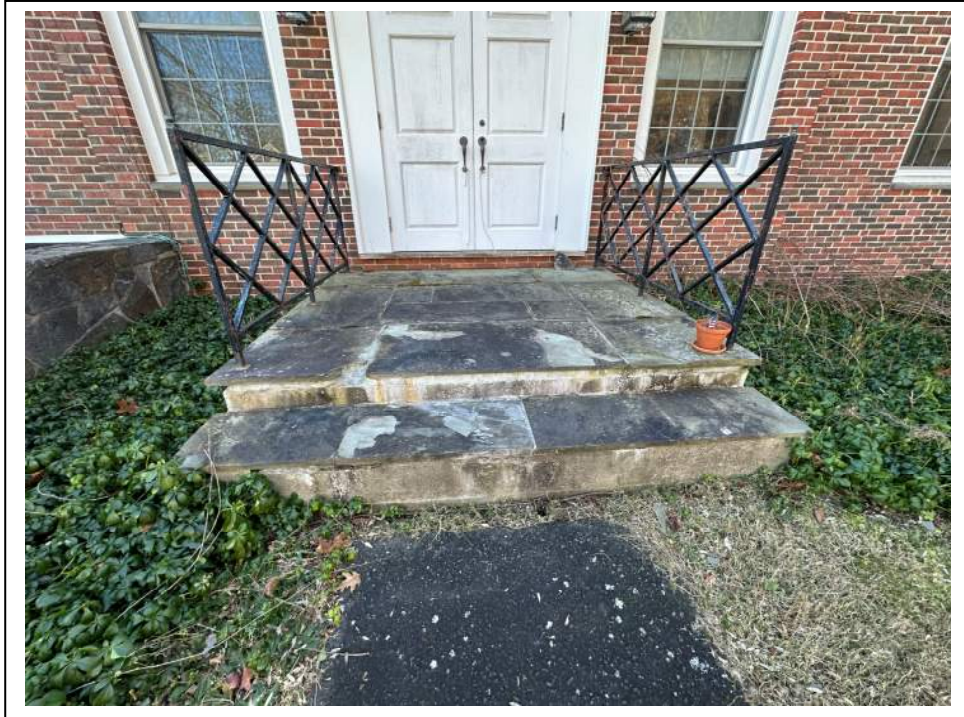
Exhibit 11

The bluestone topping of the main entrance is delaminating and requires replacement. The delamination of the stones has created a potential trip hazard, which presents a safety concern. Water infiltration, freeze/thaw cycles and the application of deicers will cause these deficiencies to worsen, and these areas should be repaired/replaced. Please refer to Photograph Exhibit #11.

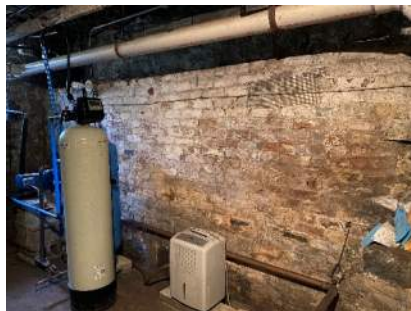
The exterior walls bear on stone and masonry walls, with a concrete slab. Although the masonry block walls appear to be in very good condition, there was some efflorescence noted throughout the basement.

Masonry foundation. Visible efflorescence

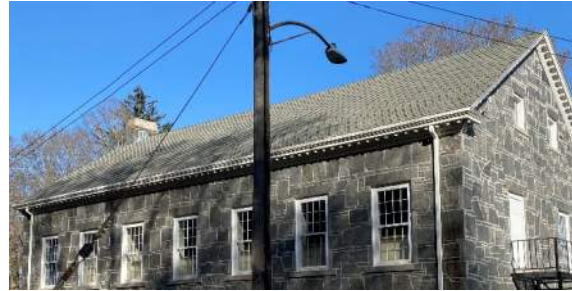
The Old Town Hall roof is a gabled structure with asphalt shingles. The fish scale style roof shingles appear to be in good condition with no visible damage or fading, however, the age of the shingles could not be concluded, and if the installation was 20 or more years ago, replacement should be considered.

Asphalt shingle roof

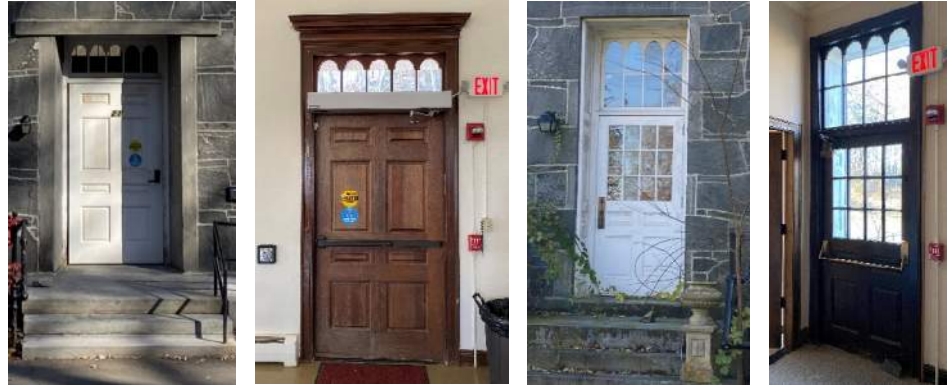
entrance is provided with an ADA compliant hardware and a door opener. Exterior hardware at the other doors is not ADA compliant.

Entry door, exterior

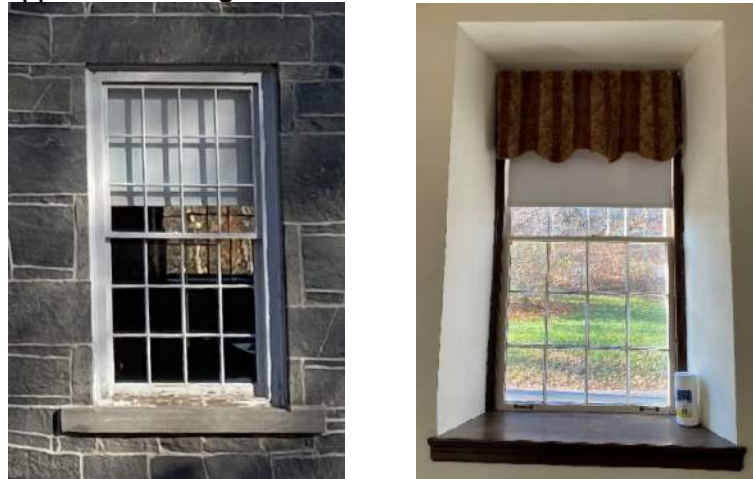
The windows at the Old Town Hall are typically double hung with a 12 over 12 lite pattern. Although they look to be in good condition, they appear to be original to the structure and are uninsulated and inefficient.

Typical double hung window, exterior

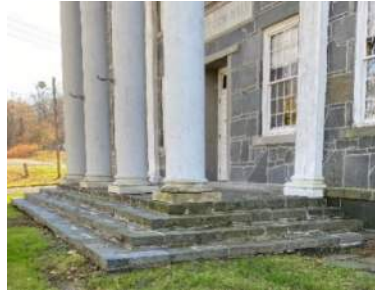
The East façade of the Old Town Hall is distinguished with a Greek Revival style porch. The stone steps are in moderate condition; however, mortar joints are loosening and organic matter is growing. This could be a tripping hazard. The colossal Tuscan columns appear to be in good condition; however, paint is fading and chipping.

Column base

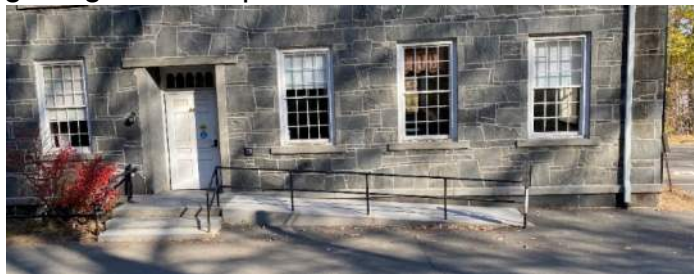
The accessible ramp at the West entrance provides handicapped access to the building, however the handrail does not meet current standards lacking extensions at the bottom of the run. The fire escape for the 2nd floor on the South Elevations is in very good condition, although level grading should be provided at the base of the stairs.

Front entry ramp

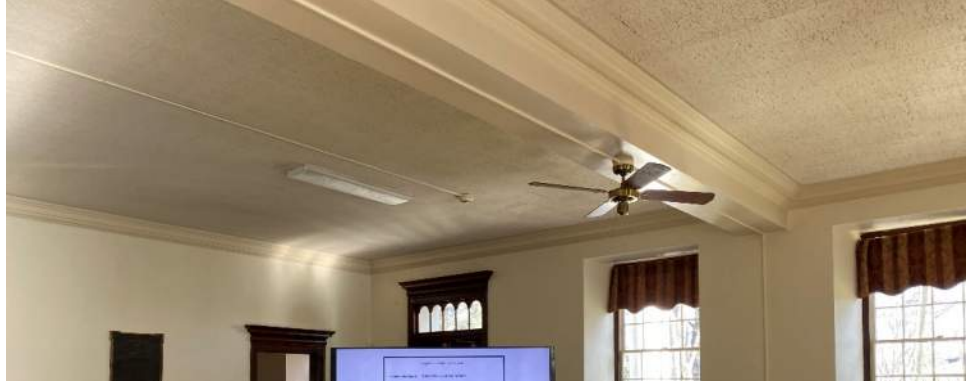
Due to the age of the structure, the adhered ceiling tile in the Meeting Room should be tested for hazardous materials in the tiles and/or adhesive.

Meeting Room ceiling

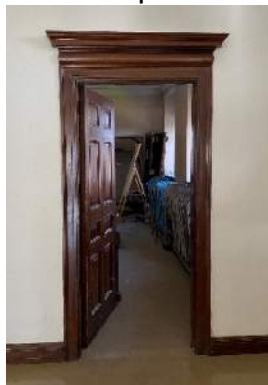
The typical doors on the 1st Floor of the Old Town Hall are 6 and 8 panel wood doors. The doors appear to be original to the building and are in good condition. Door handles are generally door knobs and are not ADA compliant.

8 Panel historic door and trim

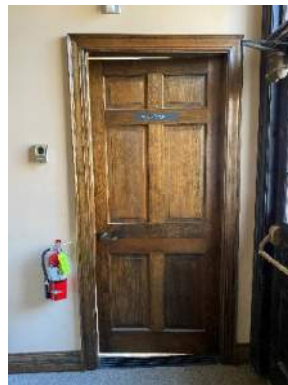
6 Panel historic door

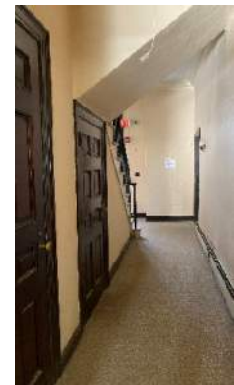
Corridor doors

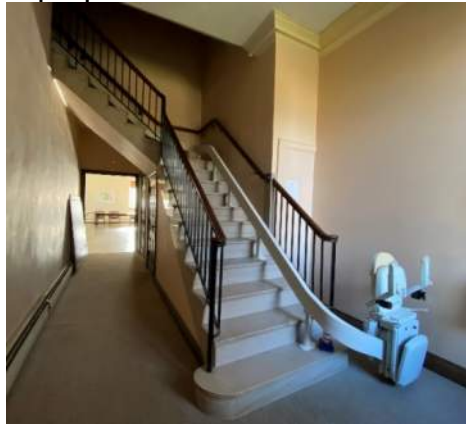
The main stair is located near the north entrance and provides access to the 2nd floor. The grand stair case is in good condition and although it no longer meets code with proper tread and riser dimensions, it is equipped with a chair lift to provide ADA access to the 2nd floor. The marble treads could be slipping hazards and should be provided with non-slip treads.

1st Floor stair

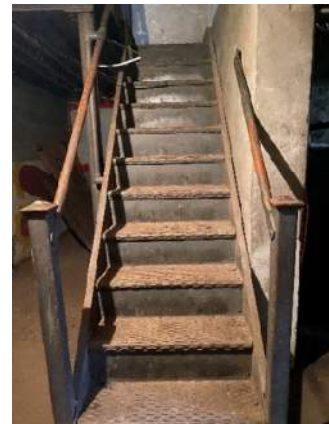
The narrow metal stairs to the basement do not meet current code with improper tread and riser dimensions.

Basement stair

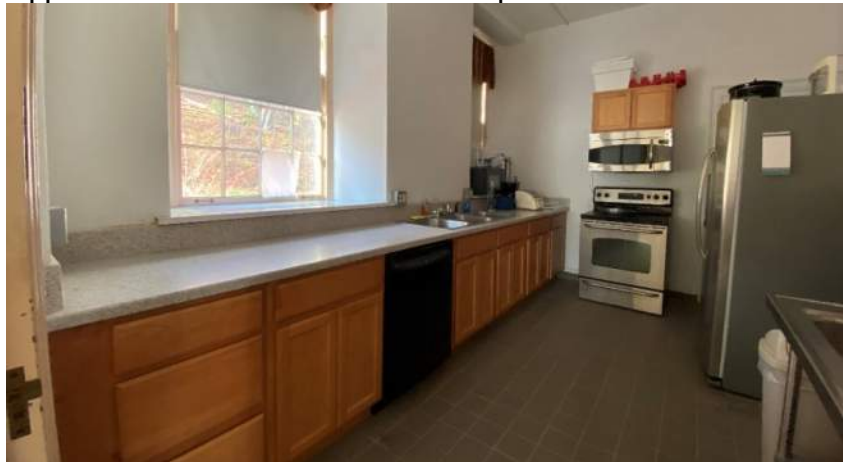
Cabinets, countertops, and fixtures all appear to be in good condition, however they are not ADA compliant. Cabinets are not the proper height, nor do they provide knee space at the sink for wheelchair access. Upper cabinets are also out of the required 48” reach zone.

1st Floor Kitchen

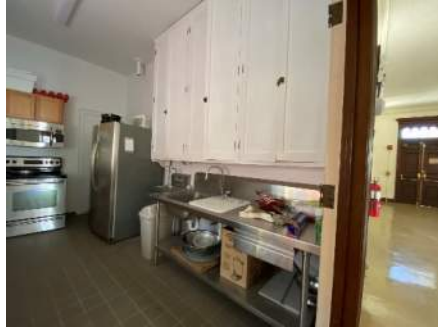
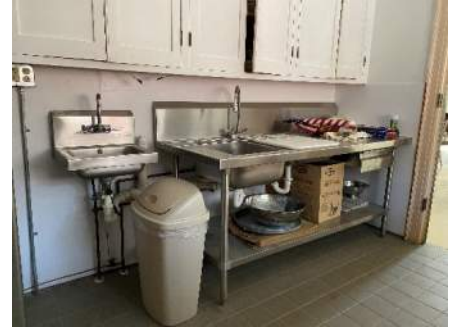
Kitchen cabinets

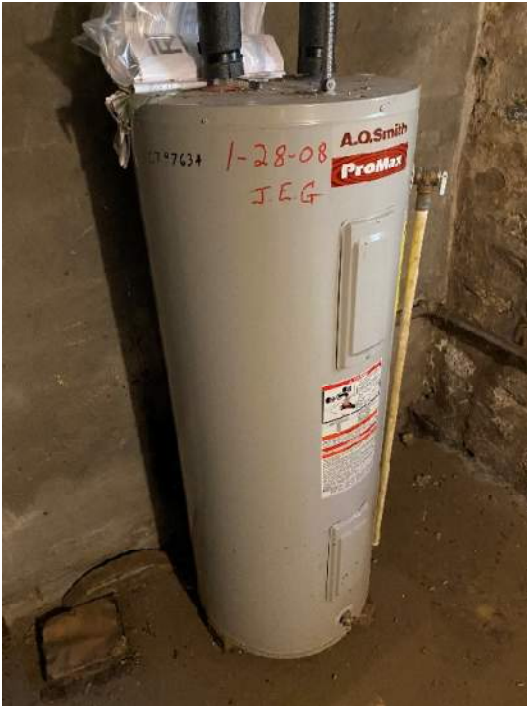
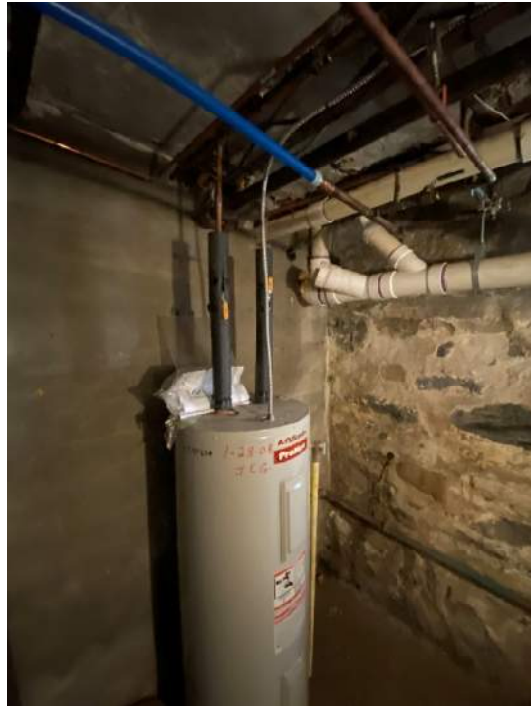
The buildings domestic hot water is generated by an electric storage tank water heater. Domestic hot water piping is a mix of copper with soldered fittings and PEX piping. Piping is currently un-insulated. The existing water heater is dated from 2008, recommend removing and replacing. Recommend insulating all domestic copper piping to reduce heat loss and energy loss.

Water Heater

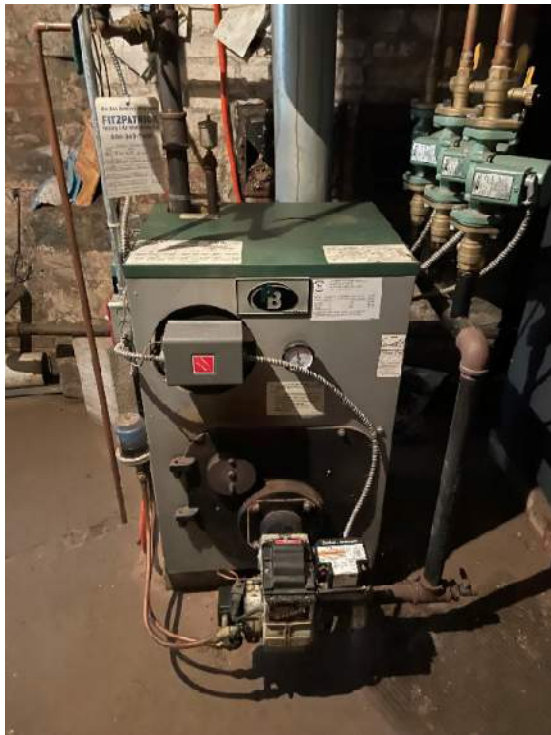
The building is heated with an oil fired boiler located in the basement. The boiler distributes hot water via three inline pumps to perimeter radiation. There is no insulation at hot water heating piping. There is no cooling or ventilation/fresh air provided at this building. The boiler and pumps are in good condition.

Hot Water Boiler

Provide split system heat pump units for cooling and back up heating. Add insulation to hot water heating piping.

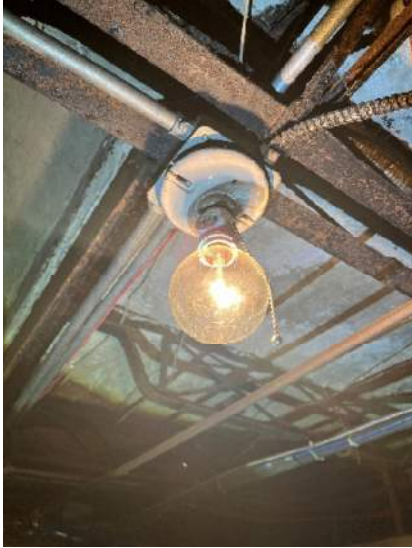
A photograph of an incandescent light bulb hanging from a ceiling in a basement. The bulb is illuminated and is surrounded by a network of pipes and structural beams.
<p>Security Touch Keypad</p>	<p>Basement Incandescent Lamp</p>

1. Retrofitting existing lamps to LED and installation of localized standalone vacancy/occupancy sensors is recommended for additional energy savings.
2. The building currently doesn't have an active internet connection. Providing a basic high-speed internet connection is recommended as it will promote a more desirable use of the space. It will also allow for the installation of a small-scale video surveillance system with remote monitoring.
3. Assess and replace exposed branch circuit wiring in poor condition. Its current condition represents a fire hazard.

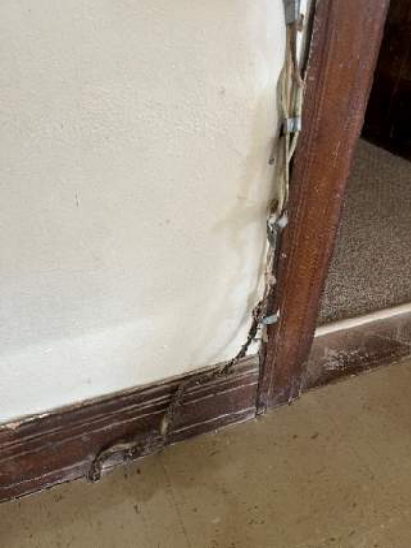
The main electrical equipment is located in the basement, which also contains the electric meter, main service disconnect, and distribution panelboards feeding the building's various mechanical, lighting, and receptacle loads. The electrical service is fed via an optional standby Automatic Transfer Switch (ATS) rated at 100Amp, 208/120V, 3-phase, 4-wire, which provides full building backup. The ATS is connected to a 20kW pad mounted diesel generator located on the exterior of the building. Some of the interior exposed branch wiring was observed in poor condition.

A photograph showing exposed electrical wiring. The wires are bundled together and run along the edge of a wooden door frame, where they are not properly enclosed in a conduit or raceway.	
<p>Exposed branch circuit wiring</p>

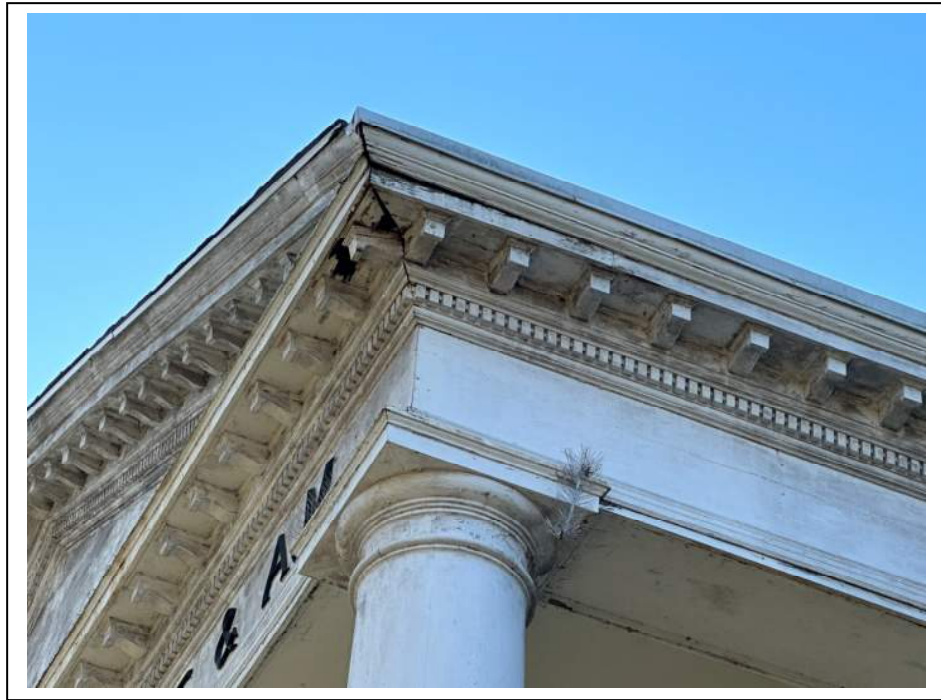
Exhibit 5

The ornate wood trim at the roof level could only be observed from grade level. Deterioration was observed and further inspection is required to determine the extent of the damage. Remedial work will be required. Please refer to Photograph Exhibit #5.

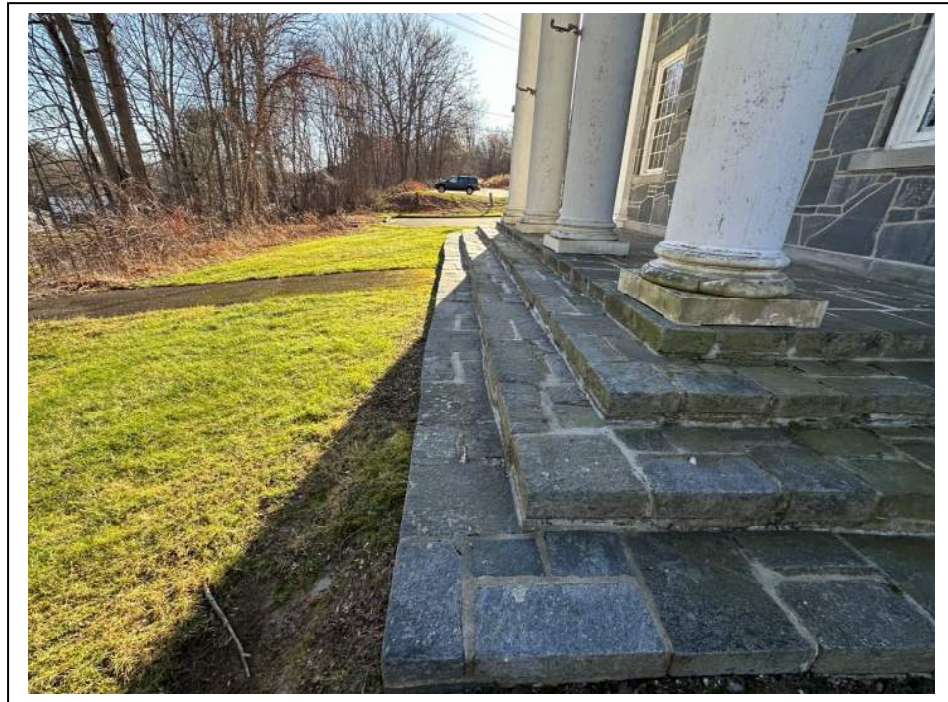
Exhibit 6

The exterior stone stairs, walkways and window well are all in need of repointing. Water infiltration, freeze/thaw cycles and the application of deicers will cause these deficiencies to worsen, and these areas should be repaired. Please refer to Photograph Exhibits #6 and #7.

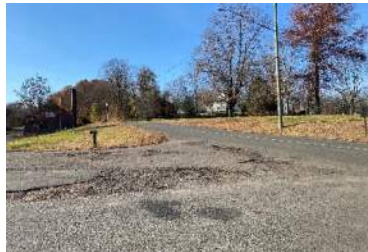
The Haddam Community Center, situated on approximately .3 acres, sits on a site that slopes upward to the west and is shared with the Haddam Veteran’s Museum. A large parking area is provided for the building, however there are no marked spaces, and the lot has many pot holes and bare unpaved patches. The entrance to the parking merges directly into the road, with little to distinguish between the two.

Entrance to parking lot

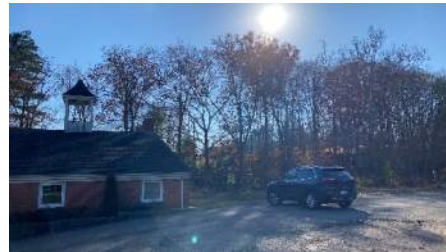
View of parking lot from Candlewood Hill Road

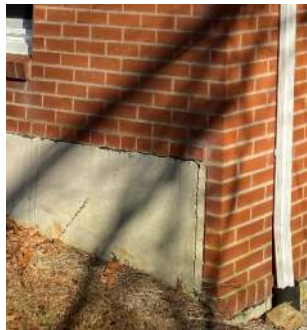
The exterior walls of the Community Center are brick veneer with wood frame backup on a cast concrete foundation. Overall, the brick appears to be in good condition, are clean, and show minimal signs of efflorescence. The mortar joints look to be solid with no obvious loose material, however several locations were noted with cracking and/or damaged brick.

Cracking at concrete foundation joint near brick

The structure is supported on what appears to be a cast-in-place concrete foundation. There is a change of grade of approximately 2'-0" at the front and side of the building, where the first floor is set below grade. Significant cracks were observed in the concrete slab within the boiler and storage rooms. Please refer to Photograph Exhibits #1 and #2. The cause of the cracks could not be determined, however, no vertical displacement was detected, therefore the cracks are likely due to the shrinkage of the concrete after placement. The cracks should be repaired and monitored for future movement.

- b. Repair, re-point, replace damaged masonry
 - c. New 30-year architectural asphalt shingles
 - d. Scrape, clean, and re-paint cupola
3. Doors
 - a. Update door hardware to ADA standards

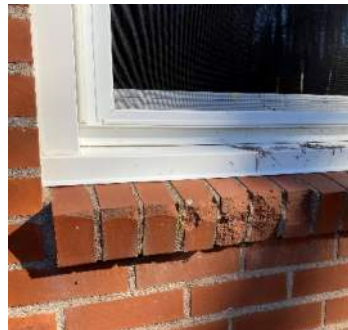
Damaged brick at window sill

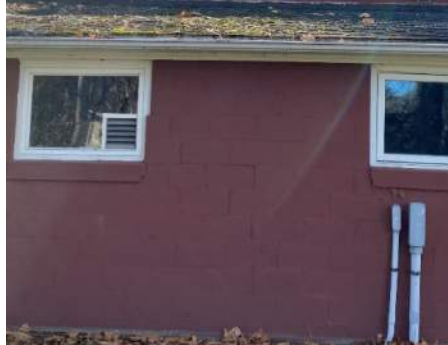
The garage/storage portion of the structure is constructed of CMU block and while overall it appears good, several cracks were noted in the walls and at the pre-cast lintels.

East Elevation – mortar joint crack

Cracking was observed in both the exterior CMU walls and the brick veneer, in various locations. No control joints were visible in the veneer which could explain the cause of vertical cracking at the long stretches of wall. Cracks were also observed in the brick chimney extension above the roof and require repair. Previous repairs were performed on the chimney and should be inspected. Water infiltration and freeze/thaw cycles will cause these deficiencies to worsen, and these areas should be repaired. Please refer to Photograph Exhibits #3 and #4. Please note that failure to repair the brick chimney could result in failing bricks.

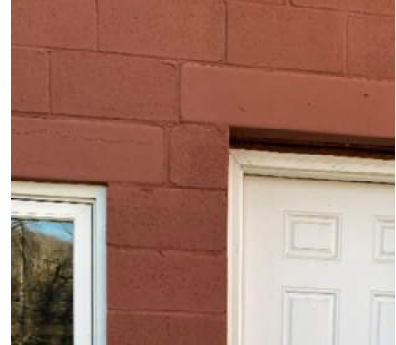
Horizontal cracking at pre-cast lintel and along vertical mortar joints

Precast concrete lintels are present on the rear elevation of the building over the window and door openings. Horizontal cracks are present in the lintels. The cracks are likely caused by either overstressing of the lintel or water infiltration into the lintel that has caused the reinforcing to begin to corrode. The lintels should be replaced with new steel or precast. Cracking and displacement of the CMU were observed in the rear exterior walls, as

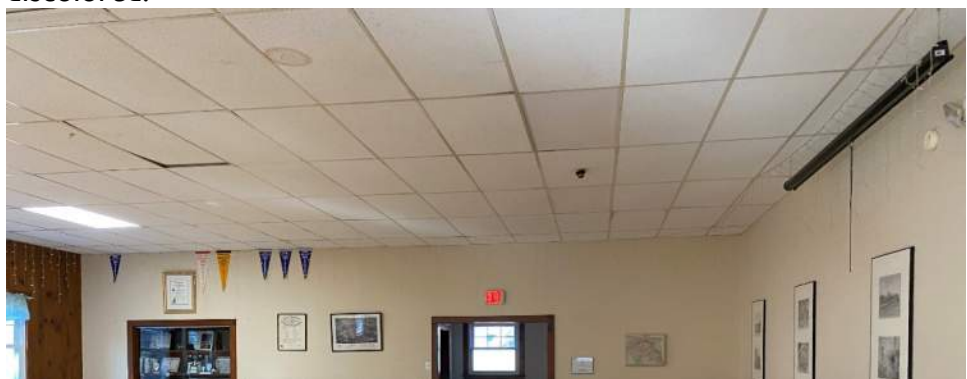
The ACT ceiling in the Meeting Room is in moderate condition with several tiles that are sagging and water stained, and the ceiling grid is discolored.

Typical Acoustical Ceiling Tile ceiling

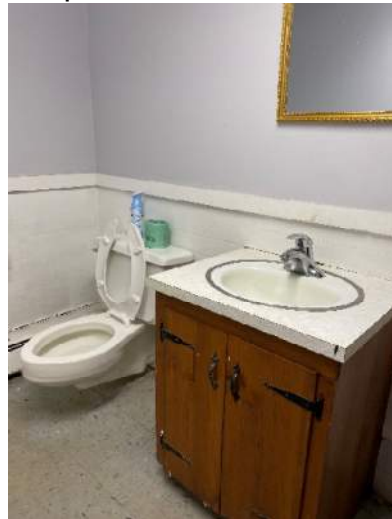
Single occupancy Men's and Women's Toilet Rooms are located to the rear of the building. Plumbing fixtures appear to be in good condition, however vanities are not. The Men's vanity appear to be nothing more than a wooden box supporting the sink. Neither toilet room is ADA compliant.

Women's toilet room

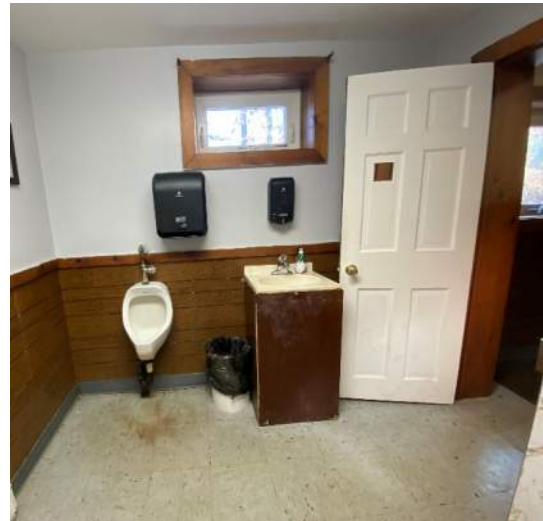
Men's toilet room

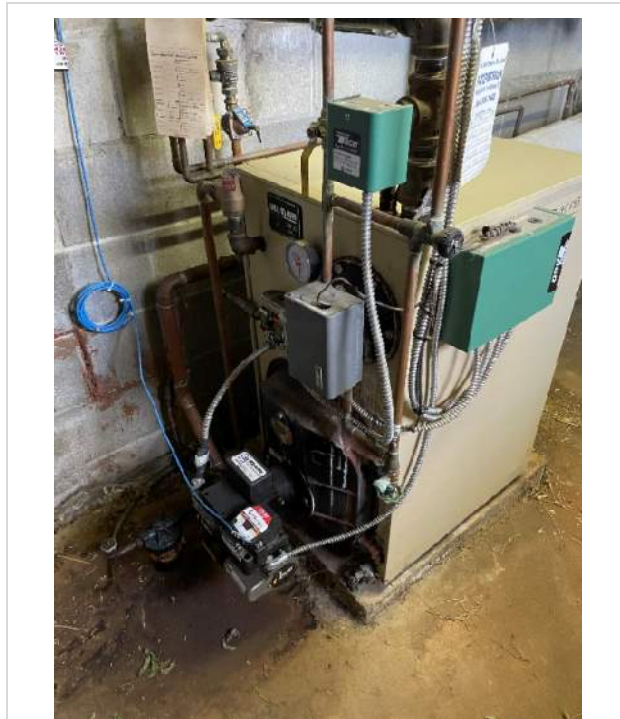
The buildings domestic hot water plant was not identified. It is believed that the hot water is generated from the buildings boiler and is piped to an indirect water heater located in a restricted access room. Recommend insulating all domestic hot and cold water piping to reduce heat loss and energy loss.

Boiler

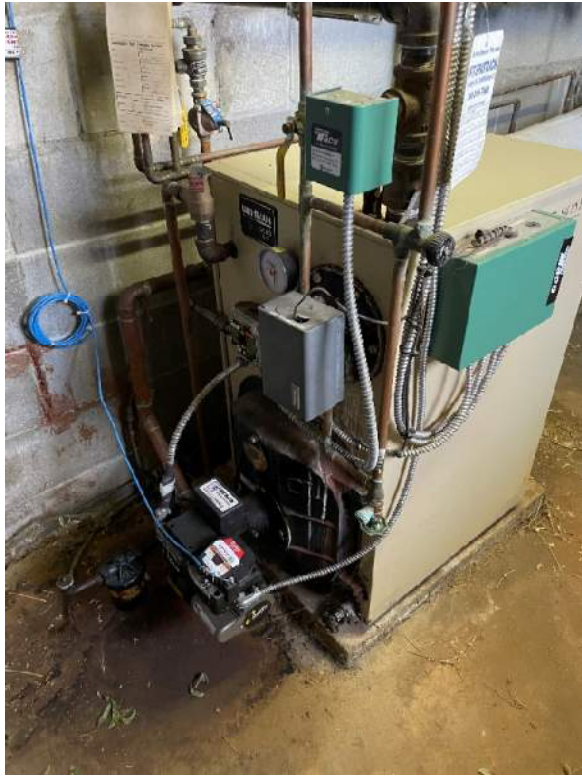
The buildings heating is provided by an oil fired boiler. The boiler is manufactured by Weil McLain and in good condition. There are three hot water pumps that distribute hot water to fin tube radiation, wall heaters and unit heaters. There is no insulation on the hot water piping. The large community room has an exhaust grille connected to an exhaust fan. The garage storage area has two ceiling hung unit heaters. There is no mechanical cooling or ventilation at this building. Ventilation is via operable windows.

Oil Fired Boiler

Add insulation to the heating hot water piping. Ensure thermostats are programmed correctly with night set backs and heat is set back during unoccupied hours. Provide split system air conditioning units/heat pumps to provide cooling and back up heating. An Energy Recovery Unit could be added for enhanced indoor air quality.

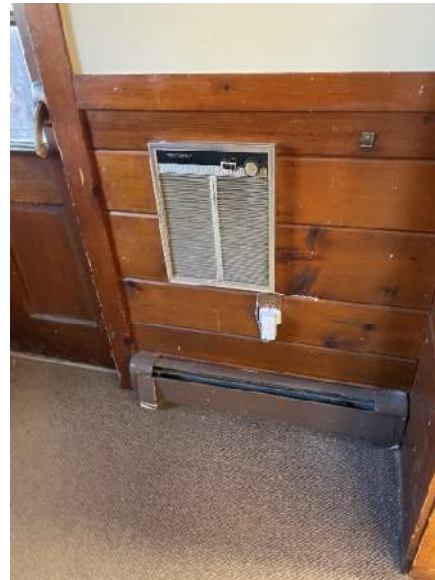
Wall heater and baseboard heater at entrance

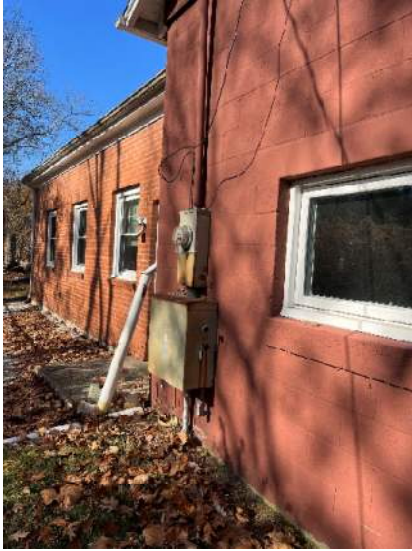
Electric service entrance and meter

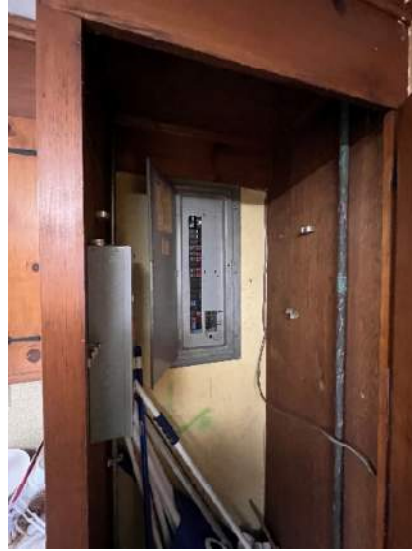
Main electrical panel

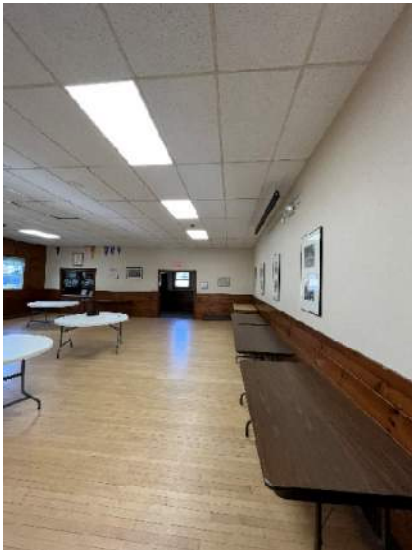
Typical 2'x4' recessed light fixtures

1. Retrofitting existing lamps to LED and installation of localized standalone vacancy/occupancy sensors is recommended for additional energy savings.
2. The building currently doesn't have an active internet connection. Providing a basic high-speed internet connection is recommended as it will promote a more desirable use of the space. It will also allow for the installation of a small-scale video surveillance system with remote monitoring.

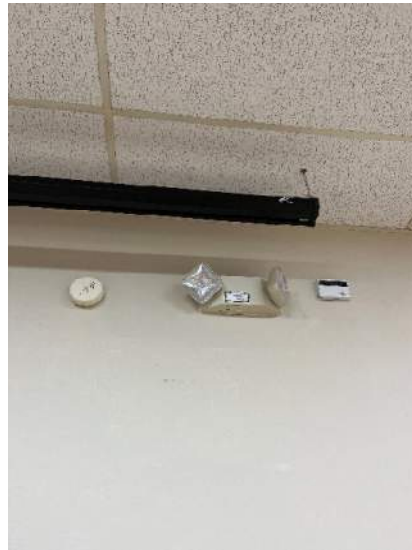
Emergency lighting consists of combination exit sign or stand-alone self-contained battery units. Code compliant coverage was observed in the corridors.

Typical self-contained emergency light

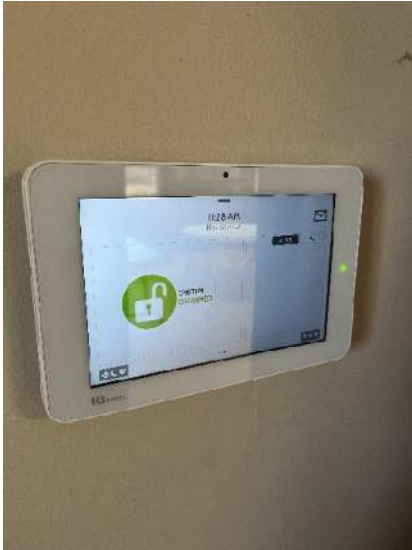
No telecommunication or video surveillance equipment was observed in the property. Intrusion detection consists of door and motion sensors, and security keypads.

Security touch keypad
