TOWN OF HADDAM

FACILITY ASESMENT REPORT

Six Town Buildings

April 1, 2024

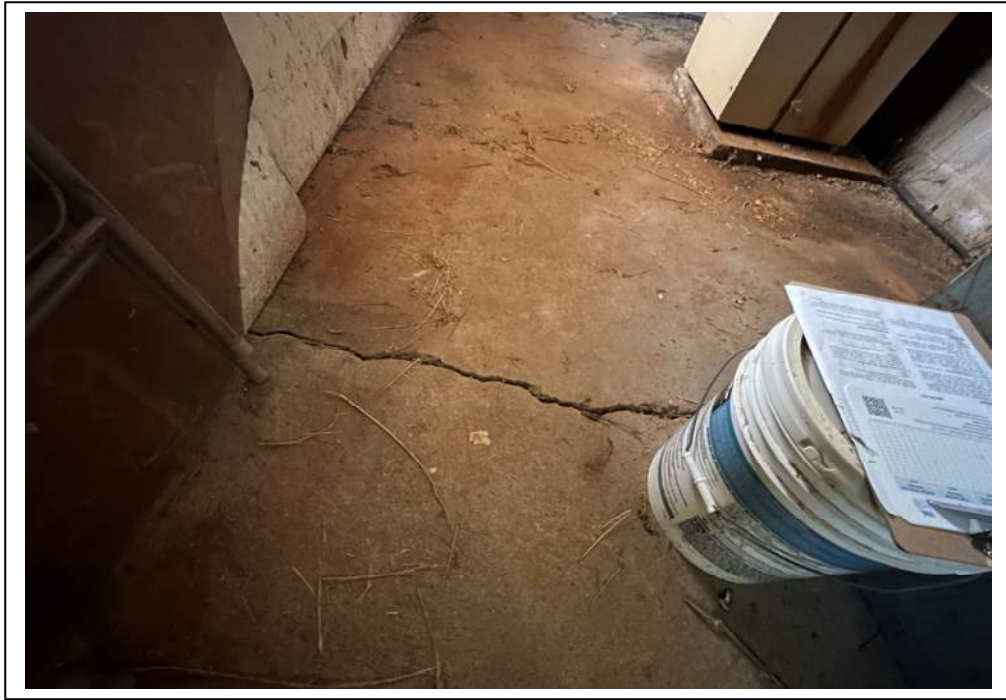
Exhibit 1

The structure is supported on what appears to be a cast-in-place concrete foundation. There is a change of grade of approximately 2'-0" at the front and side of the building, where the first floor is set below grade. Significant cracks were observed in the concrete slab within the boiler and storage rooms. Please refer to Photograph Exhibits #1 and #2. The cause of the cracks could not be determined, however, no vertical displacement was detected, therefore the cracks are likely due to the shrinkage of the concrete after placement. The cracks should be repaired and monitored for future movement.

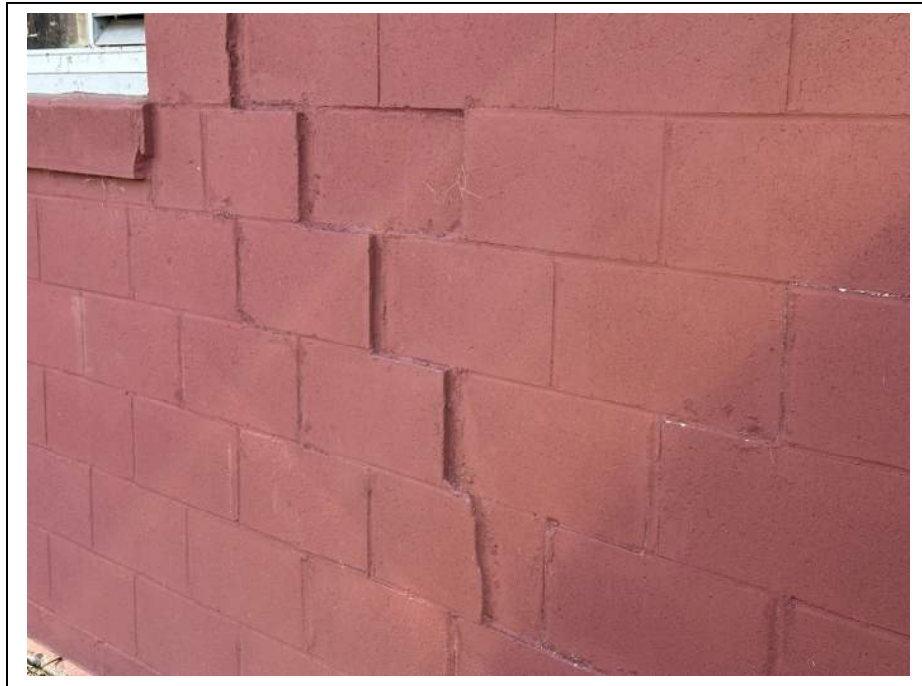
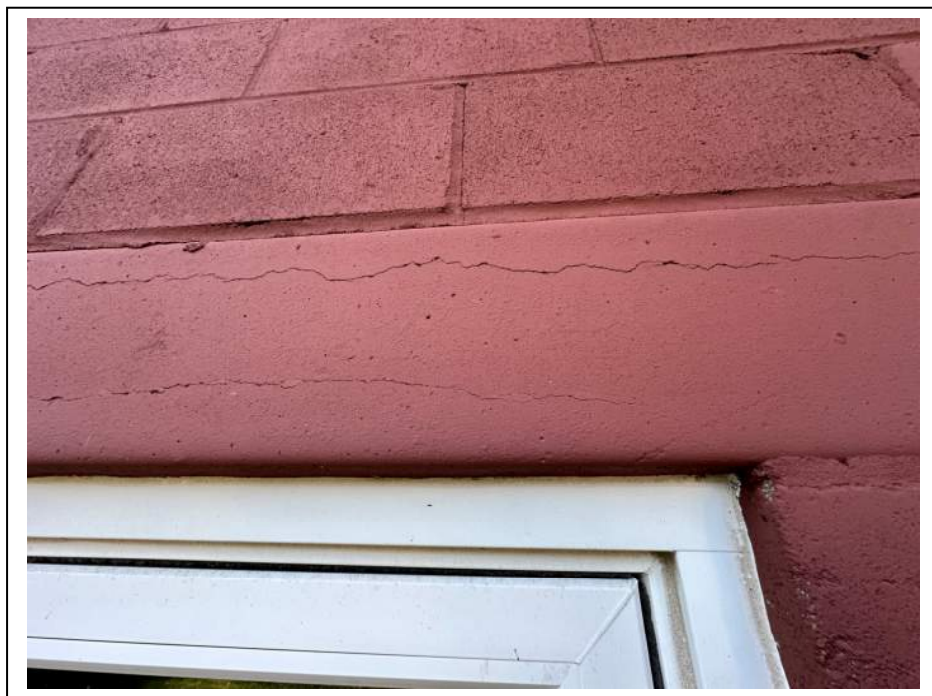
Precast concrete lintels are present on the rear elevation of the building over the window and door openings. Horizontal cracks are present in the lintels. The cracks are likely caused by either overstressing of the lintel or water infiltration into the lintel that has caused the reinforcing to begin to corrode. The lintels should be replaced with new steel or precast. Cracking and displacement of the CMU were observed in the rear exterior walls, as

well as open control joints. Water infiltration and freeze/thaw cycles will cause these deficiencies to worsen, and these areas should be repaired. Please refer to Photograph Exhibits #5 and #6. It could not be determined if brick ties were present, or their condition.

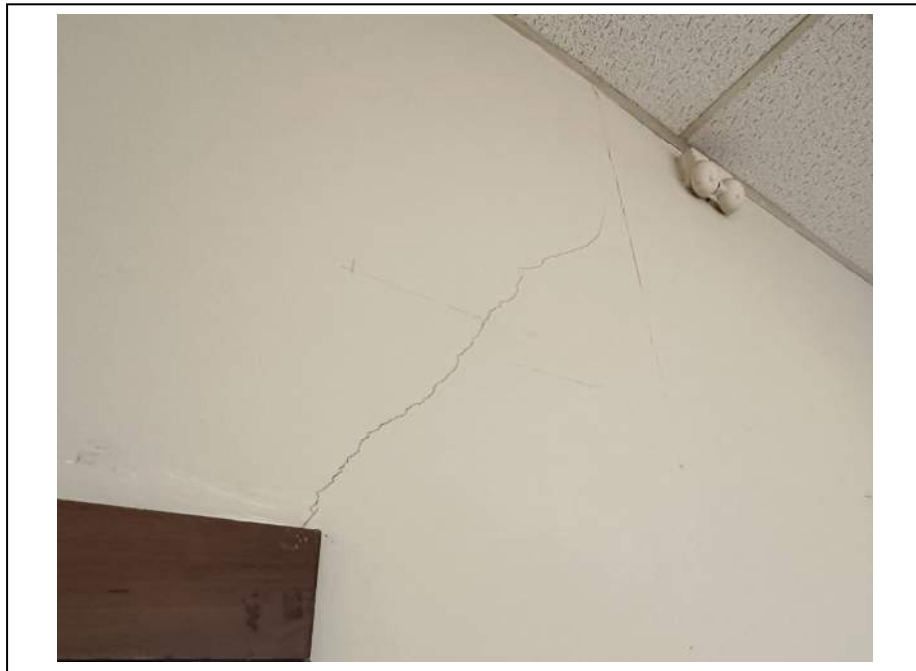
Exhibit 7

As previously stated, the interior face of the exterior walls and roof framing are concealed by in place finishes and could not be observed. Some cracking of the finishes was observed. The cracks appear to be cosmetic in nature and do not represent a structural concern at this time. Should the cracking continue or appear in additional areas, further investigation will be required. Please refer to Photograph Exhibits #7.

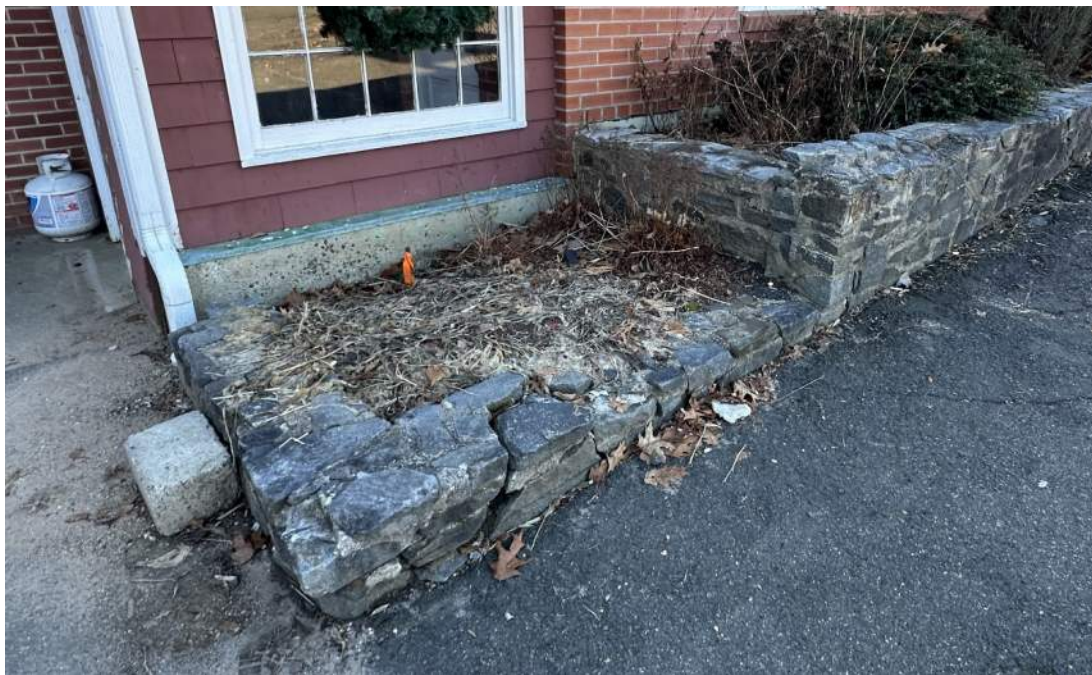
Exhibit 8

The exterior stone planter walls located on the north side of the building are displaced and in need of repairs. Water infiltration and freeze/thaw cycles will cause these deficiencies to worsen, and these walls must be repaired to prevent further damage. Please refer to Photograph Exhibits #8.

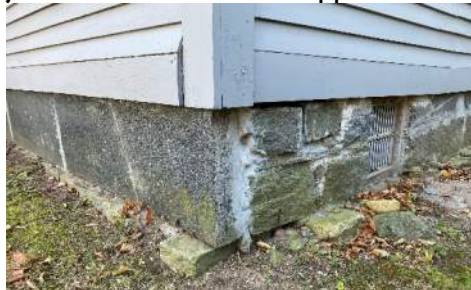
Portions of the foundation appear to be original to the structure, constructed from stone and mortar. The Kitchen and Toilet Room addition at the rear of the building are built on a newer cast-in place concrete foundation. Except for some efflorescence, and poor mortar joints, the foundations appear to be in good condition.

Stone foundation

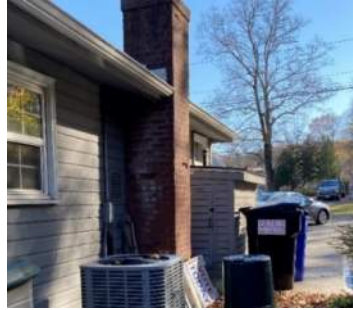
The chimney appears to be in good condition, however there are several spalled bricks, some visible efflorescence, and it is need of cleaning and re-sealing.

Visible efflorescence at chimney

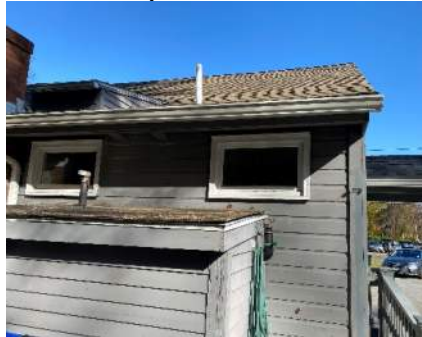
Windows in the Toilet Rooms are vinyl awnings. Kitchen windows are 6 over 6 vinyl double hung. Similar to the front windows, they appear to be relatively newer and insulated.

Awning windows at Toilet Rooms

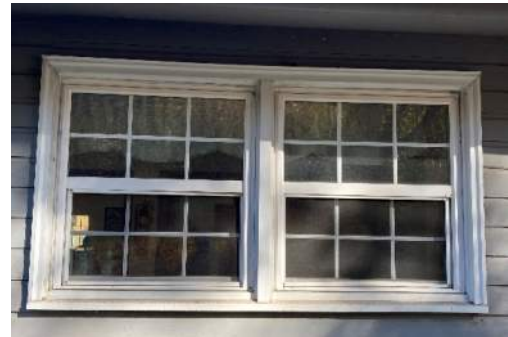
Double hung windows at Kitchen

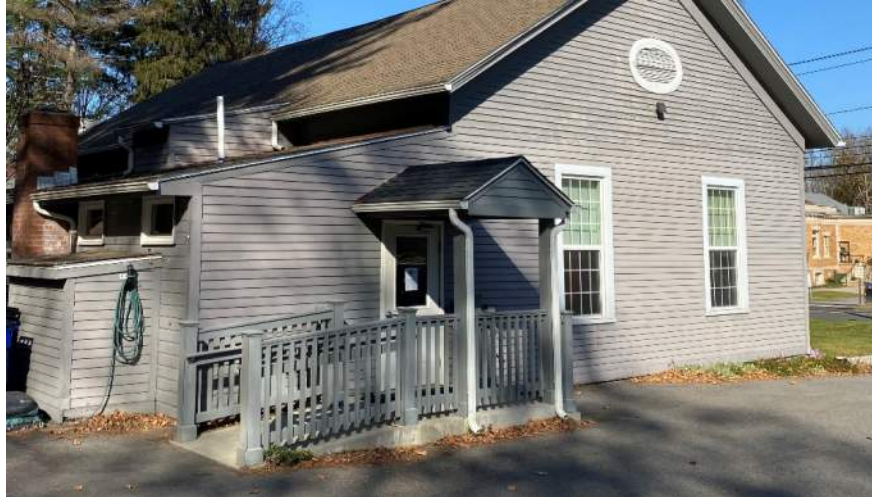
An accessible concrete ramp at the south entrance allows for handicapped access to the Senior Center. Handrail extensions are not provided.

Accessible ramp entrance

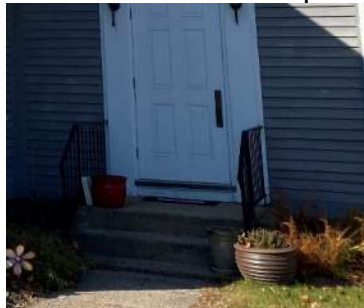
Concrete steps lead to the original school entry doors. The steps are overgrown with moss and organic matter, and there are multiple cracks. Wrought iron handrails do not meet current ADA guidelines, lacking extensions and size requirements.

South steps

At the exterior concrete stairs and landings; cracking, corrosion of railings at the point of embedment, and opening of joints were observed. Please refer to Photograph Exhibit #5. Water infiltration, freeze/thaw cycles and the application of deicers will cause these deficiencies to worsen. These areas should be repaired to avoid further disrepair of the stairs and railings.

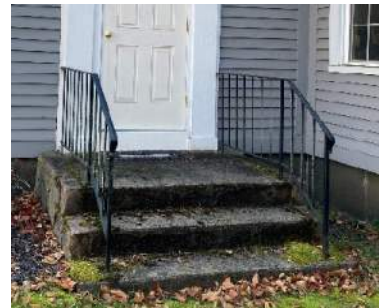
North steps

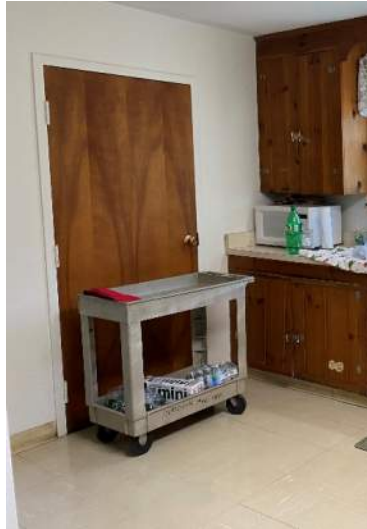
The Mechanical Room is a closet space located directly off the Kitchen. Mechanical equipment is tight in the room and there is little space for workers to maneuver around. Kitchen paraphernalia was blocking the door at the time of this review.

Door to Mechanical Room from Kitchen

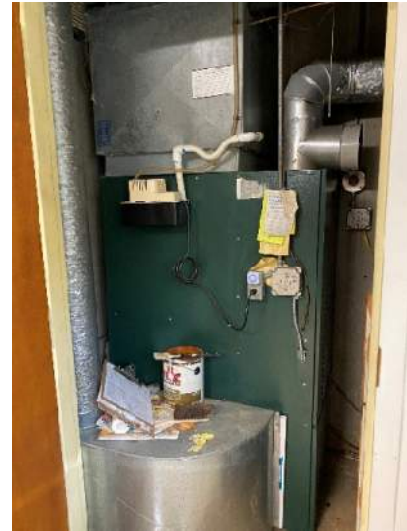
Mechanical equipment

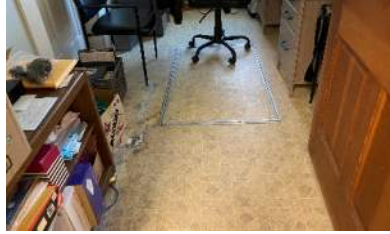
Flooring for the Office is sheet vinyl and is worn and dated.

Typical vinyl flooring in office

1. Site
 - a. Additional parking is recommended
2. Exterior
 - a. Clean and seal masonry chimney
 - b. Clean efflorescence from foundation
3. Doors
 - a. Update door hardware to ADA standards
4. Floors
 - a. Provide new flooring and wall base throughout
5. Kitchen
 - a. Complete renovation of kitchen. Provide kitchen cabinets, fixtures, and appliances that are ADA compliant
6. Ceilings
 - a. Provide new ACT ceiling and grid
7. Programmatic Needs
 - a. Smaller group spaces
 - b. Storage space
 - c. Office/administrative space
 - d. Mechanical space is tight

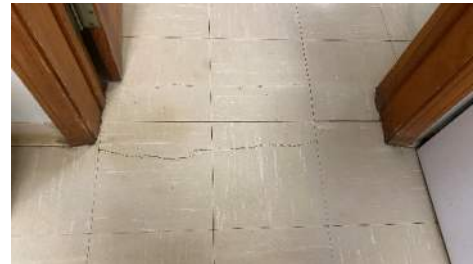
The flooring for the Senior Center is typically VCT. Most flooring appears to be in fair condition, although somewhat worn and there are several areas of cracked tiles.

Cracked VCT

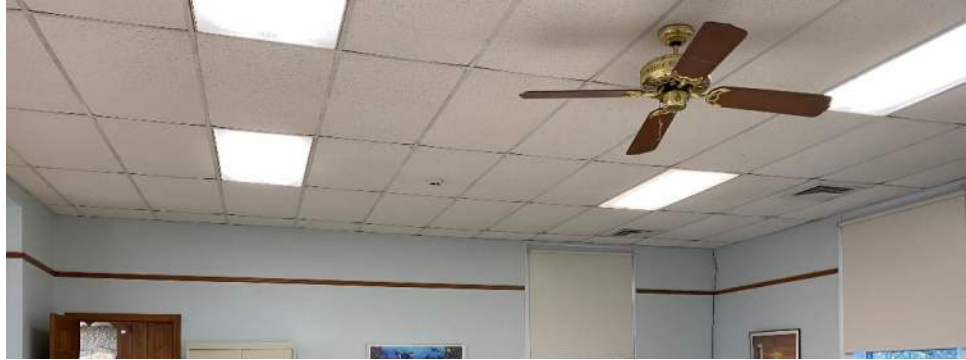
The ceilings overall are in good condition, however ACT ceiling in the Meeting Room is showing signs of sagging. Gypsum board ceilings throughout are in good condition.

Typical Meeting Room ACT ceiling

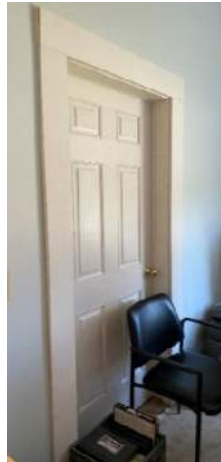
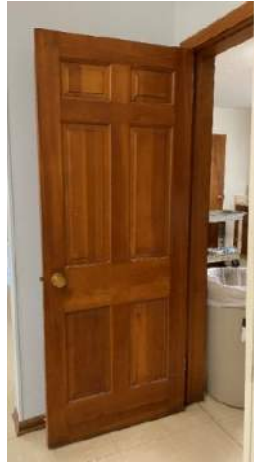
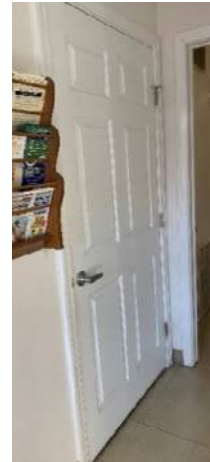
The typical doors throughout the Senior Center are 6 panel wood doors, All doors appear to be in good condition. Door handles are generally door knobs and are not ADA compliant, however the ADA t toilet room is equipped with accessible hardware.

Typical doors

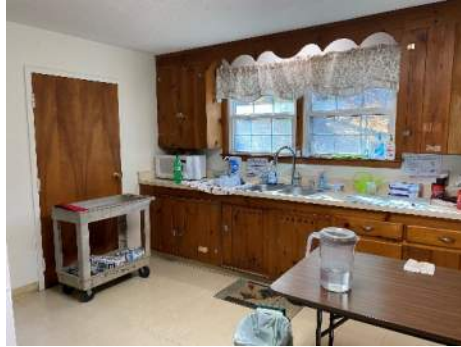
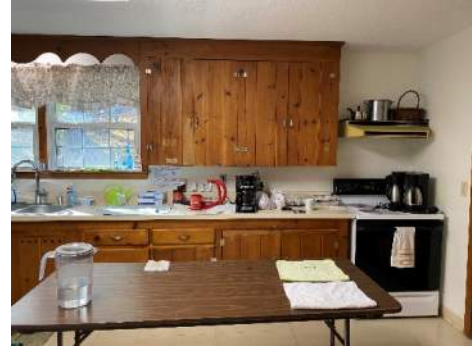
Kitchen cabinets, countertops, and fixtures all appear to be in fair condition and operable, however several doors were found to be damaged or loose on hinges. They are dated in appearance and are not ADA compliant. Cabinets should be at 34” in height and do not provide knee space at the sink for wheelchair access. Upper cabinets are also out of the required 48” reach zone.

Kitchen

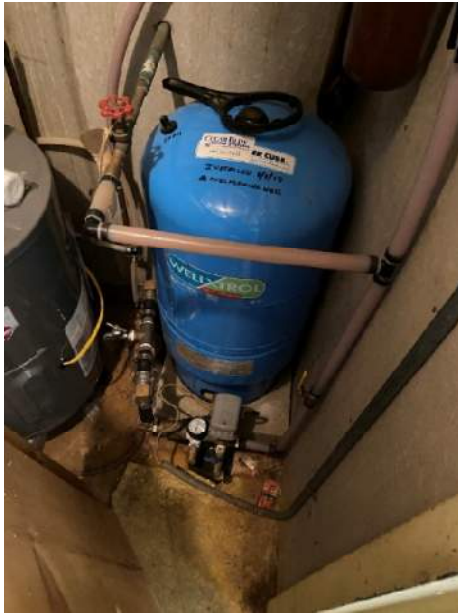
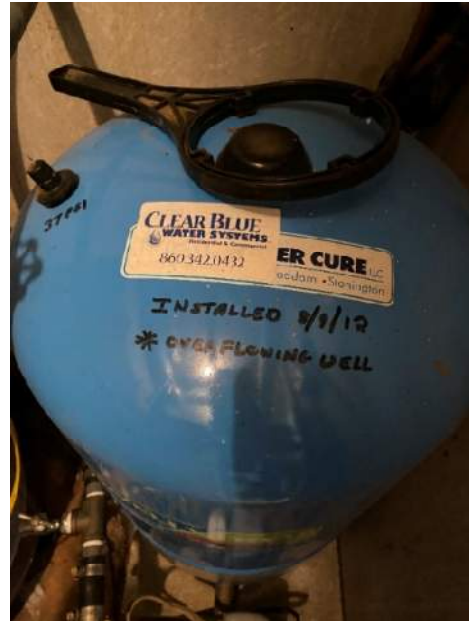
The buildings domestic water is supplied from an on-site well water system. There is a 20-gallon well storage tank located inside the building mechanical room. The well storage tank was manufactured on May 7, 2012 and installed on August 9, 2012. The unit appears to be in good working condition but is nearing the end of its life as well tanks are typically replaced every 10 to 15 years. Domestic water piping is a combination of copper and PEX. Recommend replacing well storage tank. Recommend installing low flow plumbing fixtures to reduce water consumption.

20-Gallon Well Storage Tank

1. Replace plumbing fixtures (i.e. faucets, toilets) with low-flow water saving plumbing fixtures.
2. Insulate all domestic cold and domestic hot water piping.
3. Replace existing well-water storage tank.
4. Ensure the thermostat is programmed with a night set back and set back while the building is unoccupied.
5. Retrofit existing lamps to LED.
6. Install localized standalone vacancy/occupancy sensors for additional energy savings.
7. Installing a security system and a small-scale video surveillance system with remote monitoring will improve the physical security of the building, its occupants, and internal assets.

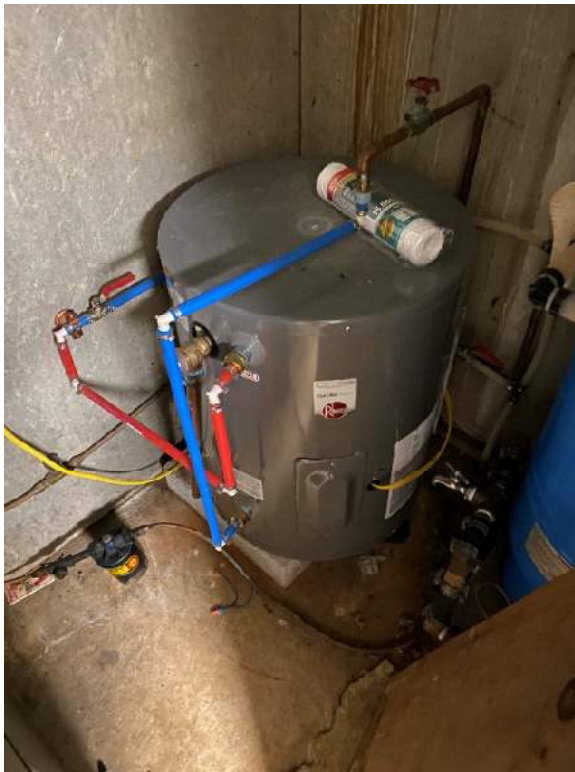
The buildings domestic hot water is generated by a 20-gallon electric storage tank water heater. Water heater was manufactured on June 16, 2022 and appears to be in good working condition. Recommend insulating all domestic hot and cold copper piping to reduce heat loss and energy loss.

Water Heater

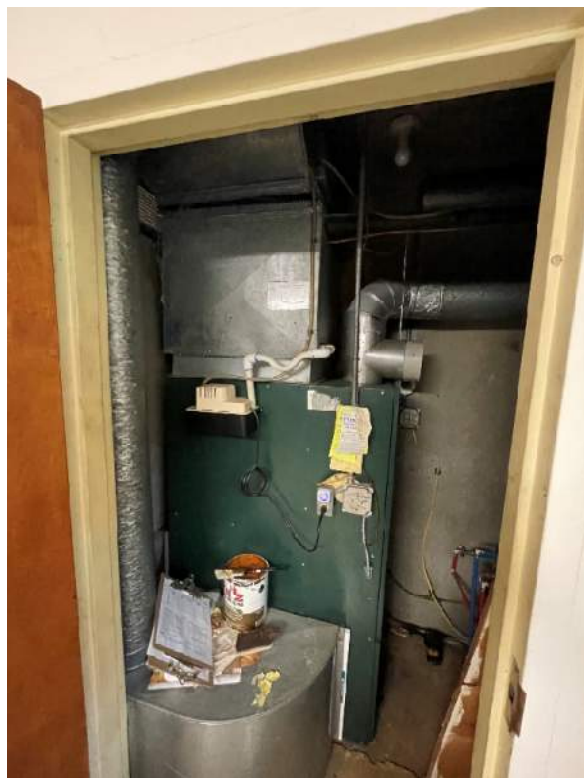
The buildings heating and cooling is provided by an oil fired vertical air handling unit (AHU). This unit is provided with a DX cooling coil connected to a grade mounted condensing unit. The unit or the building does not have any mechanical ventilation/outdoor air. There are operable windows in the building. The AHU distributes heating and cooling via an overhead ducted supply air system. The unit is controlled by a programmable stand alone local thermostat. The AHU is in fair condition.

Vertical Air Handling Unit

Ensure the thermostat is programmed with a night set back and set back while the building is unoccupied.

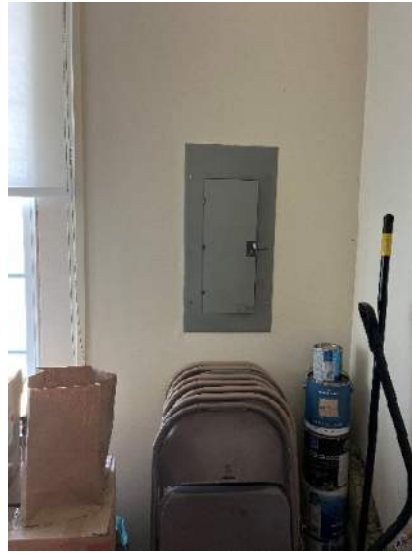
The closet housing the main electrical panelboard is currently being used as storage. Boxes and other elements were observed partially blocking equipment and working clearances.

Main Electrical Panel

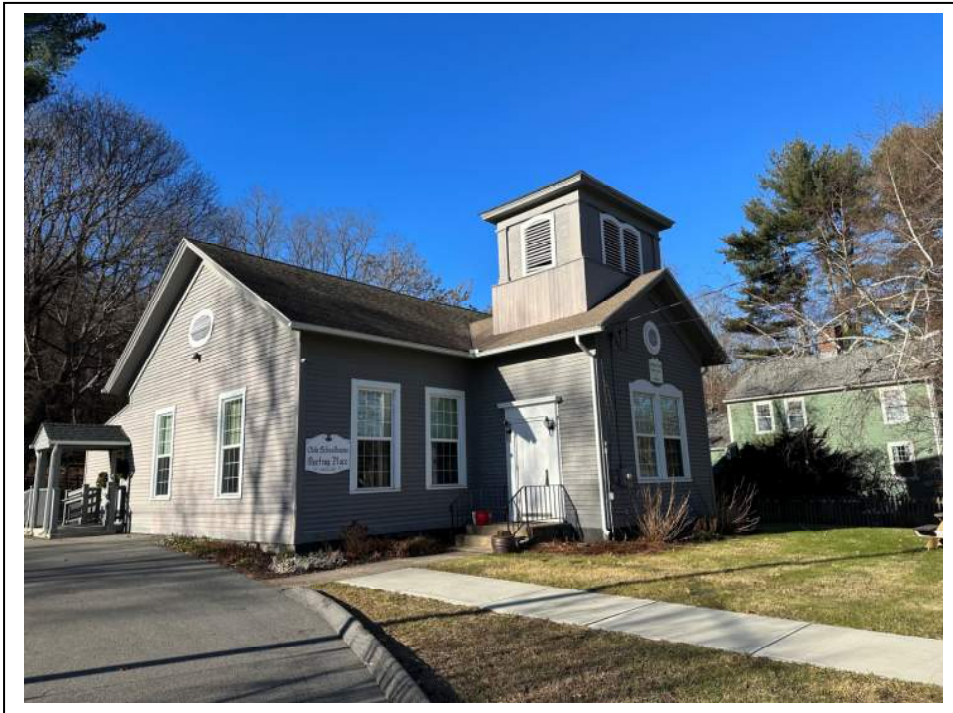
Exhibit 1

This one-story, wood framed structure, constructed in 1867 with a subsequent addition in later years (date unknown), is supported on a combination of cast-in-place concrete and stone foundations. Repointing of the stone joints is required in various areas. However, the foundations overall were observed to be in sound condition. Please refer to Photograph Exhibits #1 and #2.

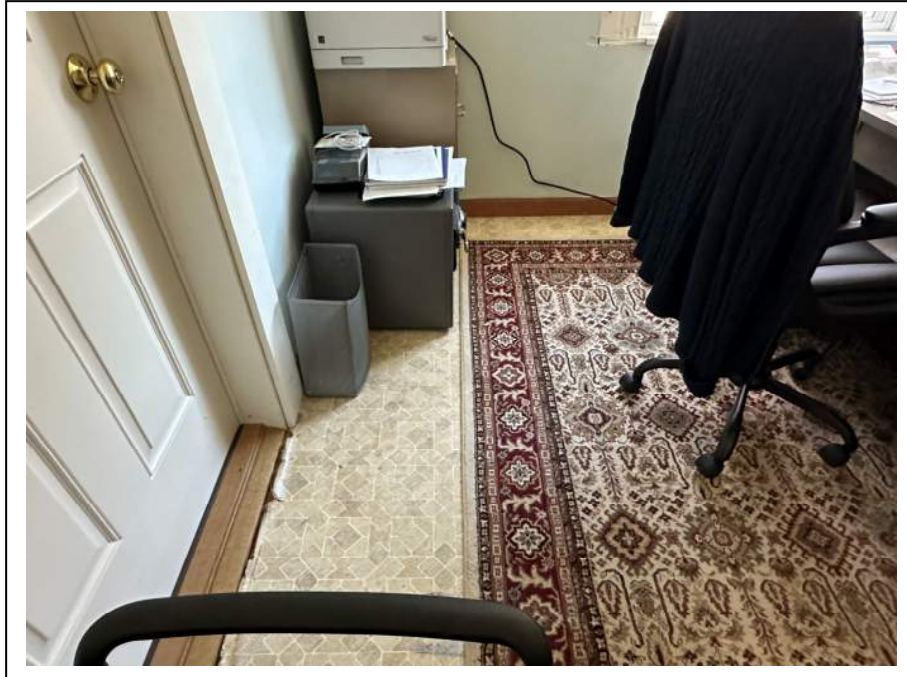
Exhibit 3

As previously stated, the wood framing is concealed by in-place finishes and could not be observed. The first floor appears to be a supported floor over a crawlspace. Please refer to Photograph Exhibit #3. Deflection of the floor framing was observed in one of the offices located towards the front of the facility. Access to the crawlspace was not available. The cause of the deflection cannot be determined without access to the crawlspace or exploratory work to expose the floor framing.

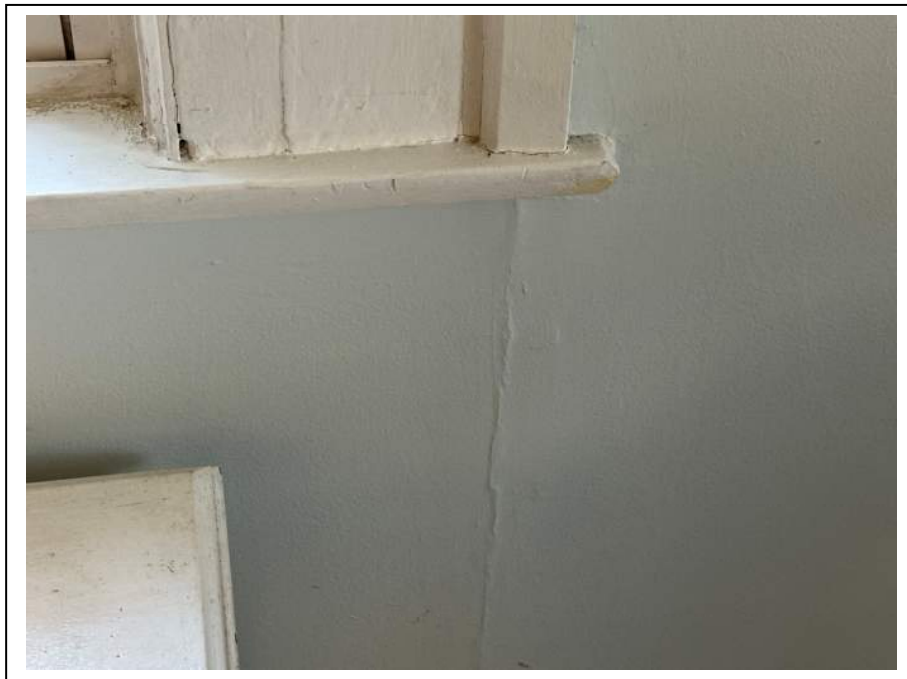
Exhibit 4

Some cracking of the plaster finishes was observed, however, the cracks appear to be cosmetic in nature and do not represent a structural concern at this time. Should the cracking continue or appear in additional areas, further investigation will be required. Please refer to Photograph Exhibit #4.

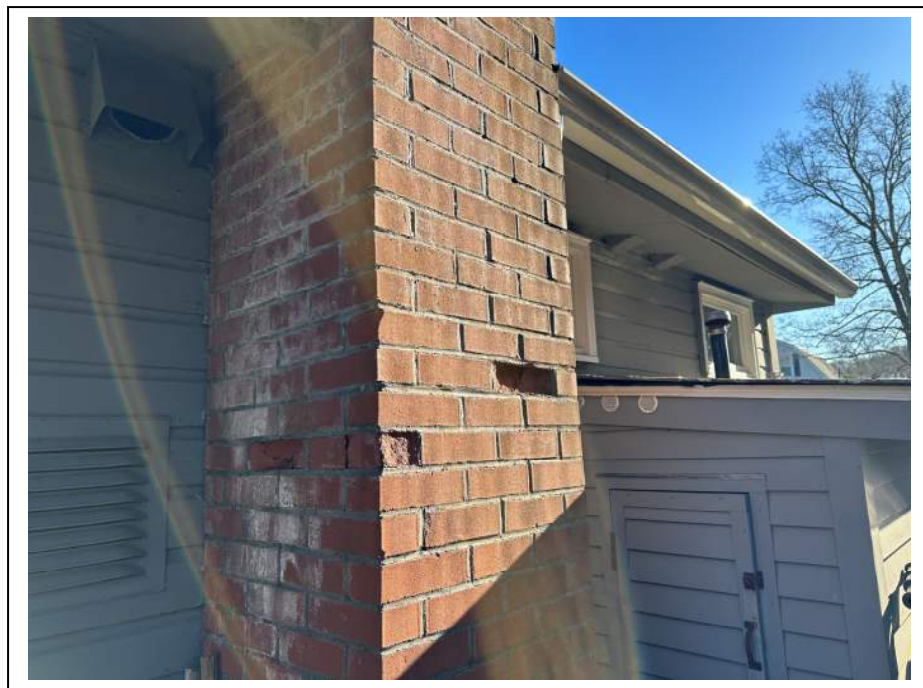
Exhibit 6

The masonry chimney is also in need of repairs. Missing bricks and failed mortar joints were observed. Water infiltration and freeze/thaw cycles will cause these deficiencies to worsen, potentially causing additional bricks to fall. Repointing of the joints and replacement of the missing bricks is required. Please refer to Photograph Exhibit #6.

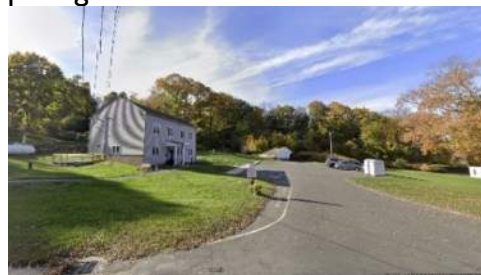
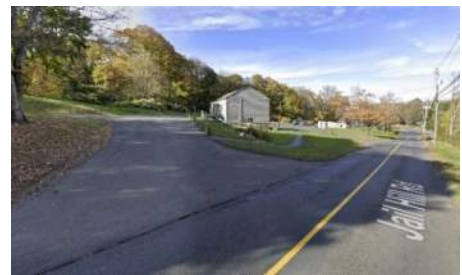
The lower lot provides 16 spaces, of which, one is ADA accessible. The upper lot provides four spaces, two of which are ADA accessible. Handicapped spaces are clearly indicated with signage and striping. Although mostly still in good condition, there are multiple cracks in the paving in both lots.

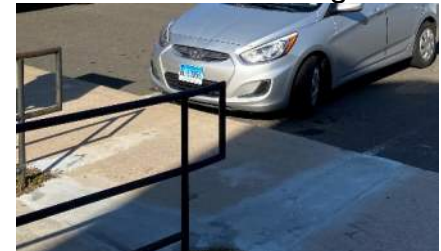
Concrete sidewalks lead from the parking areas to the Annex. Several areas were noted with cracking. These areas could be tripping hazards and will continue to get worse with water infiltration and freezing.

Cracks in various concrete sidewalks

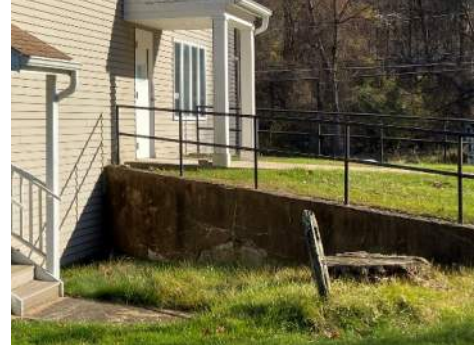
A stone retaining wall along the west side of the property appears to be in good condition. The cast-in-place retaining wall along the south east entry to the upper level is showing multiple areas of cracking and spalling

Cast-in-place retaining wall, areas of cracking and spalling

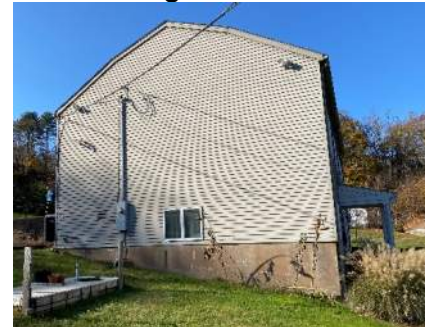
West Elevation

The exterior walls of the Municipal Annex are wood frame on cast-in-place foundation walls, with vinyl siding. There are several locations on the siding that require cleaning, and multiple spots on the west elevation that are dented, cracked, and rippling. Several small crack lines were noted on the concrete foundation, as well as some slight efflorescence.

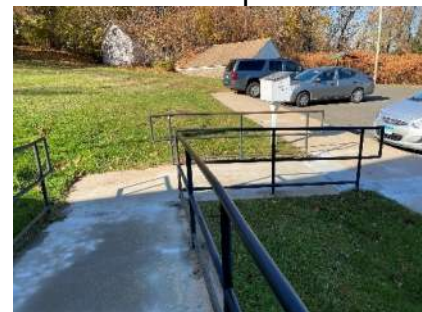
Access to the 1st Floor is via a concrete ramp that is ADA compliant and provides a direct route from the north parking lot to the building entry. The steel tube handrail that runs the length of the ramp is constructed to the proper height and has the compliant handrail extension at the end. Efflorescence and cracking was noted at one end of the ramp.

Efflorescence and cracking at bottom of ramp

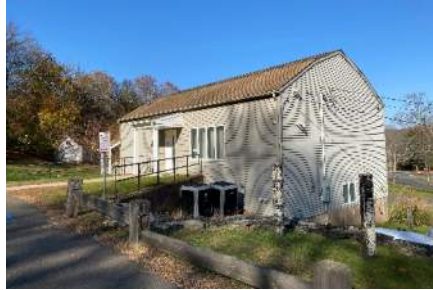
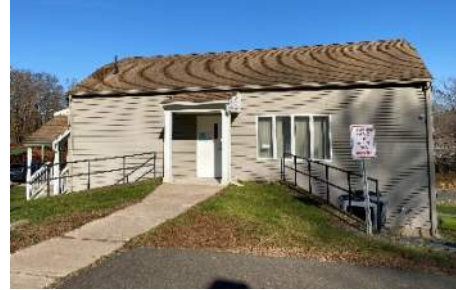
Views of sidewalk to 2nd floor entry

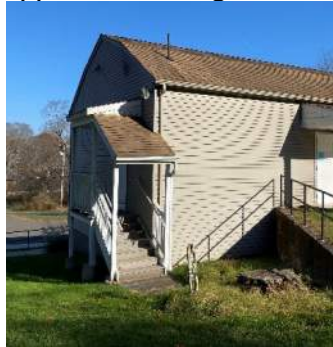
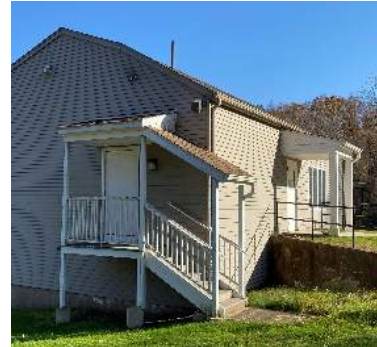
As noted earlier, there is a second door for egress on the 2nd Floor that leads to an external covered staircase to grade. The wood framed steps appear to be in good condition.

2nd Floor egress stair

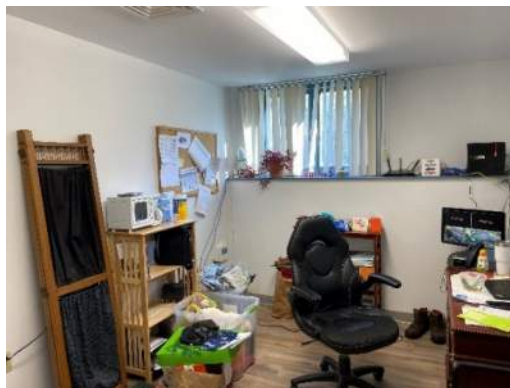
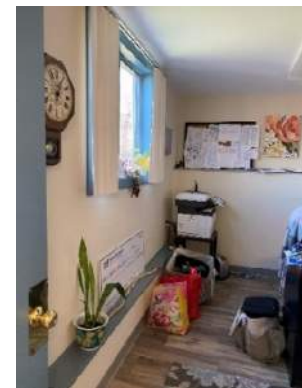
1st Floor Office

There are two office spaces on the 1st floor to provide social services for the Town of Haddam. Each office has sufficient space for a single occupant, however there is little room to expand if more staff is ever needed.

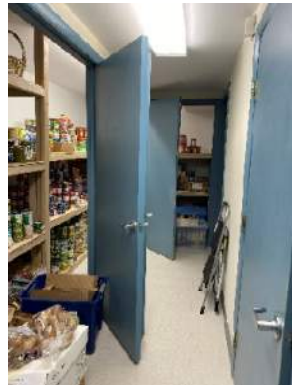
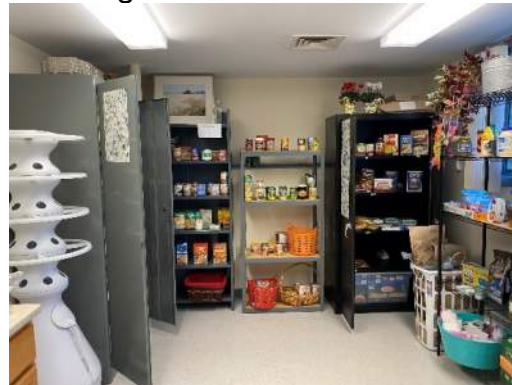
1st Floor Storage

In addition to Social Services, the 1st Floor is used for a food pantry for the residents of Haddam. Storage space appears to be sufficient, however this should be reviewed with the Annex staff to verify if their needs are being met.

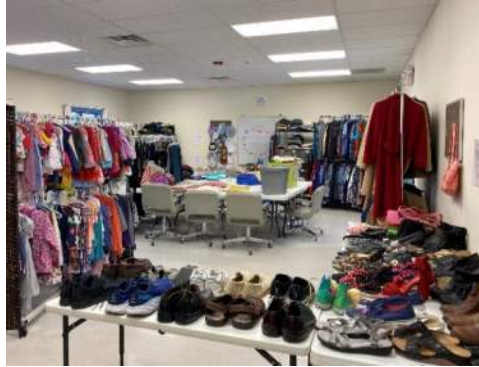
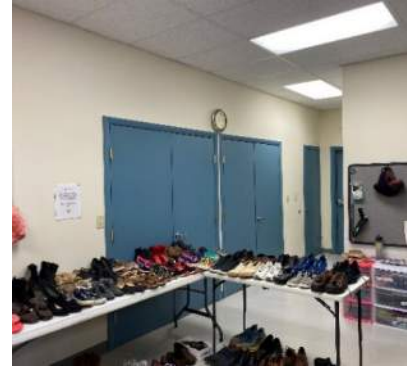
2nd Floor Donations Room

need. The large open space is in good condition. However, as noted in the previous section, there is no direct access to the 1st Floor.

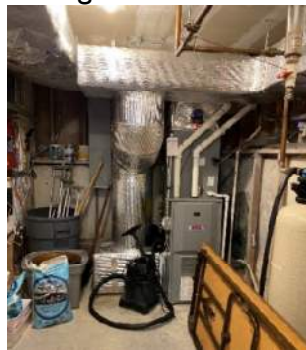
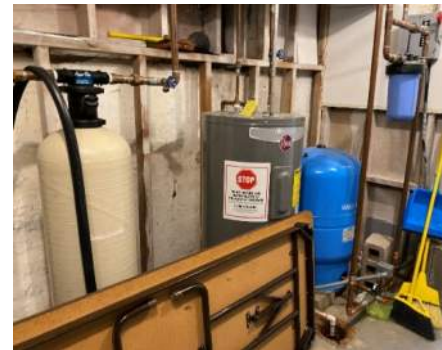
Mechanical Space

Mechanical space is located on the 1st Floor of the Annex and appears to be in good condition.

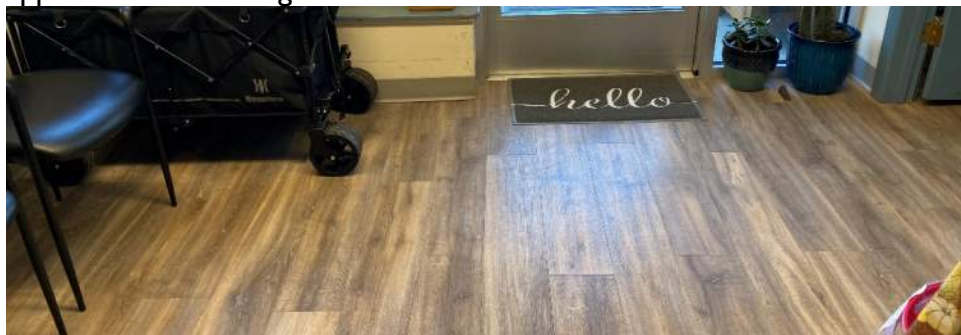
The flooring for the Municipal Annex is VCT in the common areas, and LVT wood plank in the main foyer and offices. The newer LVT is in excellent condition. VCT is in good condition, however dated in appearance. Cracking was noted in several areas.

Typical 1st floor LVT flooring

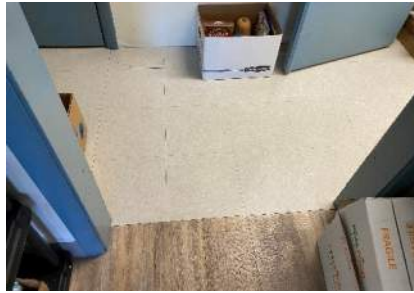
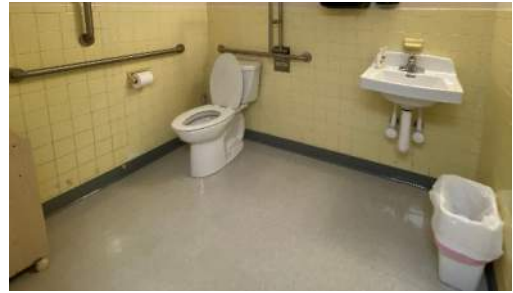
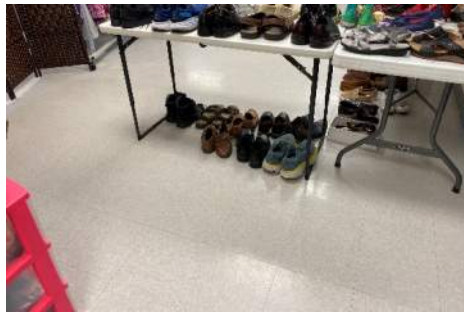
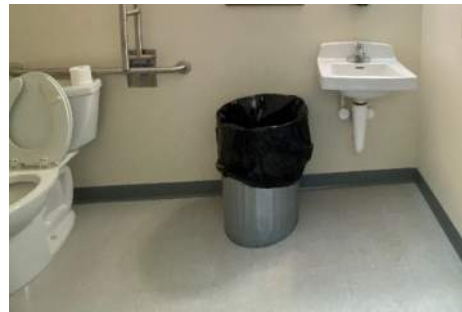
1st Floor VCT in corridor

1st Floor VCT in toilet room

2nd Floor VCT in Donations Space

2nd VCT in toilet room

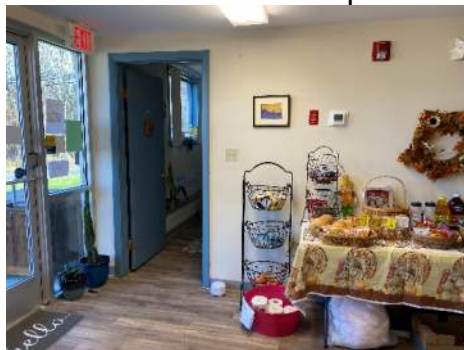
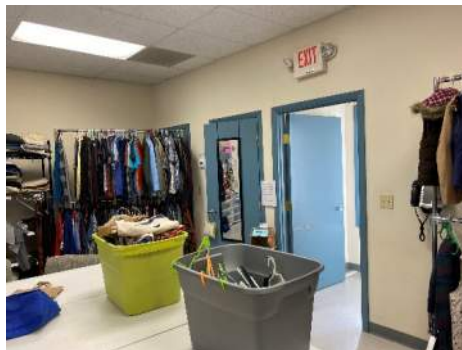
The interior walls are typically in very good condition with no major dents or dings. The typical concerns with most walls are scuff marks that can be resolved with new paint.

Typical 1st Floor wall

Typical 2nd Floor wall

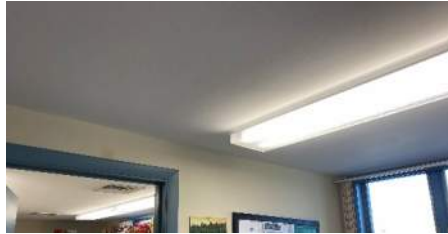
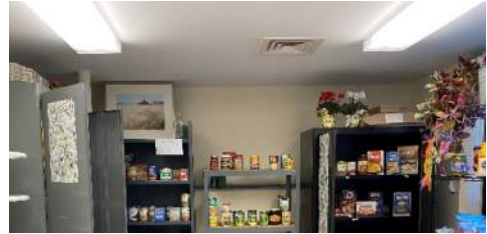
The ceilings overall are in good condition. Ceilings on the 1st floor are gypsum board and show no signs of obvious marks or cracks.

1st Floor gypsum board ceiling

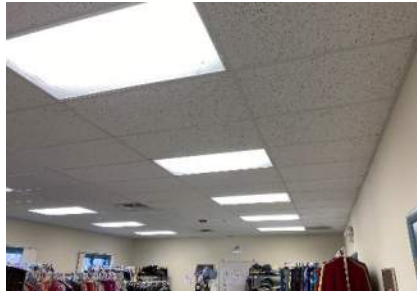
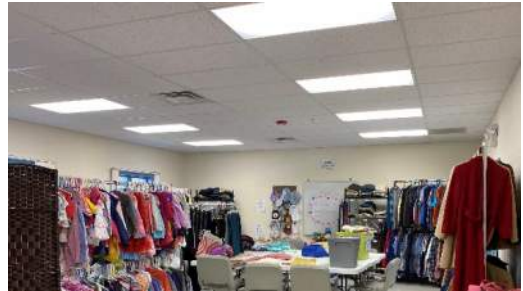
Ceilings on the 2nd floor are newer 2x4 ACT tiles and are in excellent condition.

2nd Floor ACT ceiling

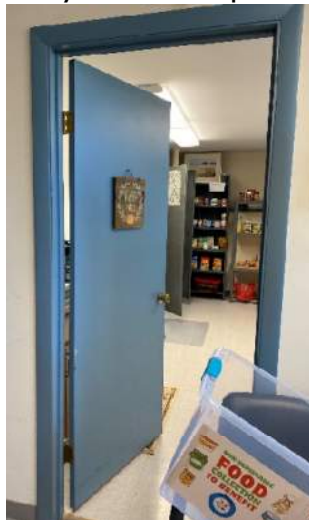
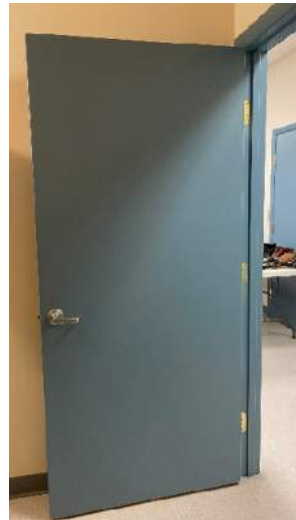
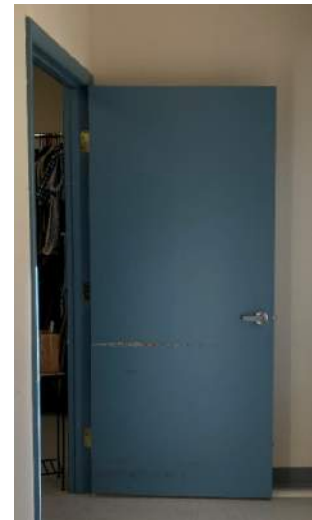
The typical doors throughout the Municipal Annex are flush panel metal doors. Door handles are a combination of door knobs and levers are not always ADA compliant.

Typical doors

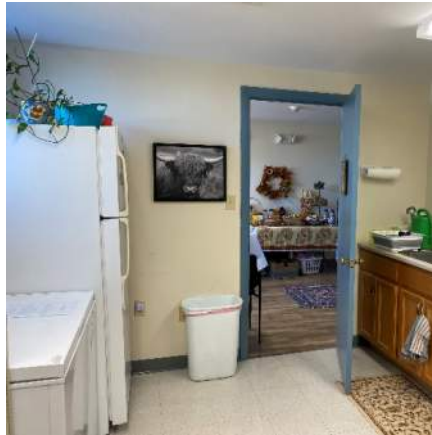
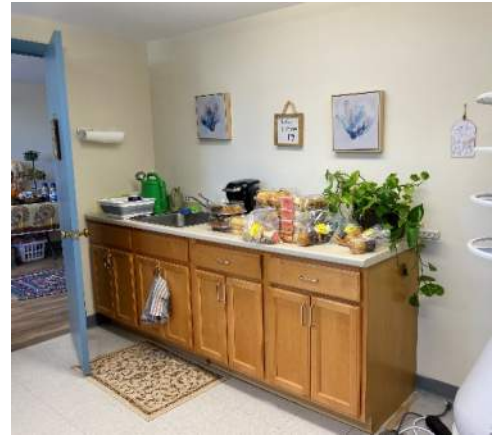
The 1st Floor kitchen cabinets, countertops, and fixtures all appear to be in good condition, however they are not ADA compliant. Cabinets are not the proper height, nor do they provide knee space at the sink for wheelchair access.

Lower level Kitchenette

Lower level Kitchenette cabinets

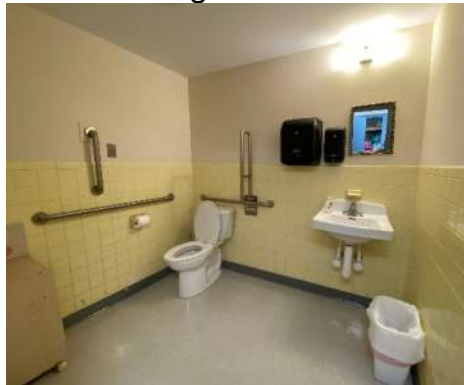
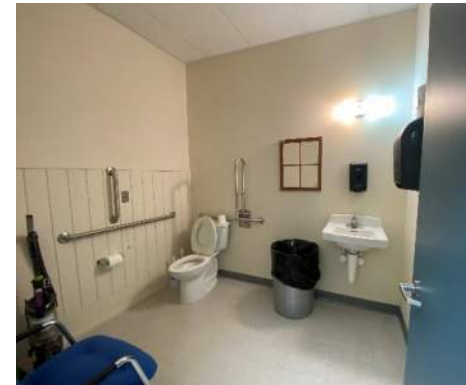
Toilet Rooms are provided for on the 1st and 2nd Floors. Fixtures and finishes are in good condition.

1st Floor toilet room

2nd Floor toilet room

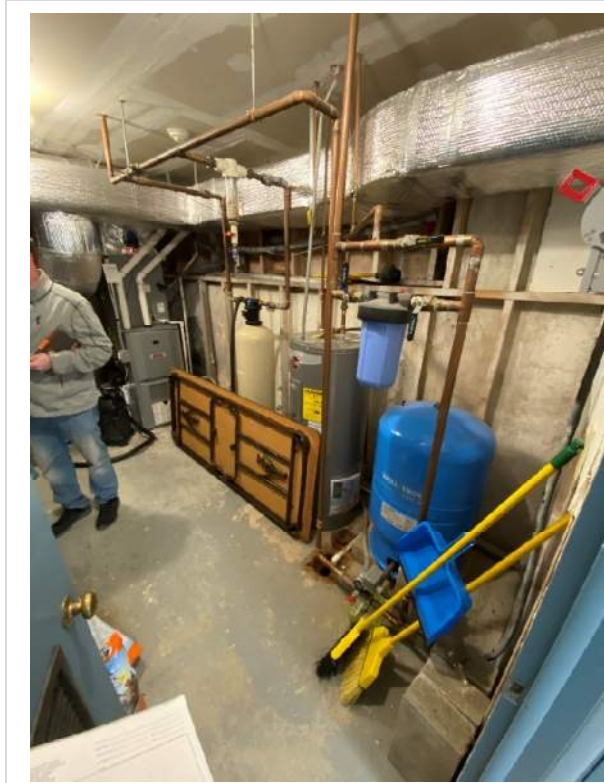
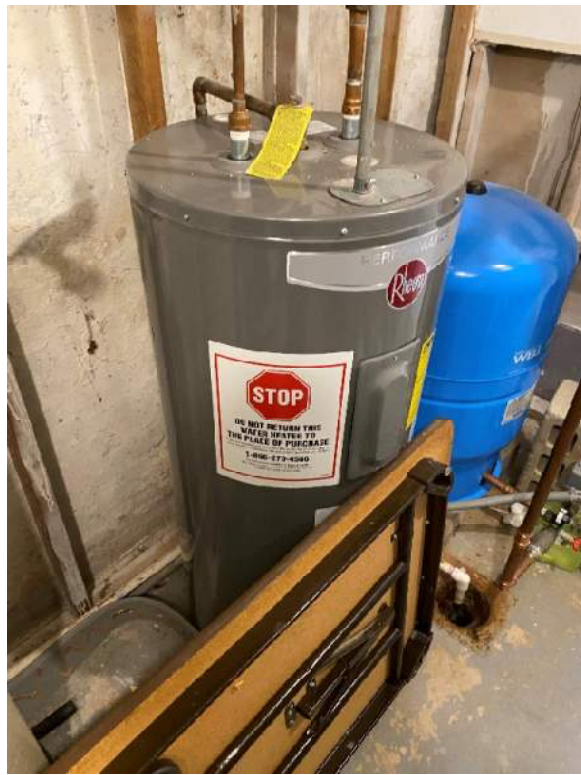
The buildings domestic hot water is generated by a 40-gallon electric storage tank water heater. The water heater was manufactured on February 16, 2021 and appears to be in good working condition. Domestic hot water piping is copper with soldered and press-fit fittings. Piping is currently un-insulated. Recommend insulating all domestic hot and cold water piping to reduce heat loss and energy loss.

Mechanical Room

Water Heater

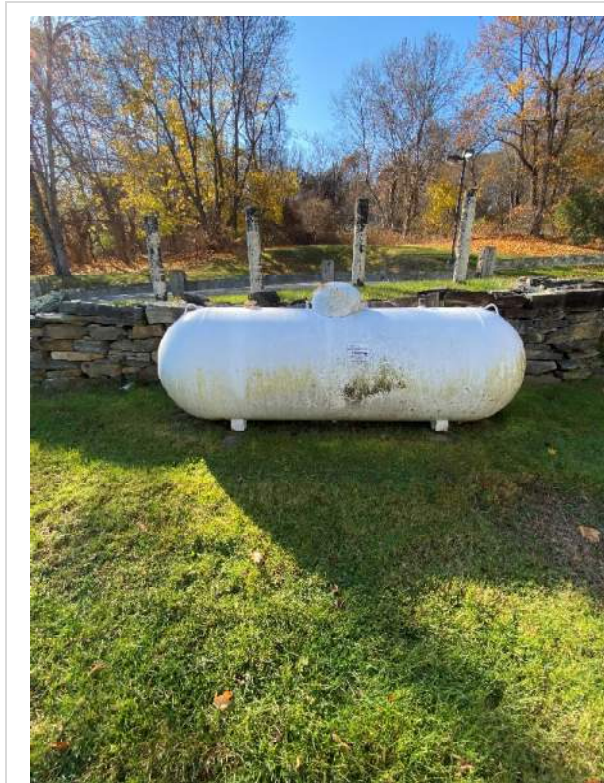
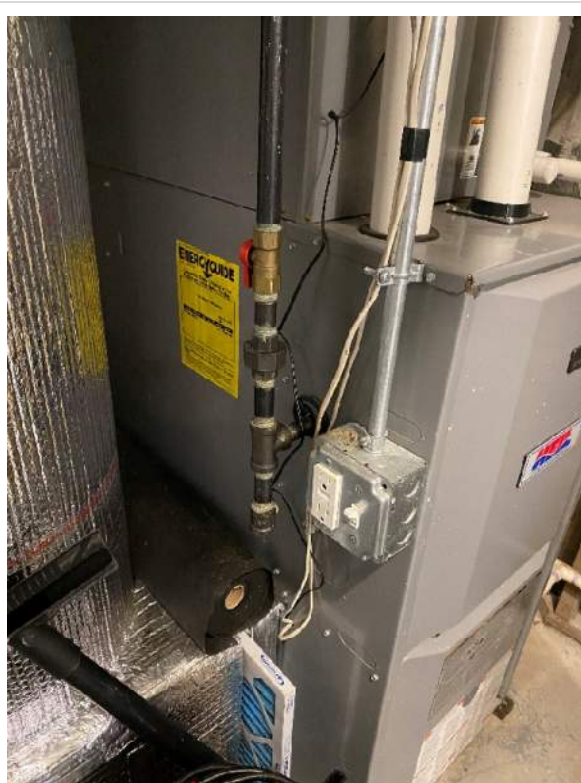
There is a 500 gallon above ground propane tank located outside the building which currently serves the building's HVAC equipment. Gas piping inside the building is black steel with threaded fittings.

500-Gallon Propane Tank

Propane Gas Piping to HVAC Unit

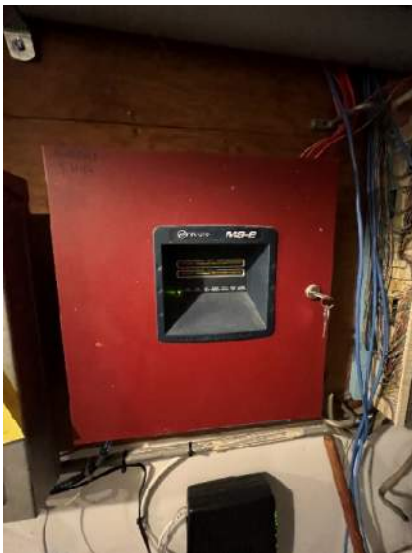
The building contains an addressable horn-strobe fire alarm system by Fire Lite. The fire alarm control panel is located in the main utility room, connected to a cellular wireless communicator by Starlink. The building is protected by smoke detectors and manual pull stations at the points of egress. Visual and/or sound notification appliances were observed at required locations.

Fire Alarm Control Panel

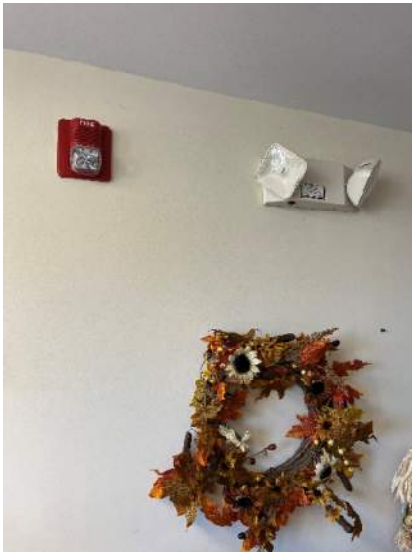
Emergency lighting consists of combination exit sign or stand-alone self-contained battery units. Code compliant coverage was observed in the corridors.

Self-contained emergency light and strobe

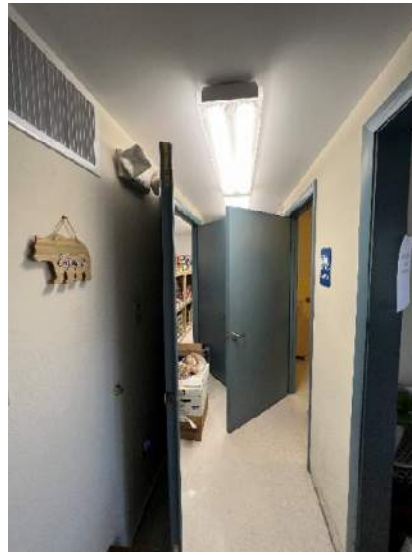
Typical surface linear light fixture

1. Retrofitting existing lamps to LED and installation of localized standalone vacancy/occupancy sensors is recommended for additional energy savings.
2. Installing a security system will improve the physical security of the building, its occupants, and internal assets.
