TOWN OF HADDAM

FACILITY ASESMENT REPORT

Six Town Buildings

April 1, 2024

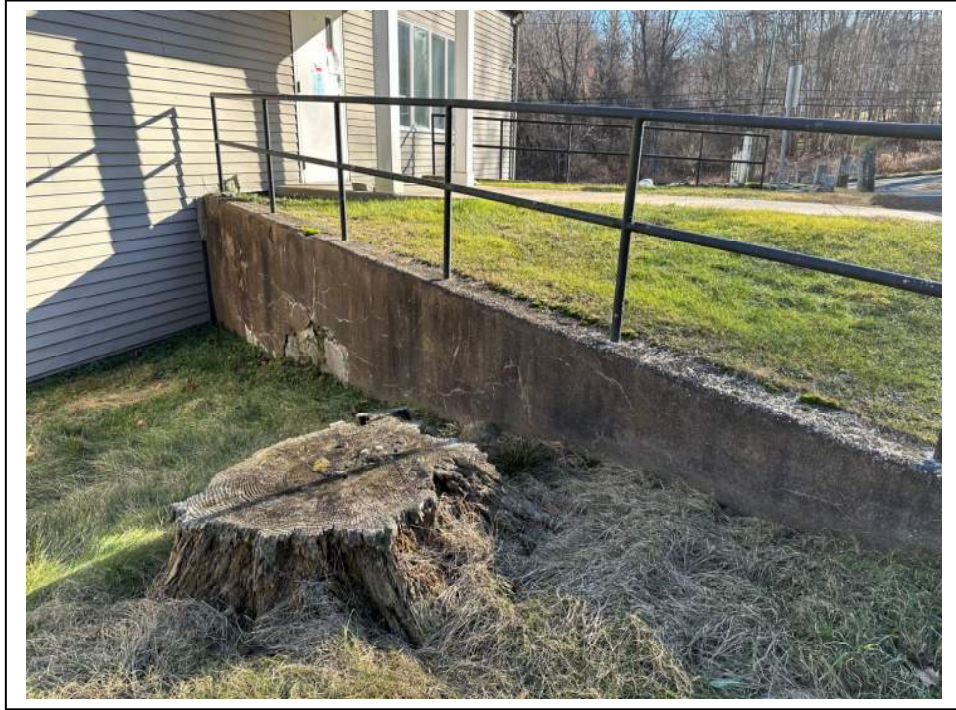
Exhibit 3

The exterior concrete site retaining walls located on the south side of the building requires structural repairs. Deficiencies such as cracking, surface spalling, and cracks at the railing embedment were observed. Water infiltration and freeze/thaw cycles will cause these deficiencies to worsen, and these areas should be repaired. Please refer to Photograph Exhibits #3 thru #5.

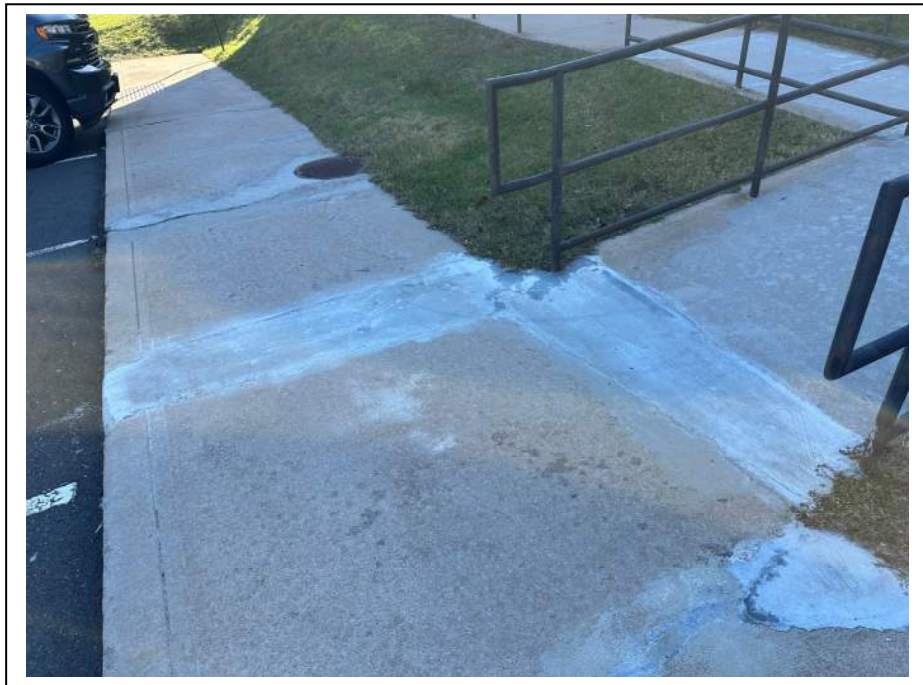
Exhibit 6

The exterior concrete sidewalks are in need of repairs, such as cracking and spalling of the concrete. Repairs were previously performed, however these patches have failed in various locations. Water infiltration, freeze/thaw cycles and the application of deicers will cause these deficiencies to worsen, and these areas should be repaired. Please refer to Photograph Exhibits #6.

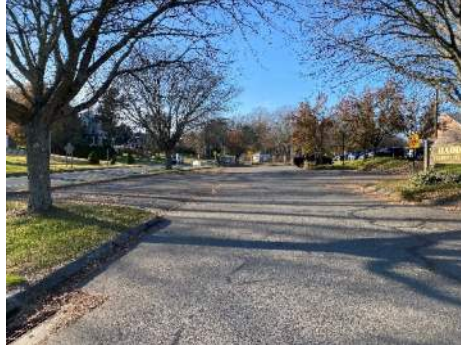
Paving overall is in moderate condition in the parking lot and drop off areas. Although there is no major damage, paving is cracked and parking lines are faded.

Entrance to parking lot

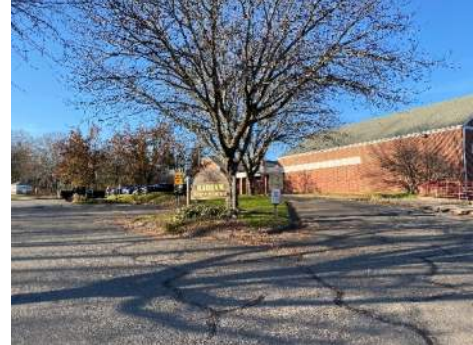
View of parking lot

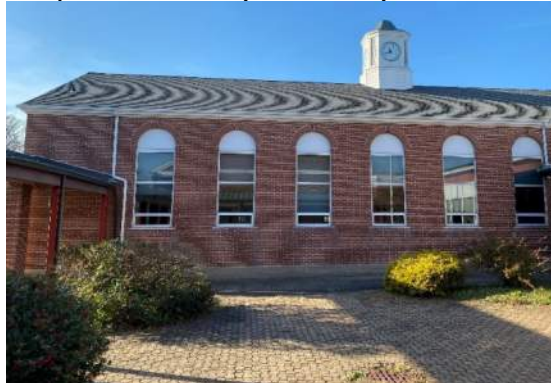
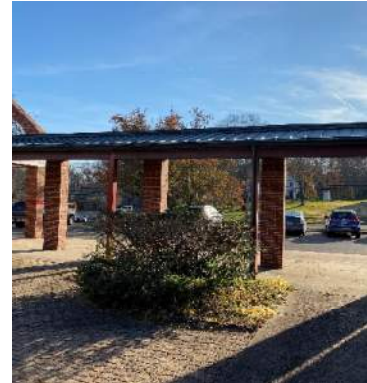
A central courtyard between the older entrance and the new is surfaced with brick pavers. The landscaping appears to be in good condition and not overgrowing, however, organic growth is expanding in the joints of the pavers and may eventually cause damage.

Courtyard pavers and landscaping

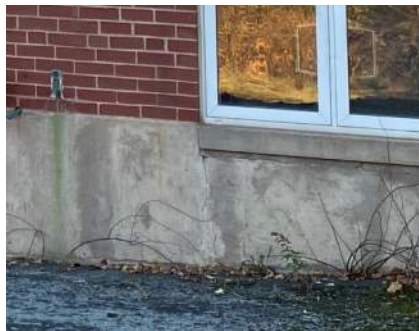
The exterior walls of the Haddam Elementary School are brick veneer with CMU block or wood stud backup, and overall appear to be in good condition. Mortar joints typically show minimal signs of cracking; however, some open joints and spalling were noted on the west façade. Some cracking was also noted in the cast-in-place foundation. Staining on the brick was observed at multiple window sills and near leaders. Graffiti was noted on the west elevation.

Crack in cast-in-place foundation

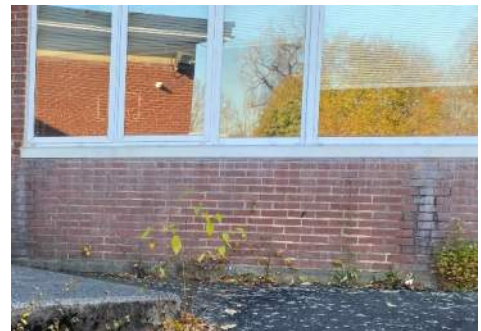
Staining at brick

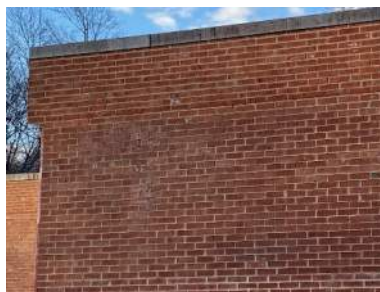
Open mortar joints and spalled brick & column requiring painting

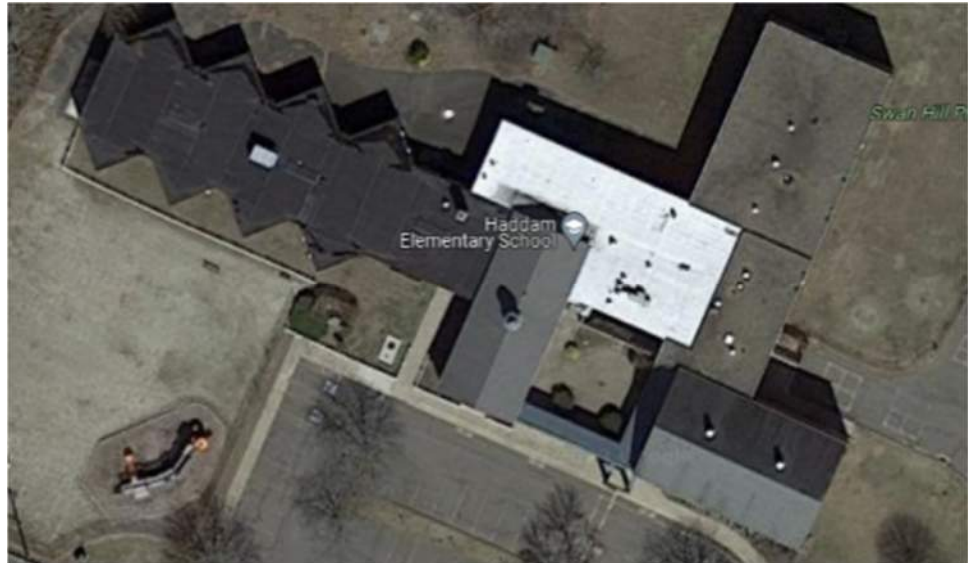
The Haddam Elementary School roof is primarily flat with an EPDM surface. The EPDM has been inspected and repaired over 20+ years, and well maintained; however, with an aging roof, replacement should be considered.

Aerial of roofs

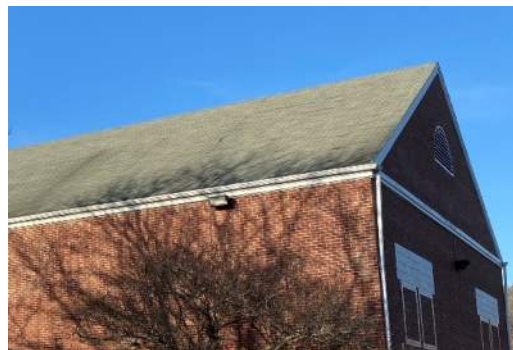
The asphalt shingles on the gabled Multi-purpose room and Gymnasium have exceeded their life expectancy and loose and missing shingles were noted.

Asphalt roof at gymnasium

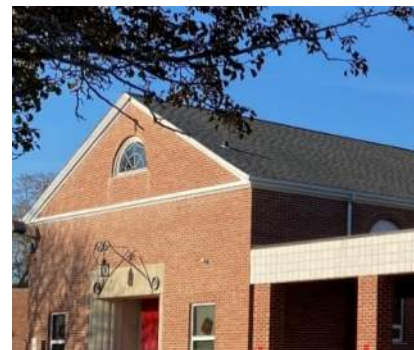
Asphalt roof at old entry

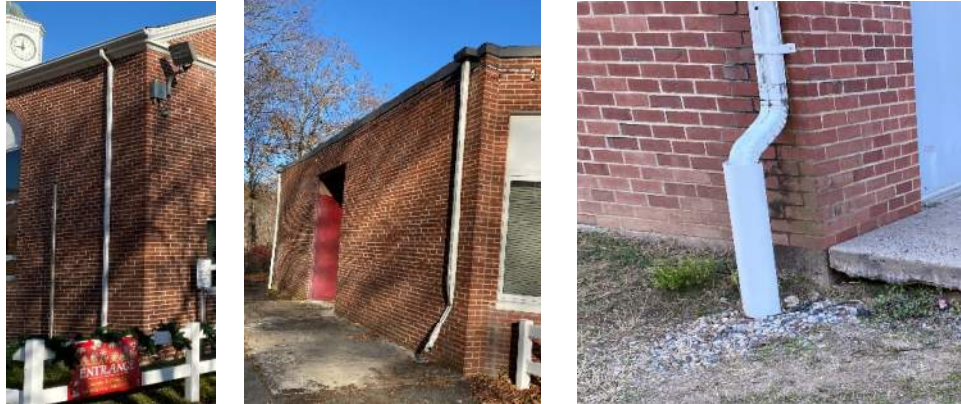
Gutters and leaders appear to be in good condition; however, several bent and damaged leaders were noted around the perimeter of the building. Leaders typically run to underground piping, although several do run to daylight.

View of roof eave, downspouts, and underground connections

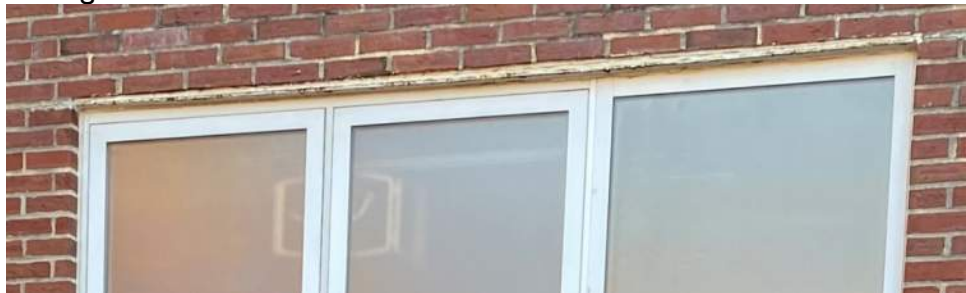
Paint is flaking at steel lintels at windows and they are showing signs of rusting.

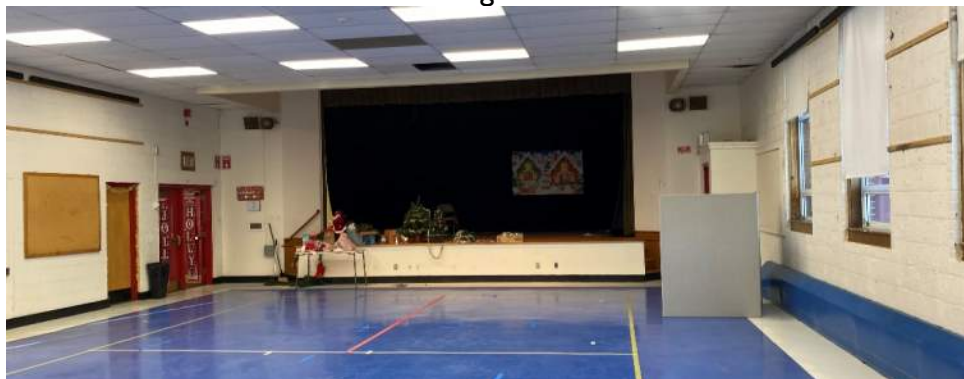
The Multi-Purpose Room, located centrally in the school, provides a space for multiple events including gym activities, plays, large group meetings, and dining. The space is in good condition overall, although water stains were noted in the ceiling tiles.

Multi-purpose Room, looking towards the stage

7. Ceilings
 - a. Provide new ACT ceiling that is sag free and clean throughout
8. Walls
 - a. Various minor repairs to walls throughout
 - b. New paint throughout

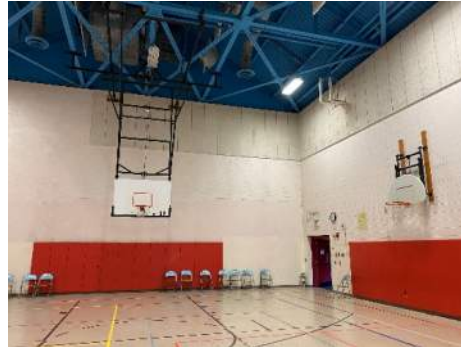
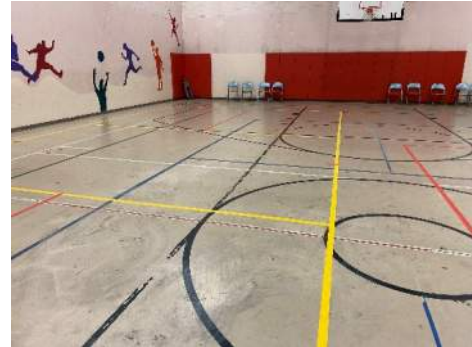
The Gymnasium, located in the lower level of the east wing was part of the last addition to the school. Overall the space is in very good condition, however the floor is cracked, striping is worn, and the surface is slippery.

Gymnasium

Gymnasium flooring

6. Floors
 - a. Carpeting in corridors and classrooms should be removed and replaced with new LVT/VCT
 - b. New gym flooring in the Gymnasium
 - c. Toilet room flooring to be replaced with new epoxy flooring

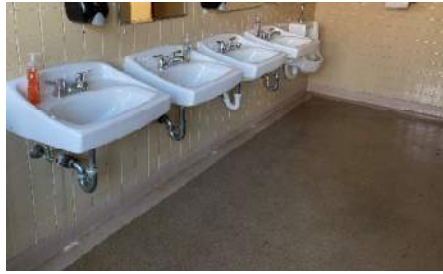
Flooring in the west wing Toilet Rooms is poured epoxy and is in moderate condition. It is dirty and stained, and locations under urinals have been replaced with what appears to be a concrete epoxy.

West wing epoxy flooring in Toilet Rooms

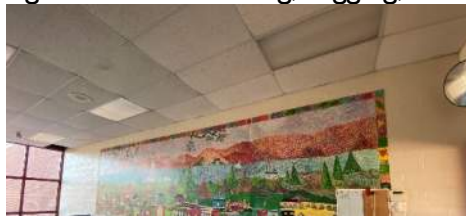
The ceilings throughout the school are mostly ACT and are showing signs of water staining, sagging, mis-matched and broken tiles.

Main Entry ceiling

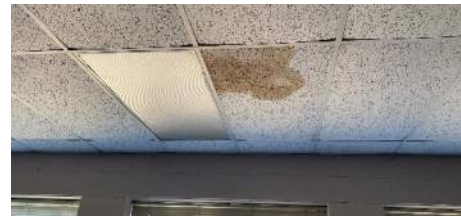
Water stains at classroom ceiling

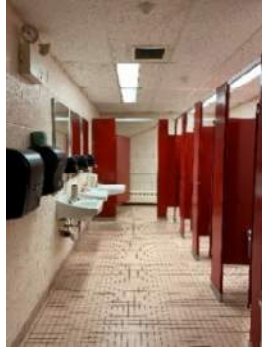
Boys and girls toilet rooms in the newer east wing are provided for on the 1st and 2nd Floors. Fixtures and finishes are in good condition. ADA compliant stalls and fixtures are provided. As discussed in the ceilings section of this report, the ACT is water stained in multiple areas. The 2x2 floor tile is showing signs of wear and tear.

East wing toilet room

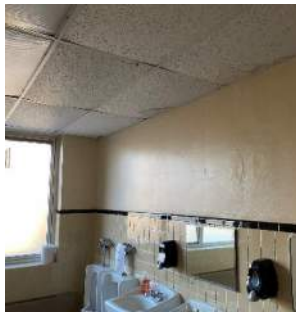
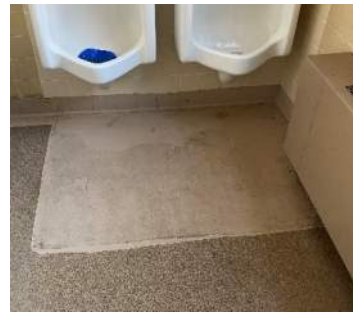
Toilet rooms are also provided in the original school's west wing. A fully compliant ADA stall is not provided, however, ambulatory stalls with grab bars are. Fixtures are in good condition. The epoxy flooring is in moderate condition with staining, pitting, and areas that have been patched in completely. Similar to the newer toilet rooms, the ACT ceiling is drooping and water stained.

West wing toilet room

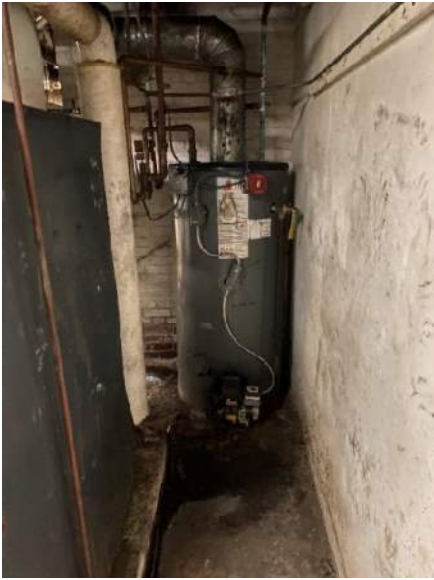
The buildings domestic hot water is generated by a 70-gallon oil-fired storage tank water heater. Domestic hot water is supplied through a master thermostatic mixing valve. The building is equipped with a hot water recirculation loop and pump. The recirculation pump appears to be new as of 02-14-2023. Recommend insulating all domestic cold water, hot water, and hot water recirculation piping to reduce heat loss and energy loss.

Water Heater	Master thermostatic Mixing Valve

Remove existing oil-fired water heater and replace with a new propane fired water heater, AO Smith model #BTH-150(A).

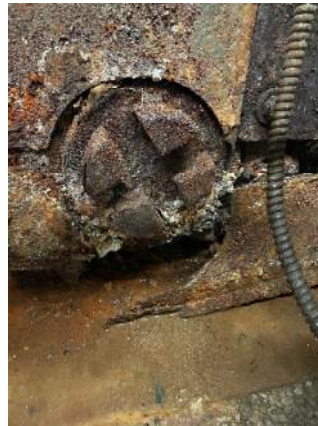
(2) Corrosion at bottom of boiler #1

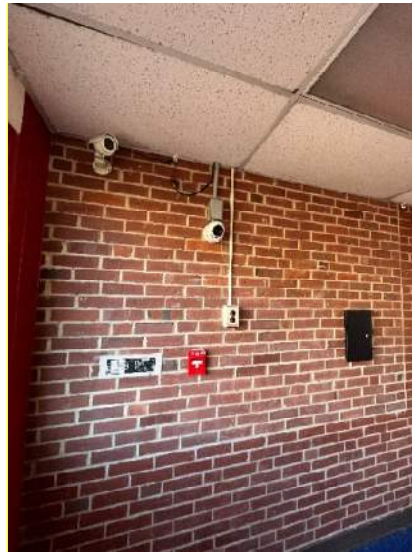
Main Entrance Lobby equipment

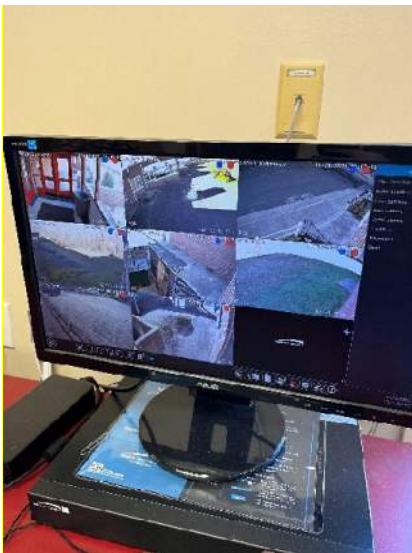
Video Surveillance NVR and Station

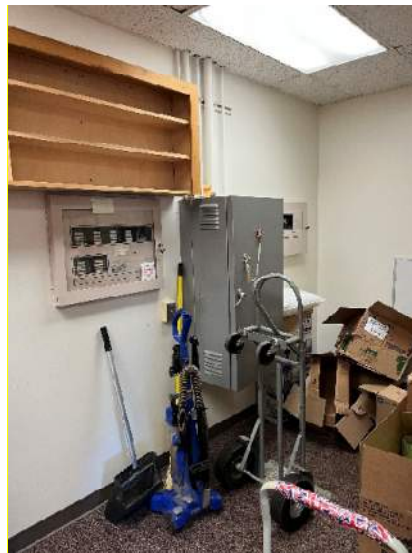
PA System headend equipment

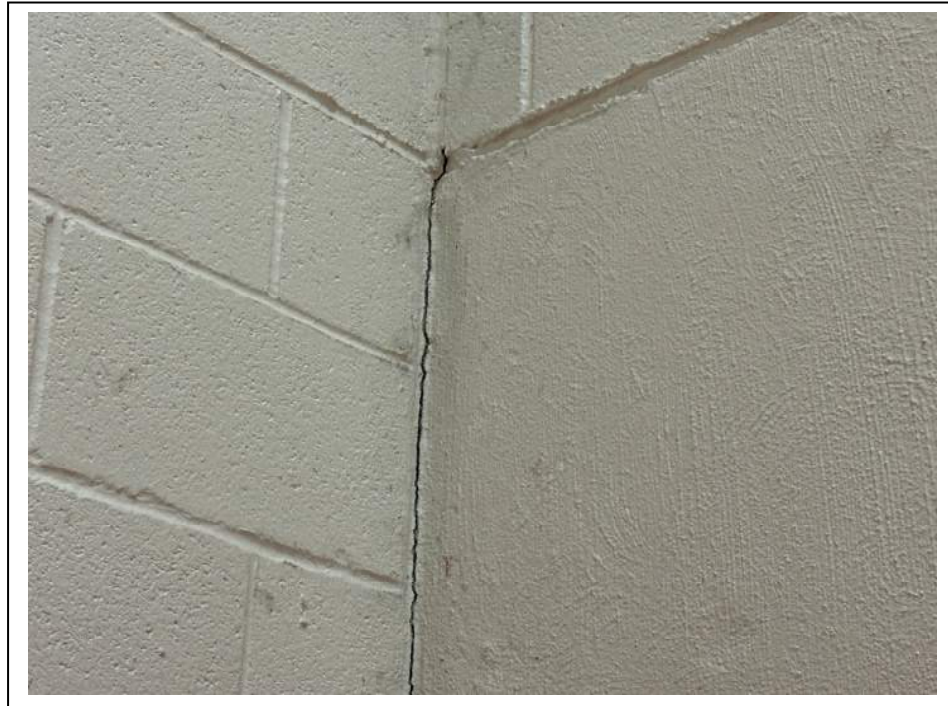
Exhibit 5

The exterior walls of the original structure consist of brick veneer with wood stud backup. The interior partitions consist of wood studs with plaster or gypsum finishes. The exterior walls of the additions consist of a brick veneer with masonry backup. The classroom and corridor walls primarily consist of concrete masonry units (CMU). Some of the corridor walls consisted of glazed blocks. Minor vertical cracks were observed in both the CMU and glazed block walls. Please refer to Photograph Exhibit #3. The Gymnasium walls consist of exposed CMU. Control joints were visible on the interior face of the gym walls. Please refer to Photograph Exhibit #4. Vertical and horizontal cracks were observed at various locations in the gym. The stairwell walls all appeared to be in good condition. Please refer to Photograph Exhibit #5.

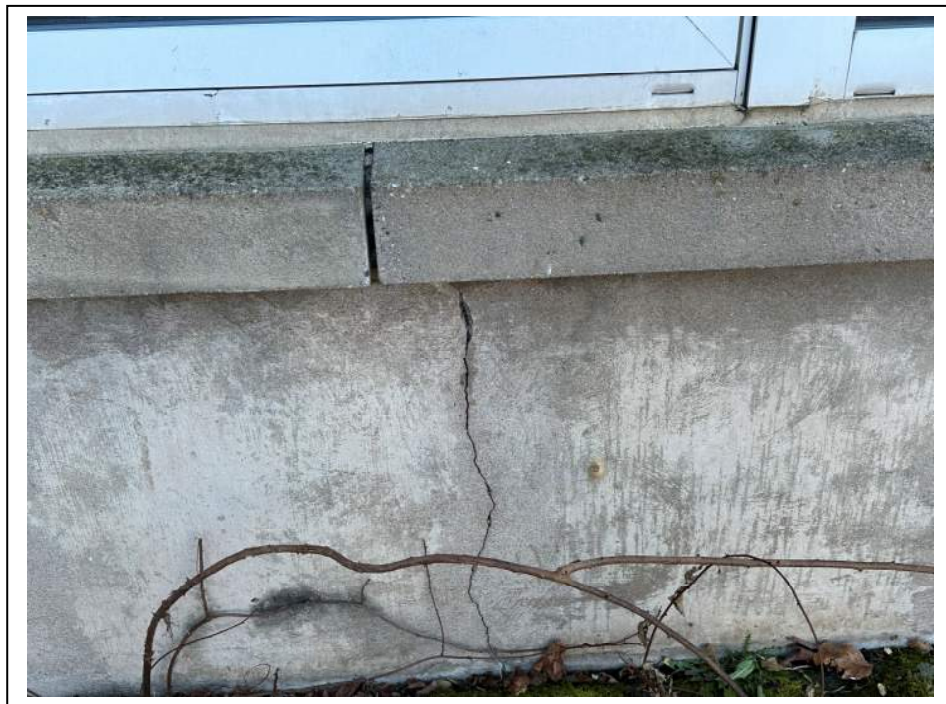
Exhibit 6

The exterior of the building consists of brick veneer with exposed concrete foundation walls. Localized foundation cracking was observed at the new addition of the building. Please refer to Photograph Exhibit #6. There were many locations where brick was noted as cracked or having the face popped. These conditions are typically due to moisture infiltration and should be addressed to avoid further deterioration of the brick. The following are a few of the deficiencies that were noted: The brick windowsill at the main entrance had several chipped or cracked bricks. Please refer to Photograph Exhibit #7. The brick chimney is missing mortar and requires repointing. The exterior fascia board was missing in the rear of the building. Please refer to Photograph Exhibit #8. Brick was cracked or popped in several of the building corners. Please refer to Photograph Exhibit 9-13. There was a large separation crack where two different additions meet. Please refer to Photograph Exhibit #14 There should be a caulked joint at this intersection to allow for differential movement of the buildings.

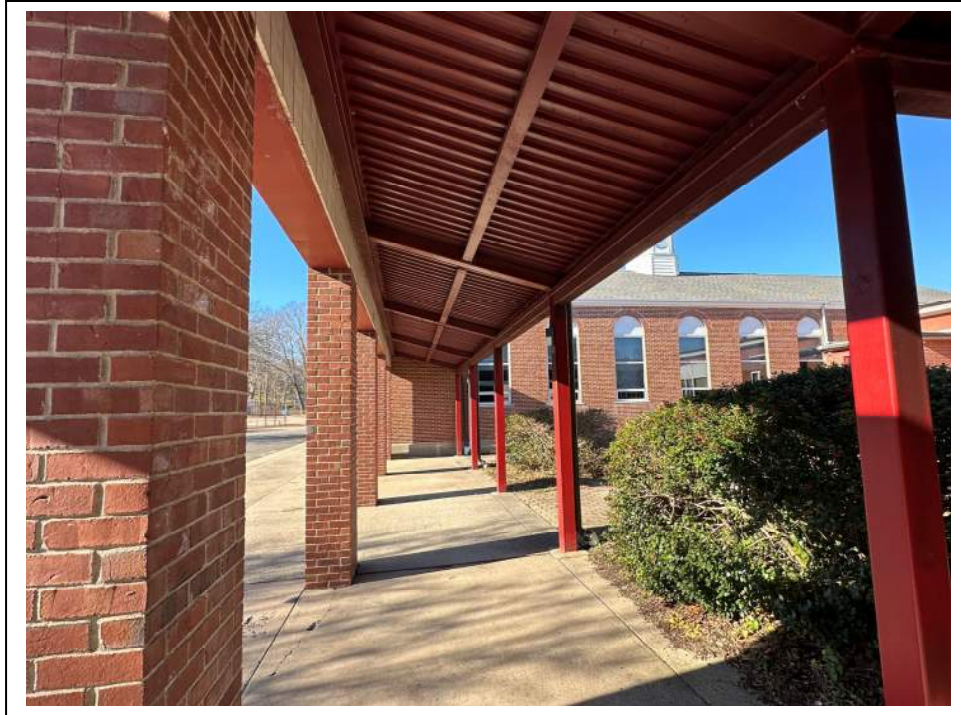
The main entrance consists of a brick archway with an adjoining canopy. The archway brick has cracked and several of the face shells have popped due to moisture entrapped in the brick and freezing conditions. Please refer to Photograph Exhibit 15 & 16 The steel lintels are also corroded at the archway. Please refer to Photograph Exhibit 17 & 18 The canopy steel columns have severe corrosion at the bases and at connections. Please refer to Photograph Exhibit 19 & 20.

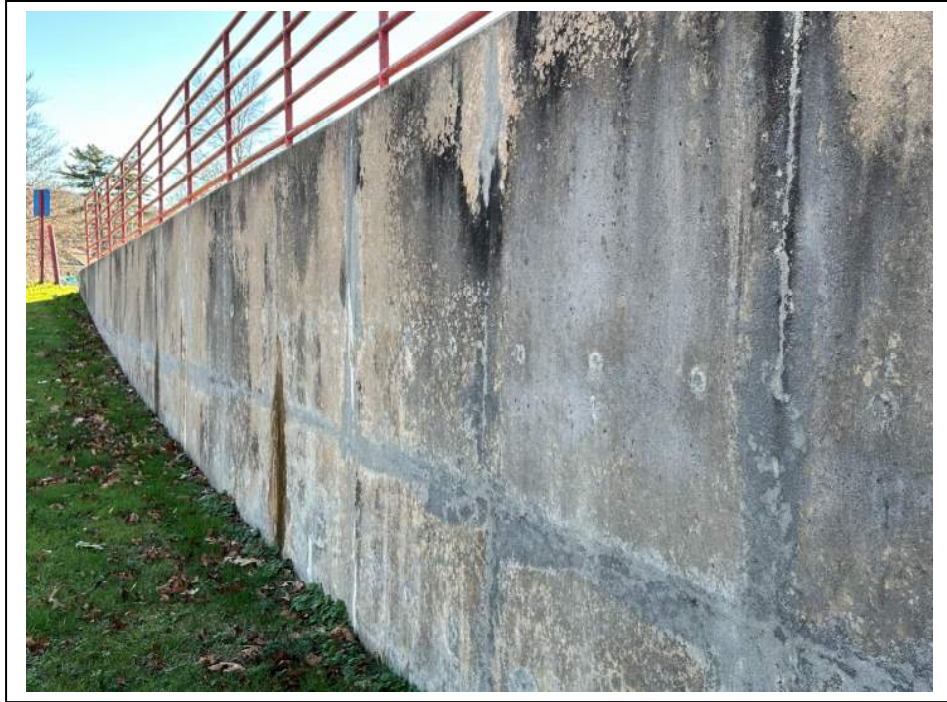
The site retaining wall has spalling concrete with water mitigation through the wall which would indicate that the wall requires waterproofing or drainage behind it. Please refer to Photograph Exhibit 21 & 22. Cracking was also observed where the steel railings are embedded into the top of the wall. Please refer to Photograph Exhibit #23 The site concrete, including stairs, had several cracks and was in poor condition. Please refer to Photograph Exhibit 24 & 25. There was organic material growing on the stairs and walls which were mainly in shaded areas.
