# Haddam

Bridge Road (Route 82) between Route 154 and East  
Haddam – Road Safety Audit

August 9, 2016

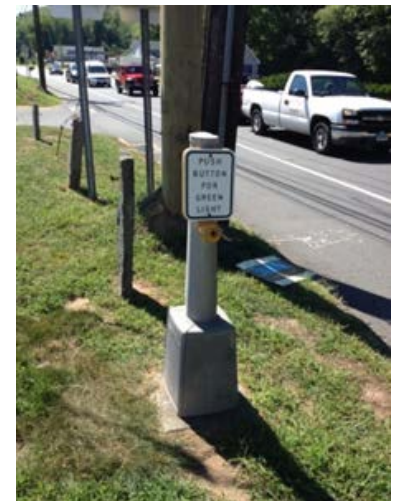
Figure 6. Pedestrian Button and Wide Shoulder on Route 154 Northbound Approaching Bridge Road

- There are "Push Buttons for Green" pedestrian pedestals on the northwest and southeast corners (Figure 6) of the intersection. The pedestrian phase is not exclusive and runs concurrently with the parallel green phase.

- The Route 82 approach shoulder and northbound Route 154 approach shoulder are wide enough for vehicles to use it as a right turn lane (Figure 6).
  - Audit members feel it helps reduce traffic delays and queuing.

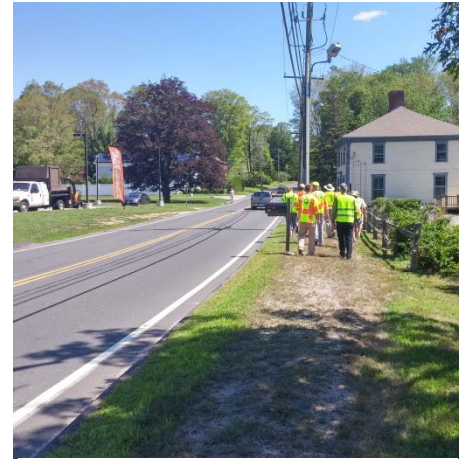
**Figure 7. Worn Path in Front of Tylerville Country Market on South Side Bridge Road**

- There is a worn path in front of Tylerville Country Market (Figure 7), although there is no sidewalk.
- If a sidewalk is constructed on the south side:

- There should be enough ROW (Figure 7).
  - There are grade issues in some places (Figure 8).
  - The relocation of utilities will increase cost. The utility poles are on the south side (Figure 9).

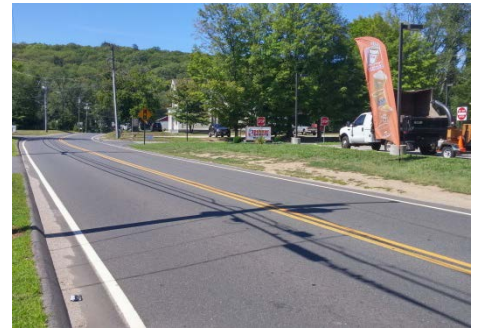
**Figure 10. Westbound Bridge Road in Front of Dunkin Donuts**

There is no on-street parking (Figure 10).

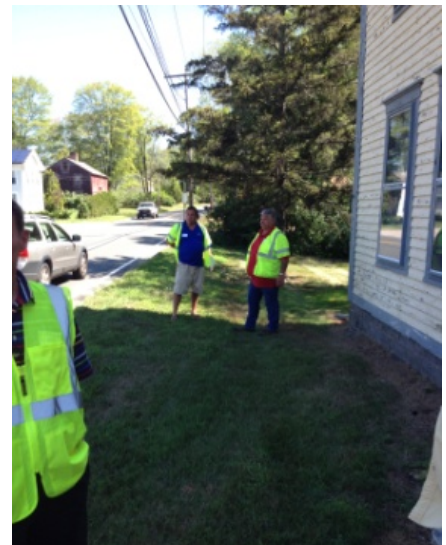
**Figure 11. Shailerville House**

- 85 Bridge Road is the historic Shailerville House. It is located close to road, but there is still enough room for a sidewalk (Figure 11).
- There is a contaminated water issue in this area.
- Department of Energy & Environmental Protection (DEEP) State Land (Figure 12):
  - The entrance gate is opposite 80 Bridge Road.
  - The land could be converted to a multi-use trail to link to Eagle Landing State Park.
  - If this is converted to a trail the Town would still like to continue the sidewalk on Route 82.

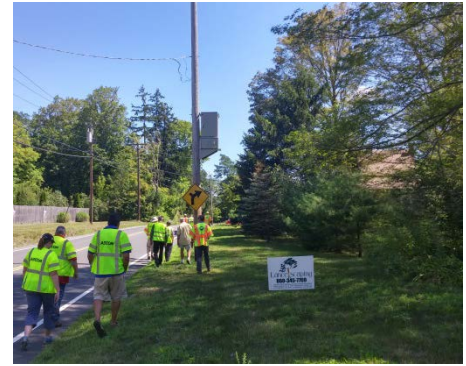
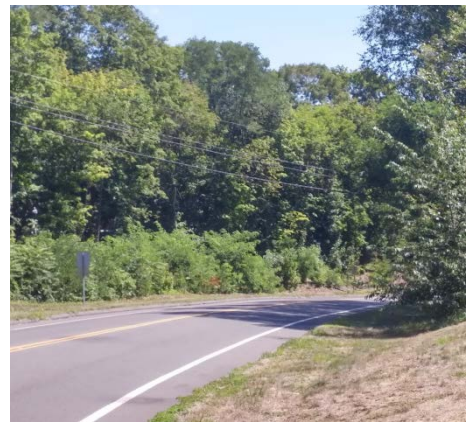
- There is a sharp curve and steep grade on Route 82 that limits sight distance for vehicles approaching the Riverhouse and Camp Bethel Road (Figure 13 and Figure 14).
- On the west side of the Riverhouse driveway there is a wide turn radius and the curbing stops, but the pavement extends outside of the driveway.
- Camp Bethel Road sign across from Riverhouse driveway is partially blocked by branches (Figure 15).
- There are tree branches on the south side of the road that may reduce the sightline on the sharp Route 82 curve (Figure 14).

**Figure 13. South Side Route 82 Before Riverhouse**

**Figure 14. Curve Near Riverhouse Driveway**

1. The Local Traffic Authority (LTA) can request the CTDOT to trim branches that limit sightlines and block signage on Route 82 at the Riverhouse driveway.
2. Begin developing concepts for the new sidewalk on the south side of Route 82.
3. Install share the road signage (Figure 20) for bikers or signs indicating that bikes can take the travel lane on the bridge. The LTA to send letter to CTDOT, OSTA (Office of State Traffic Administration) or maintenance.
4. Simplify the current wayfinding signage in the area because too much signing could be overwhelming. Consider developing a branding logo for "The Haddams" area. The LTA can request wayfinding signage with OSTA (Figure 21).

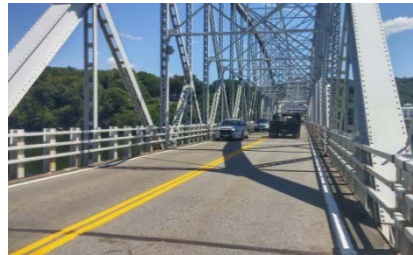
**Figure 17. Swing Bridge Roadway Cross Section Looking East**

- The travel lanes are 10.5 feet wide (Figure 17).
- The shoulders are two feet wide on the south side and one foot wide on the north side.
- The State is looking at options for providing a pedestrian facility including a cantilever walkway on one side of the bridge. There is a steep drop off on the south side which may restrict a new sidewalk. Other options such as a boardwalk on piles, etc. would have to be considered (Figure 18).
- There was a significant amount of heavy truck traffic during the short time spent at the swing bridge.
- There is limited sightline at the west end of bridge due to the horizontal alignment of Route 82 (Figure 19).

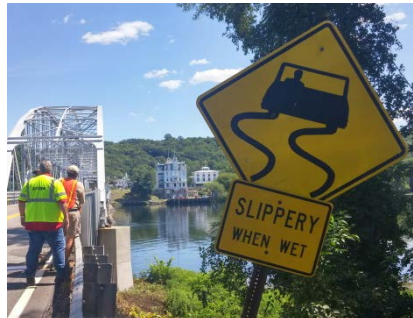
**Figure 18. Drop off on South Side of Swing Bridge (West End)**

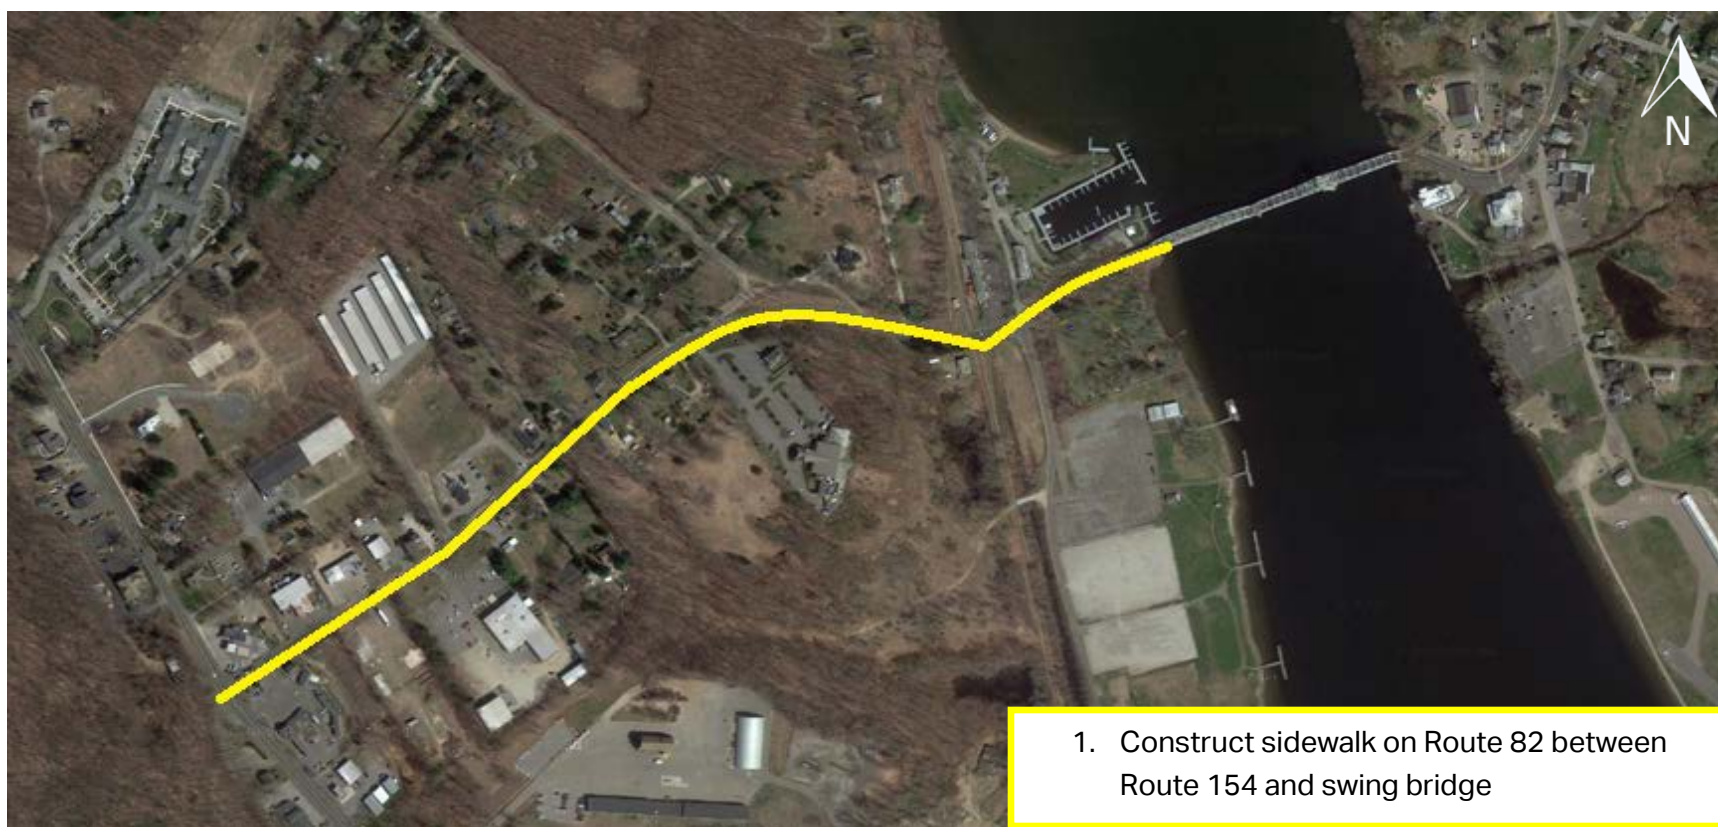
Figure 24. Long Term Recommendations

1. Construct sidewalk on Route 82 between Route 154 and swing bridge

1. Construct a sidewalk on Route 82 between Route 154 and the swing bridge. Evaluate alternatives on the west end of the bridge on the south side of the roadway such as a boardwalk facility.
2. The swing bridge restoration is in the early stages of design. The CTDOT is considering the addition of a pedestrian facility. Coordination between CTDOT and Haddam and East Haddam is required.
