# REHABILITATION STUDY REPORT

State Project No. 40-141  
Bridge No. 01138 in East Haddam  
Route 82 over Connecticut River

State of Connecticut  
Department of Transportation  
Newington, Connecticut

*Submitted:* April 2017

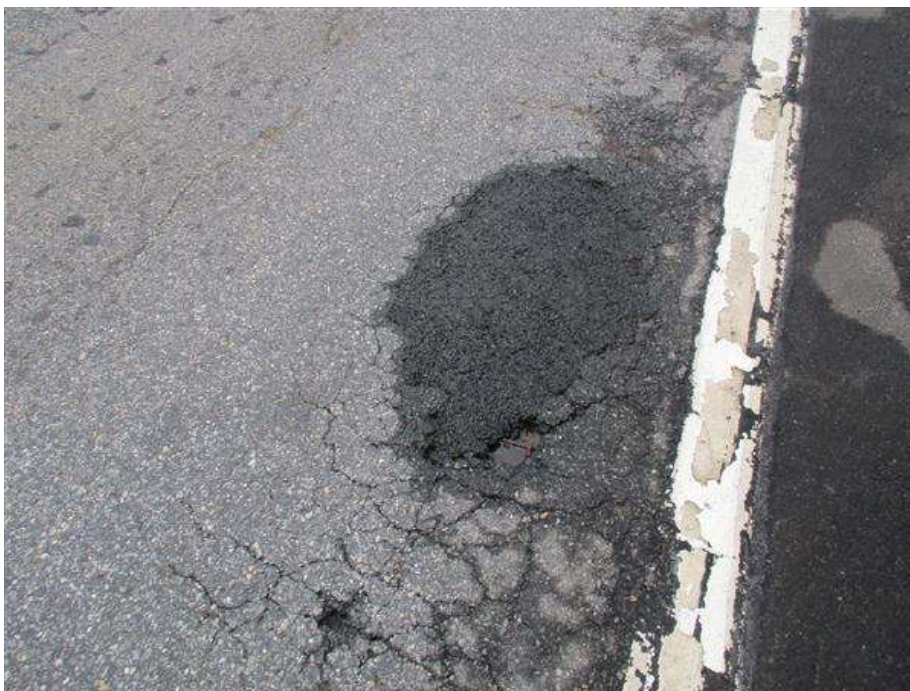
Photo Number: 7

Minor pothole in the bituminous concrete overlay in span 1 with exposed grid. Note the bituminous patch in the overlay.

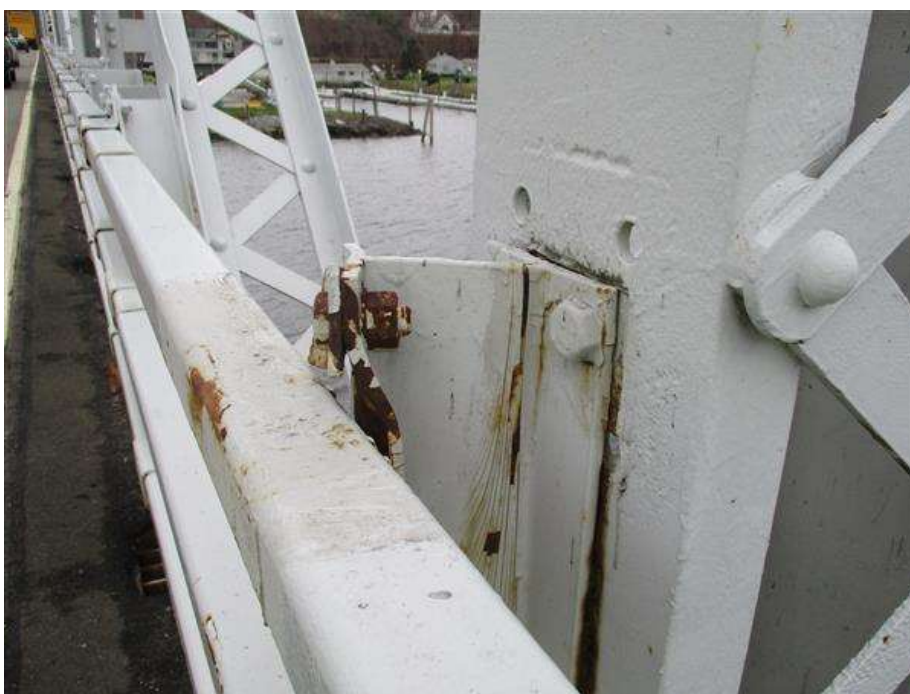
Photo Number: 17

Bent post and bracket in the north railing of span 3.

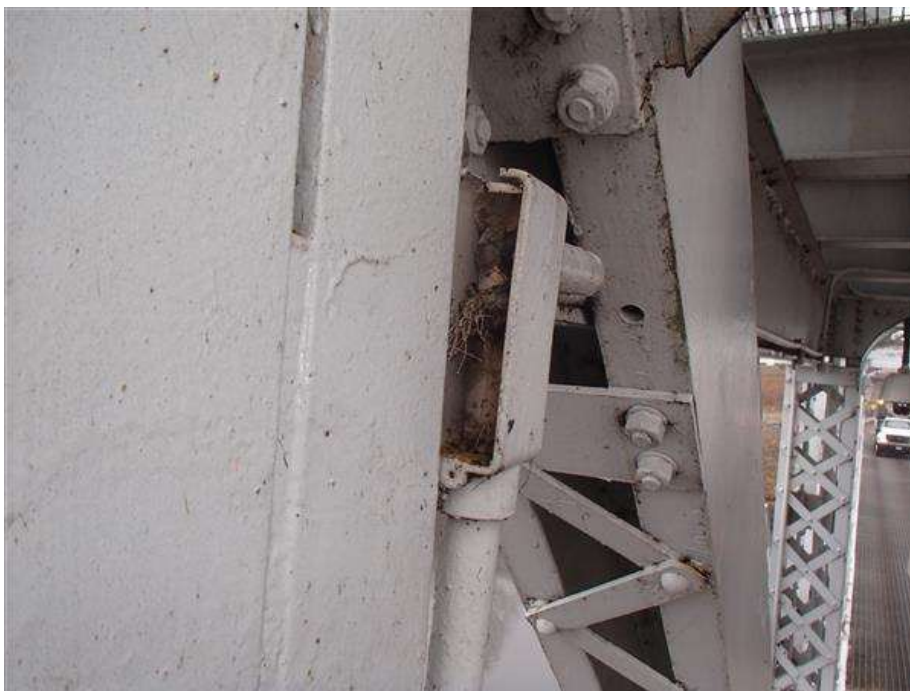
Photo Number: 23

Missing conduit access cover at panel point M9 in north truss of span 3

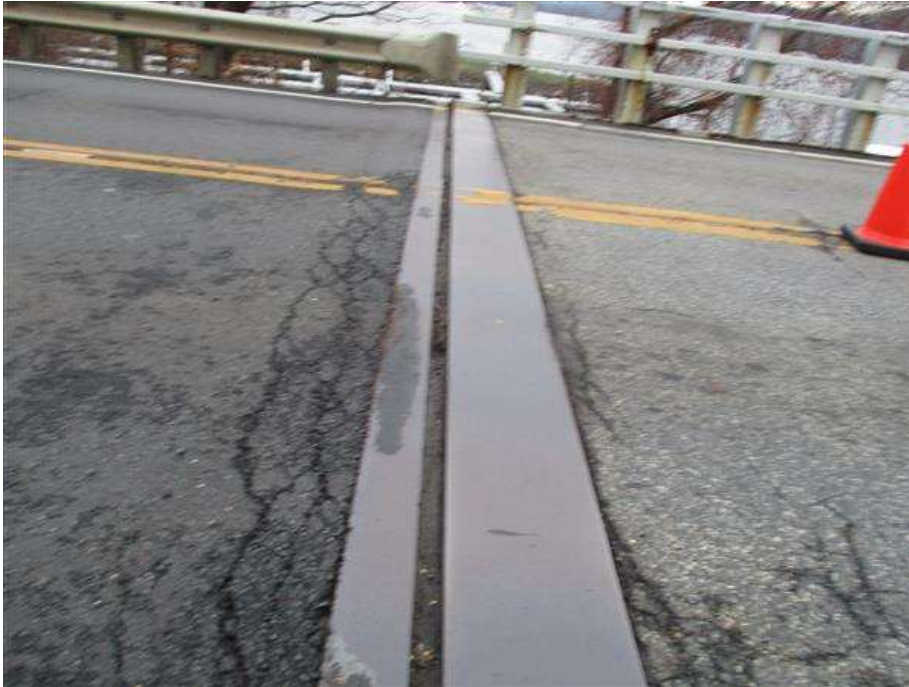
Photo Number: 25

Compression seal joint with depressed joint material at the west abutment. Note light to moderate accumulation of sand debris in joint. Also, note minor scrapes and scratches to steel headers.

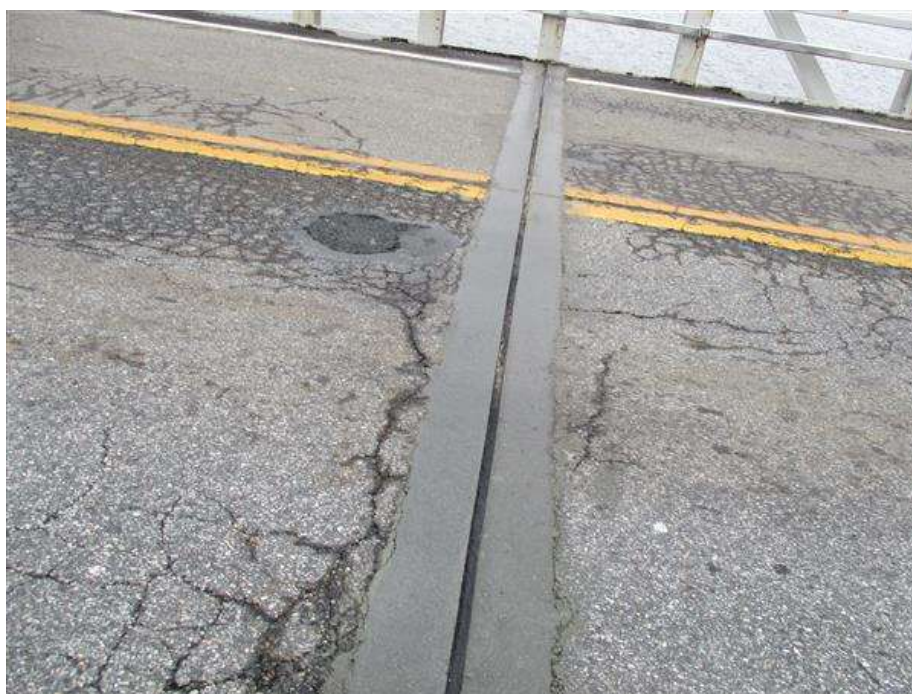
Photo Number: 27

Pourable seal joint at mid-span in span 2. Note the adhesion separation and light to moderate accumulation of sand/debris in joint.

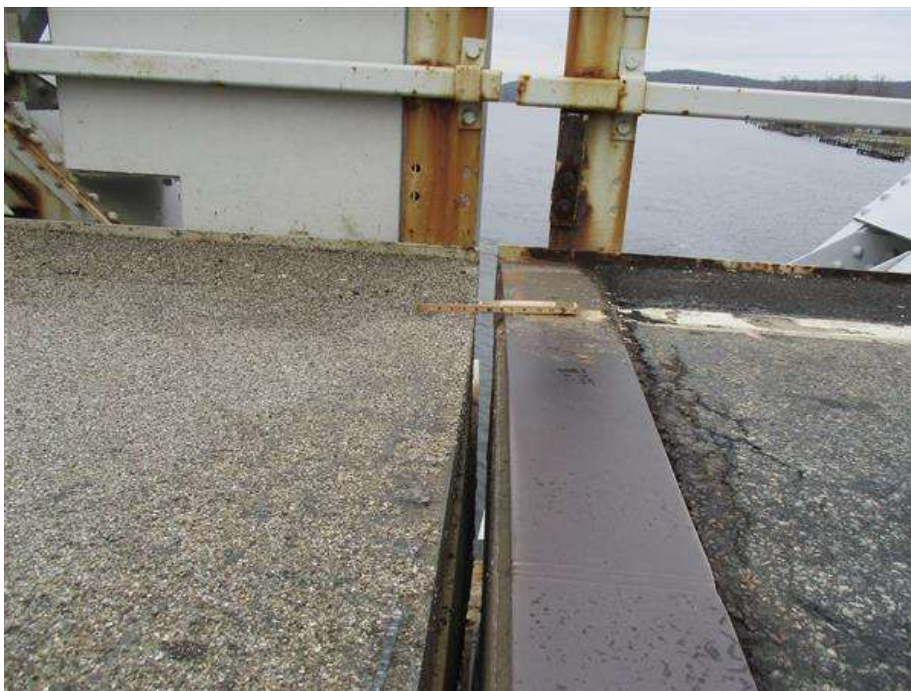
Photo Number: 29

Open joint at pier 2 with vertical misalignment.

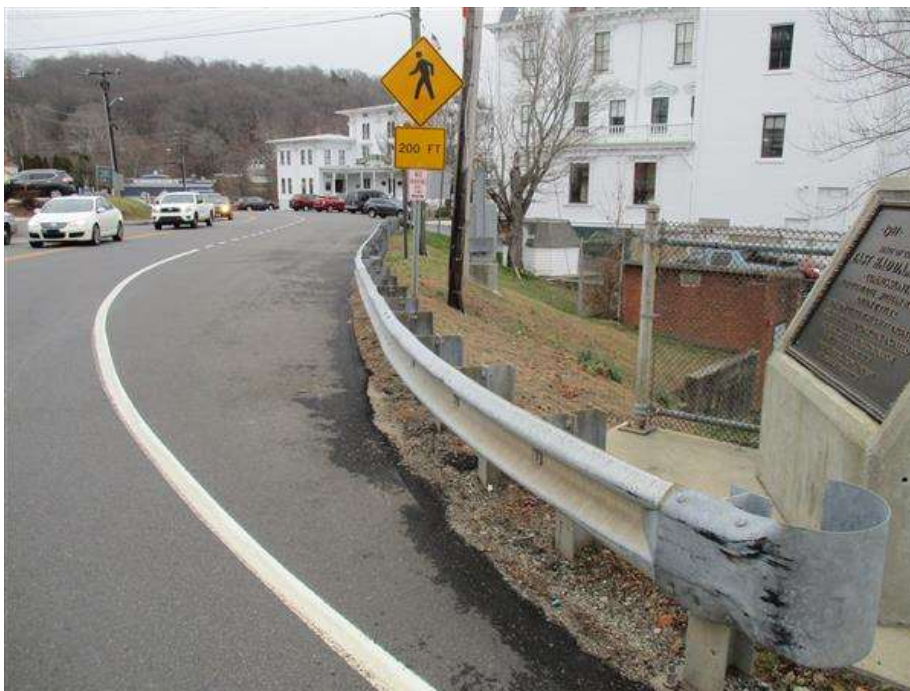
Photo Number: 31

Southeast approach metal beam rail. Note guiderail is not attached to bridge. Also, note scrapes to railing.

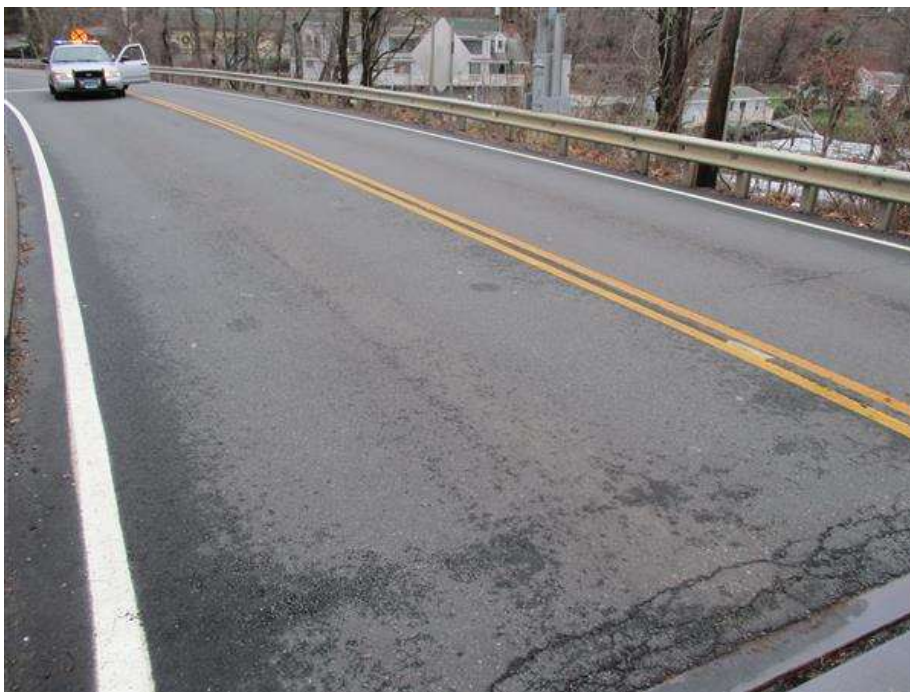
Photo Number: 32

West approach pavement. Noted map cracking in the pavement.

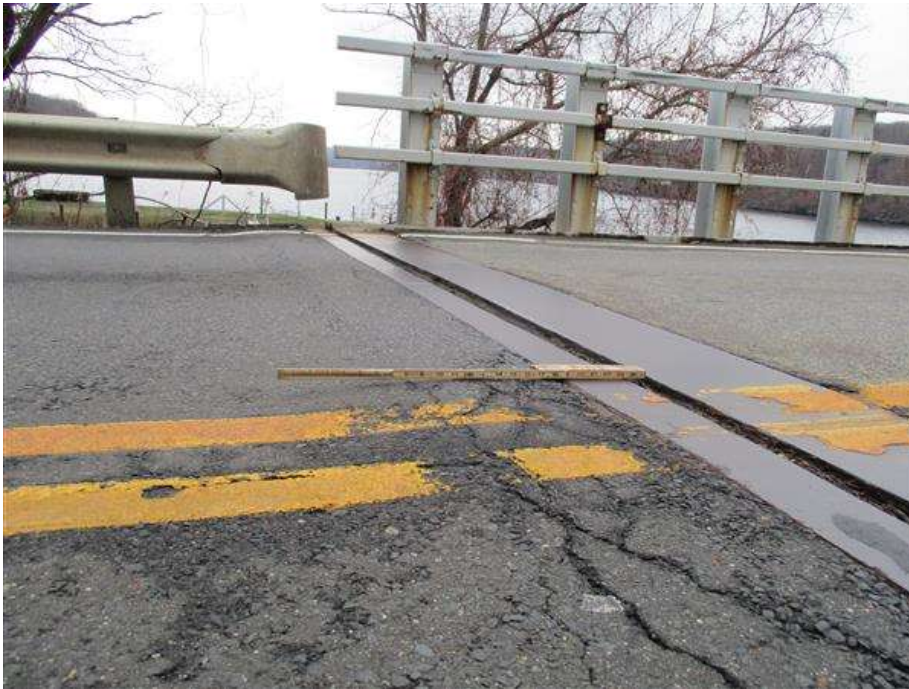
Photo Number: 33

Settlement along the west approach pavement. Note the map cracking in pavement adjacent to the west abutment joint.

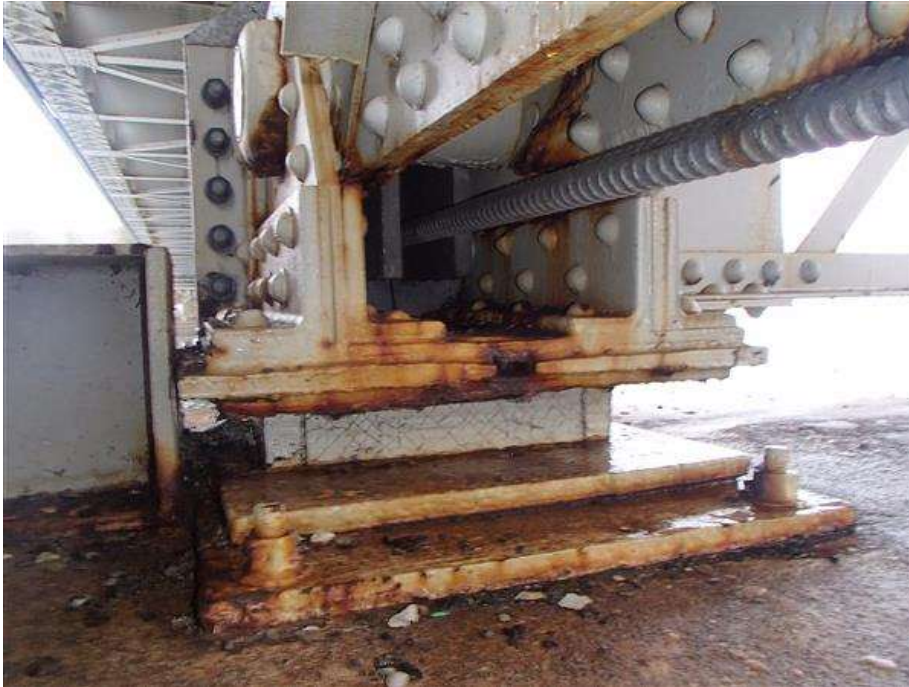
Photo Number: 35

Elastomeric expansion bearing for north truss at pier 1 in span 1. Note the painted over pitting loss on the bearing steel plate and pack rust under the north pin.

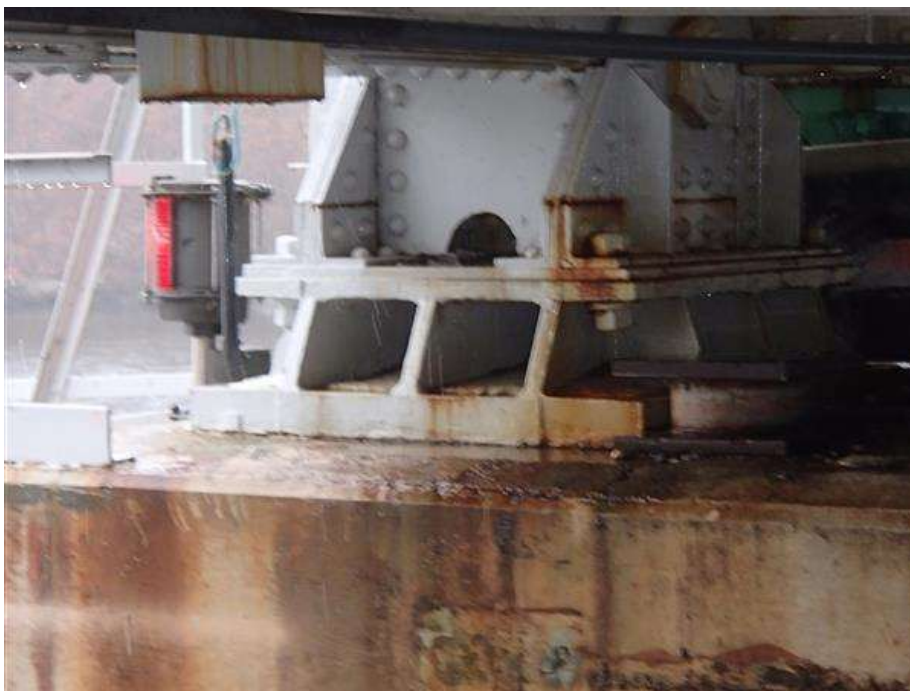
Photo Number: 37

Fixed bearing for the north truss at pier 2 in span 2.

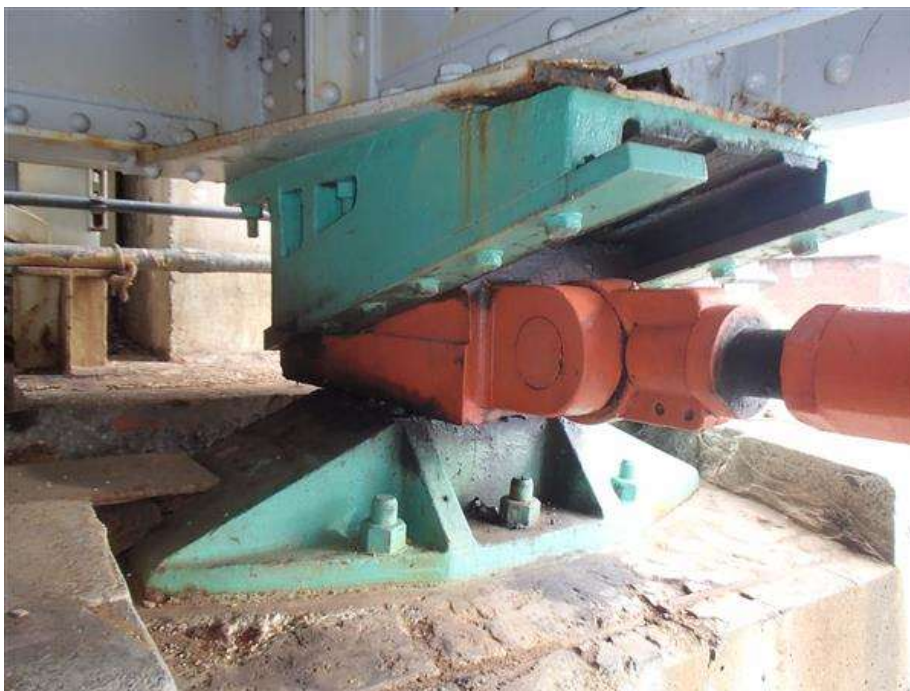
Photo Number: 39

Bearing for south truss at east abutment in span 4.

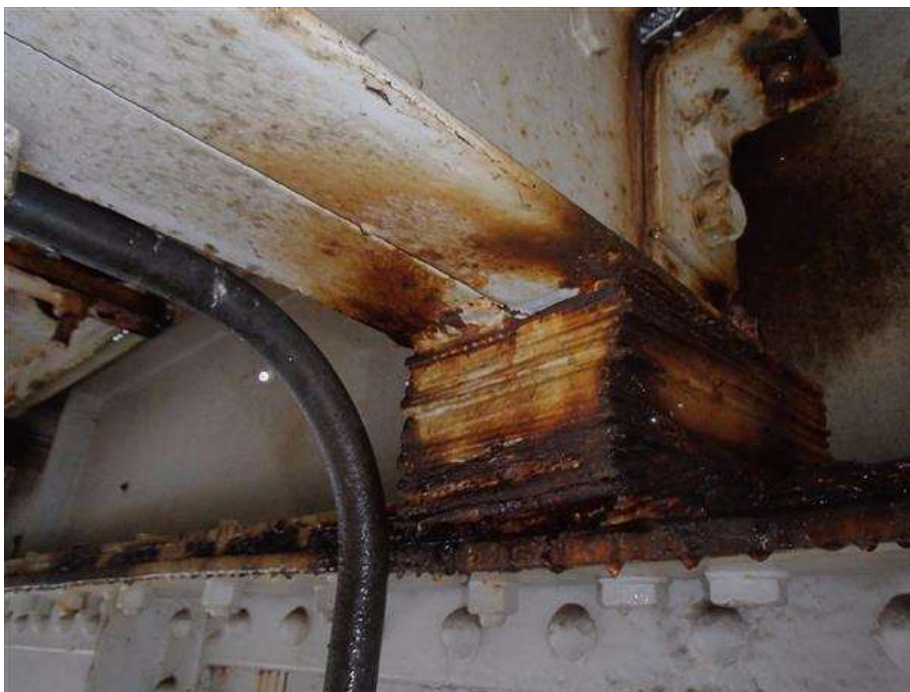
Photo Number: 40

Bearing for stringer S3 at east side of floorbeam FB L1' in span 2. Note the moderate to heavy rust on the filler plates.

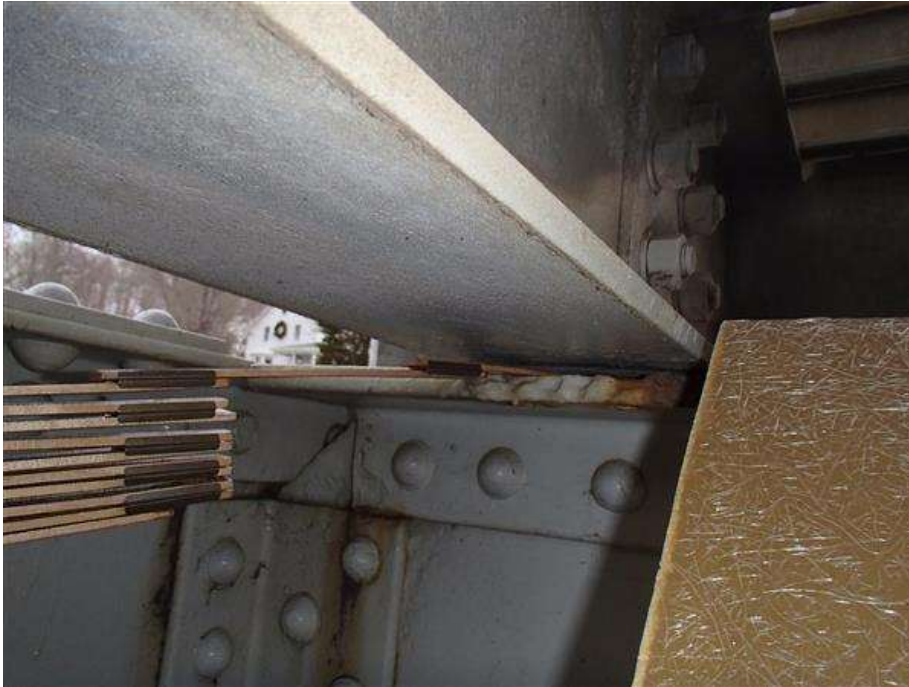
Photo Number: 41

Bearing for stringer S1 at west side of floorbeam FB9 in span 4. Note the missing filler plates with gap under the stringer.

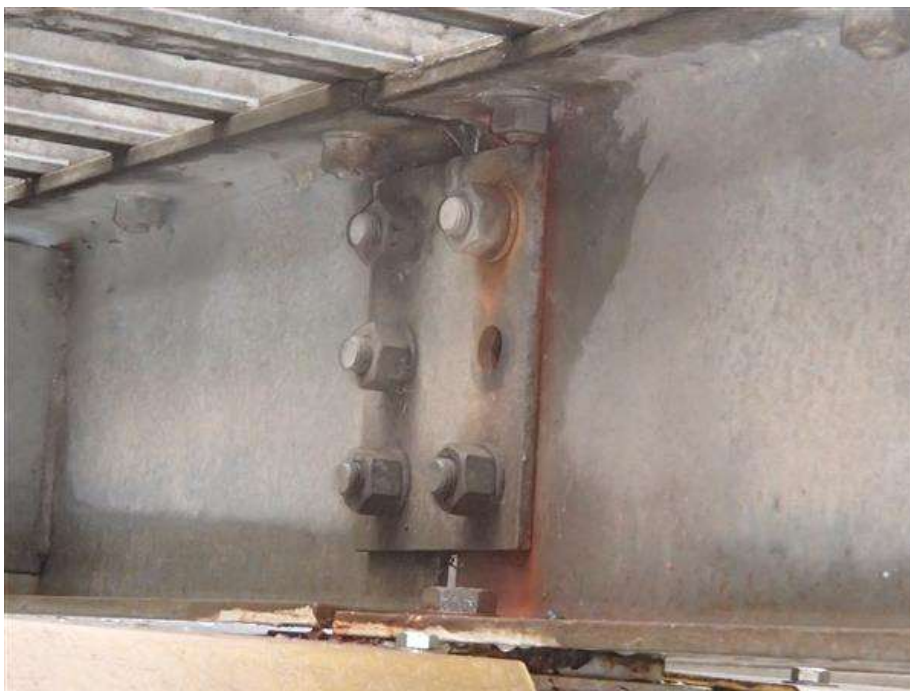
Photo Number: 43

South elevation of stringer S4 at floorbeam 17 in span 3. Note the missing and loose bolts in the splice connection.

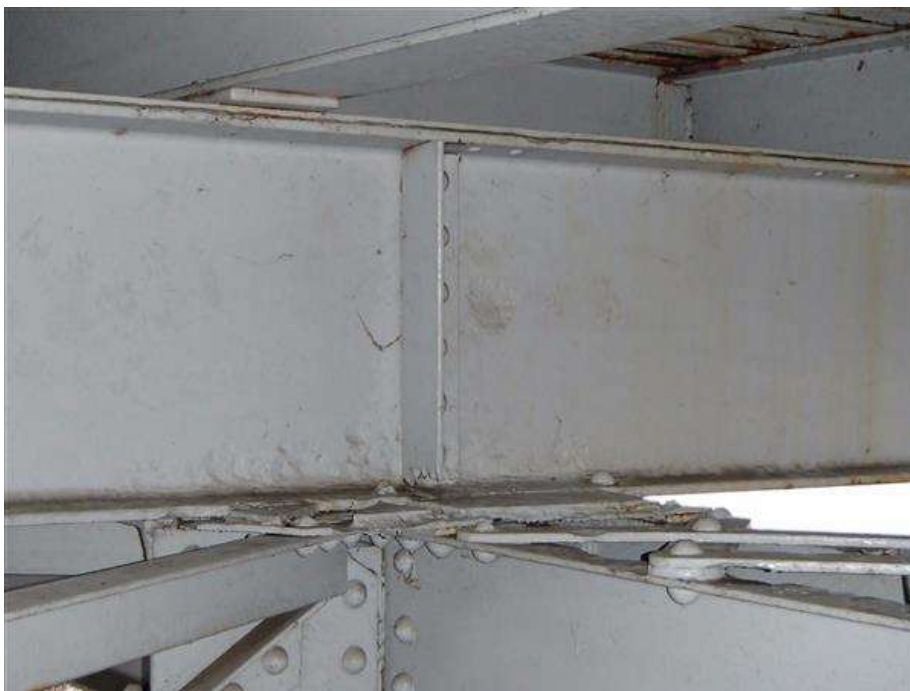
Photo Number: 45

West elevation of floorbeam FB1 connection to the south truss in span 1. Note the painted over section loss at the bottom of web and perforation at the bottom of stiffener.

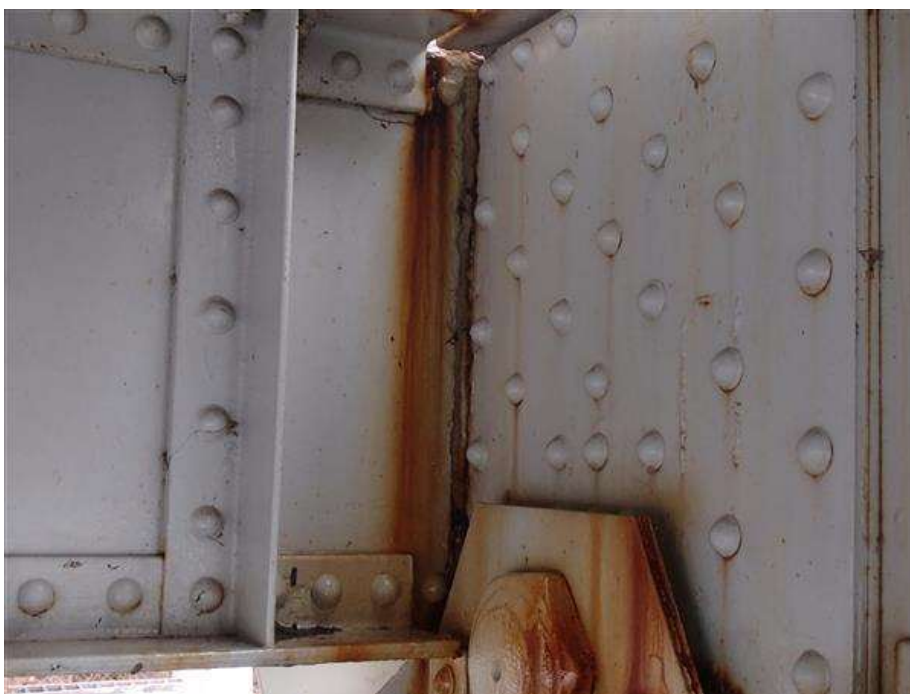
Photo Number: 46

Floorbeam FB L0' connection to north truss at pier 1 in span 2. Note the painted over section loss in web and bottom flange with recurring rust in the floorbeam web.

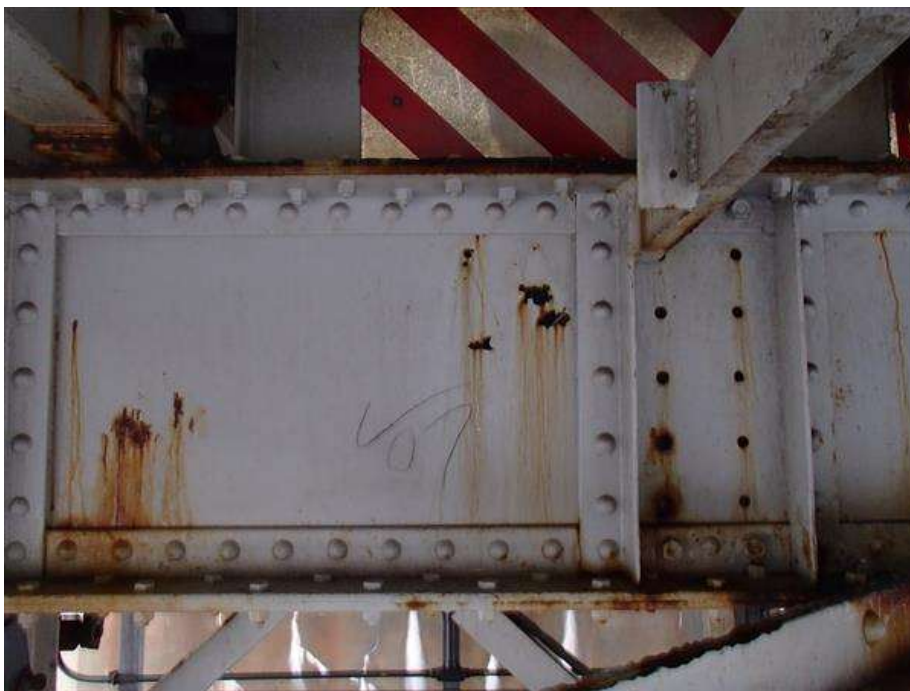
Photo Number: 47

West elevation of floorbeam FB L1' under stringers S2 and S3 in span 2. Note the perforations in the web.

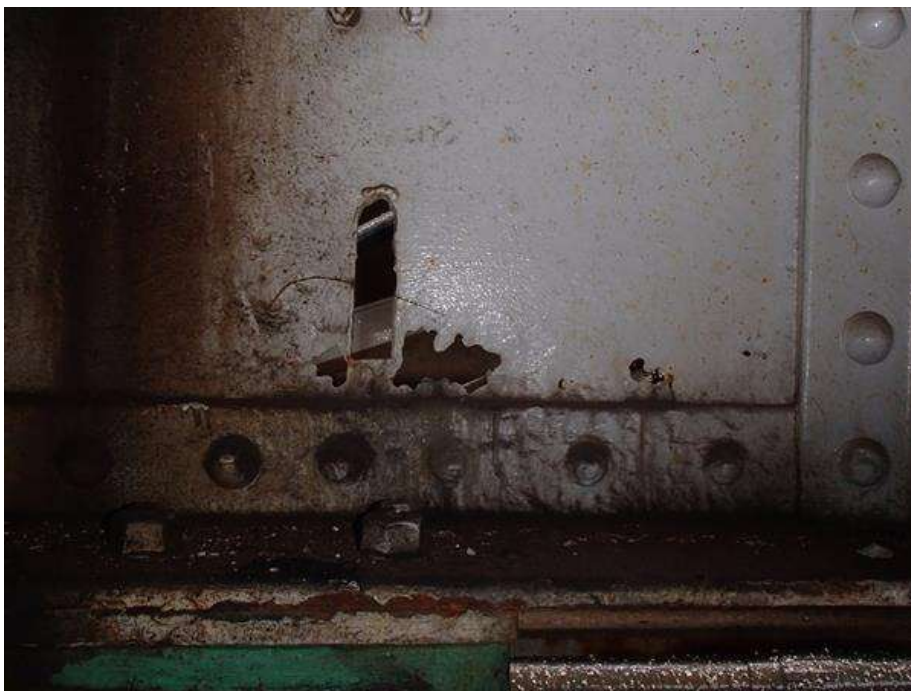
Photo Number: 49

Perforations at the bottom of floorbeam FB1 web between stringers S2 and S4 in span 4.

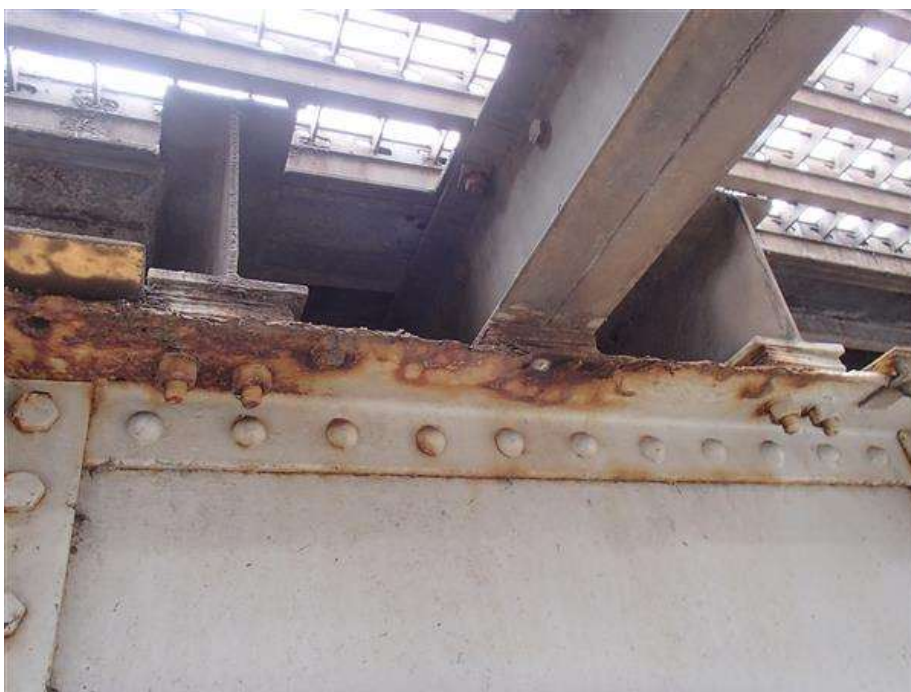
Photo Number: 50

Heavy rust with section loss and loss of width in the top flange of floorbeam FB2 (west leg) at stringer S3 in span 4.

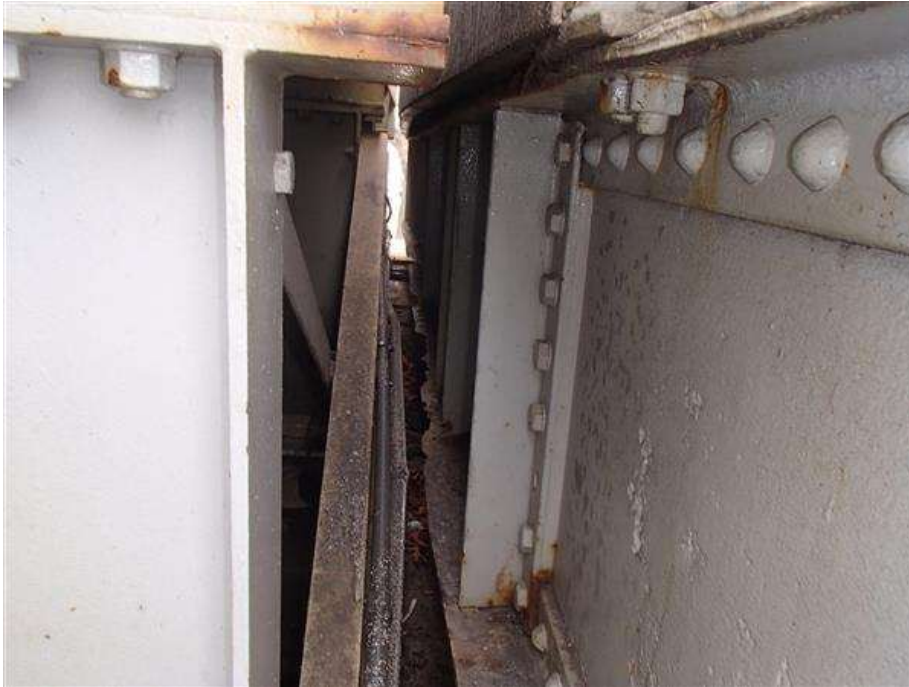
Photo Number: 51

East elevation of floorbeam FB1 in span 4. Note the section loss in the east leg of the bottom flange.

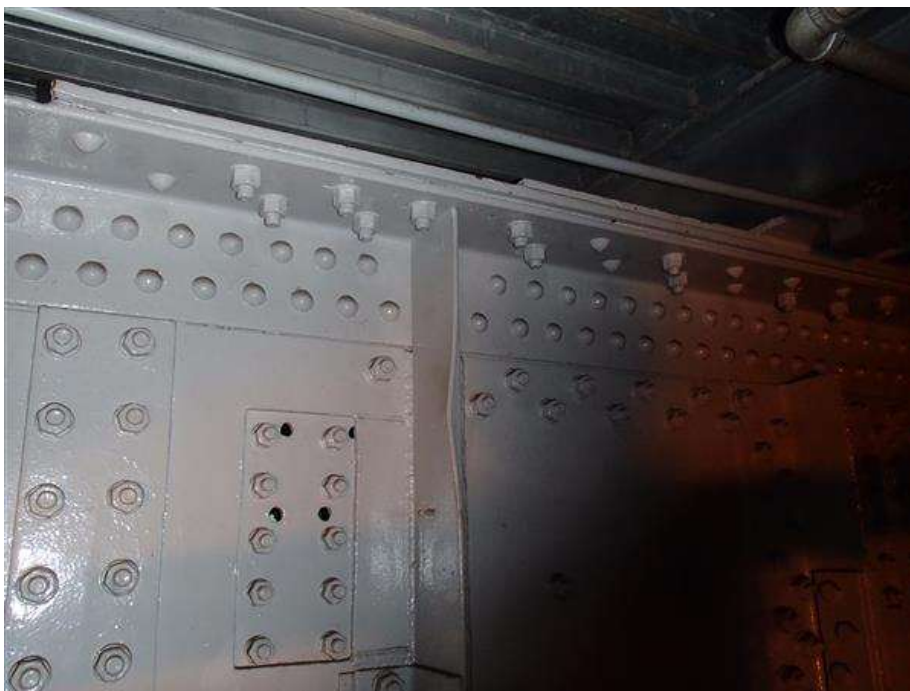
Photo Number: 53

West elevation of floorbeam FB22W in span 3. Note the mis-drilled holes and bent vertical stiffener.

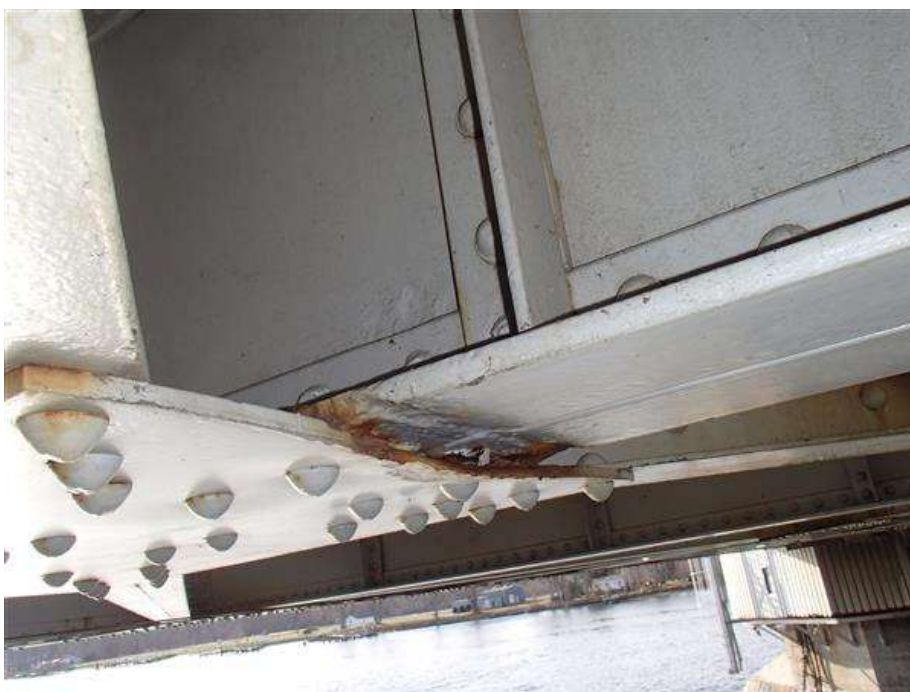
Photo Number: 54

Pack rust with gap between the gusset plate and bottom flange of floorbeam FB12 (east elevation) in span 4.

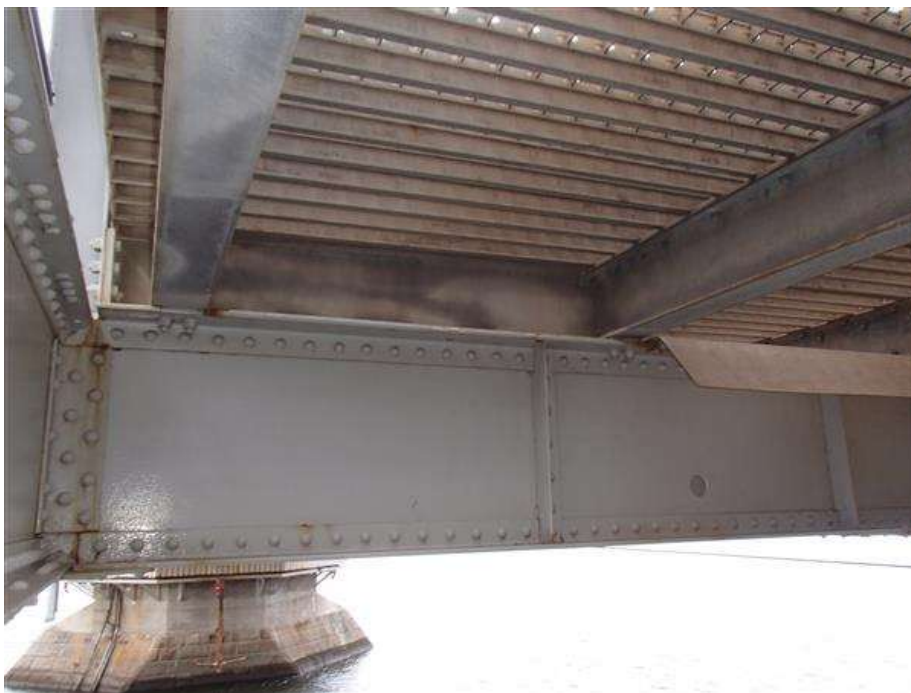
Photo Number: 55

East face of floorbeam FB10 (north end) in span 4. Note the missing fiberglass cover at the floorbeam top flange.

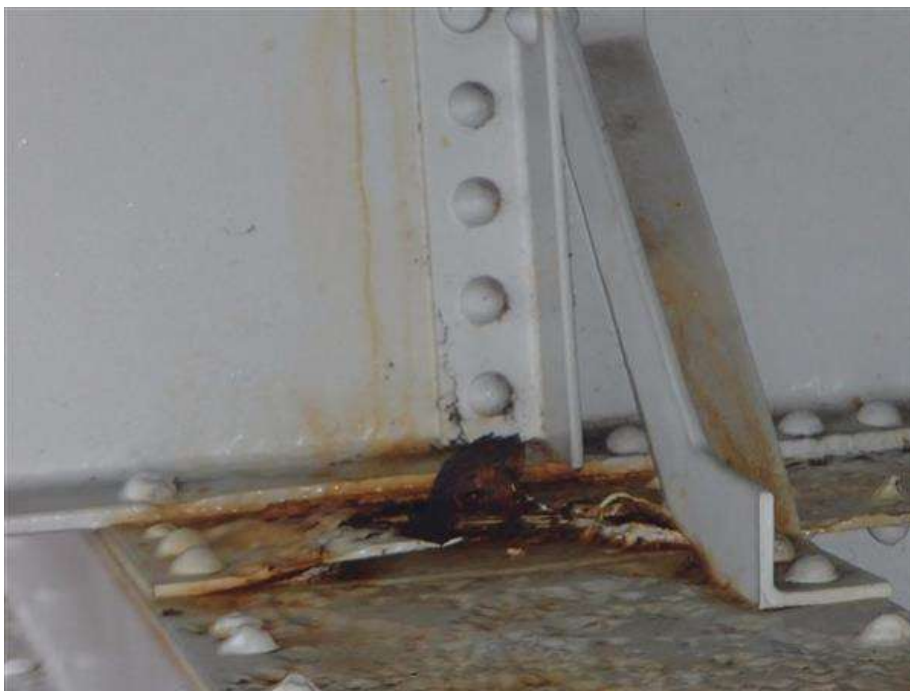
Photo Number: 57

Moderate to heavy rust with perforation in the horizontal gusset plate at panel point U3 in south truss, span 1.

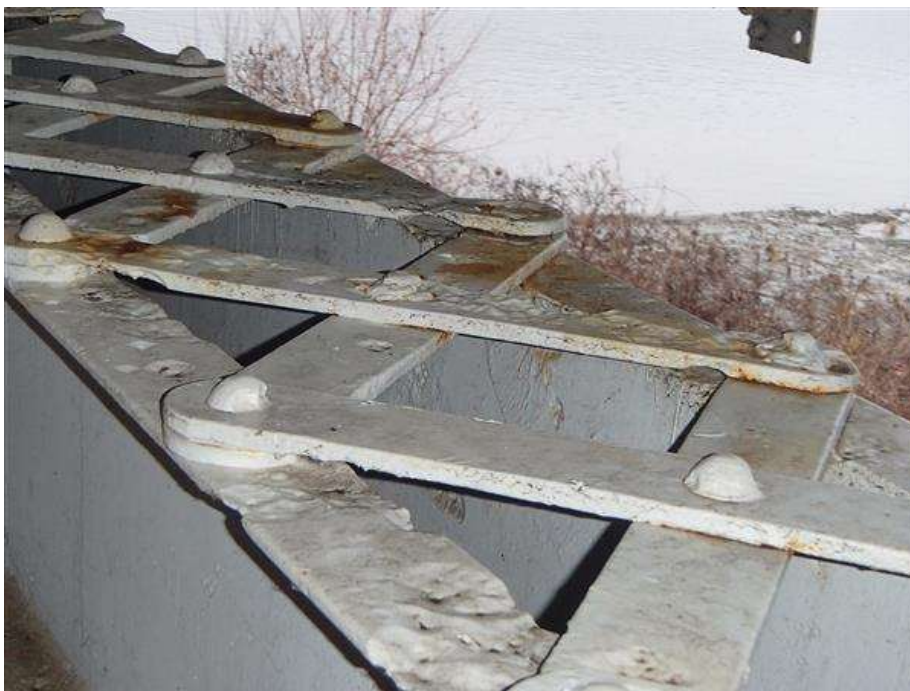
Photo Number: 59

Painted over section loss at the top of top chord, U0-U1 in south truss, span 1.

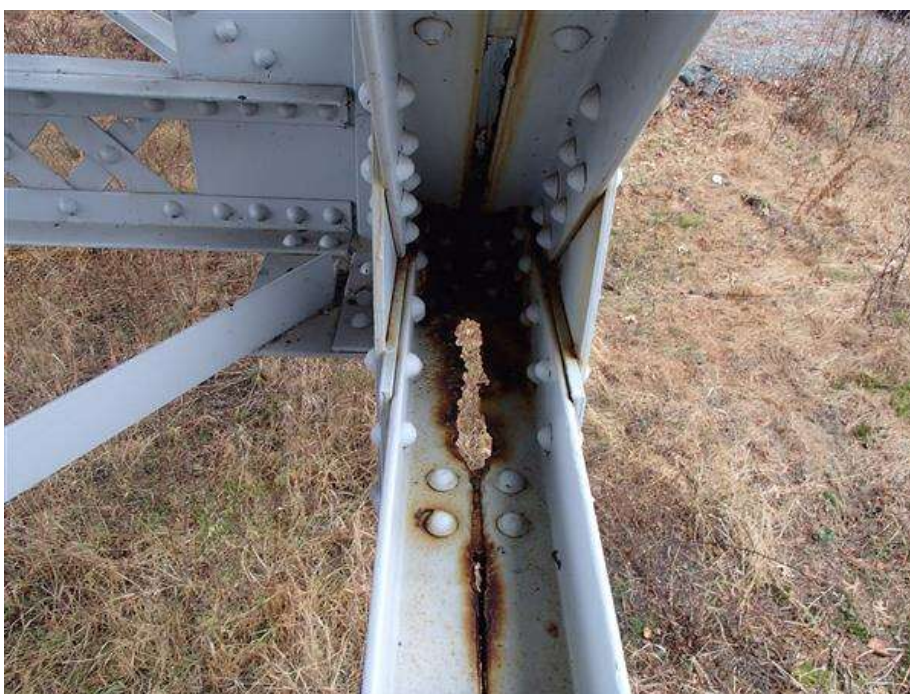
Photo Number: 61

Section loss in the back-to-back angles at panel point L8 in member L8-L9 in north truss, span 1.

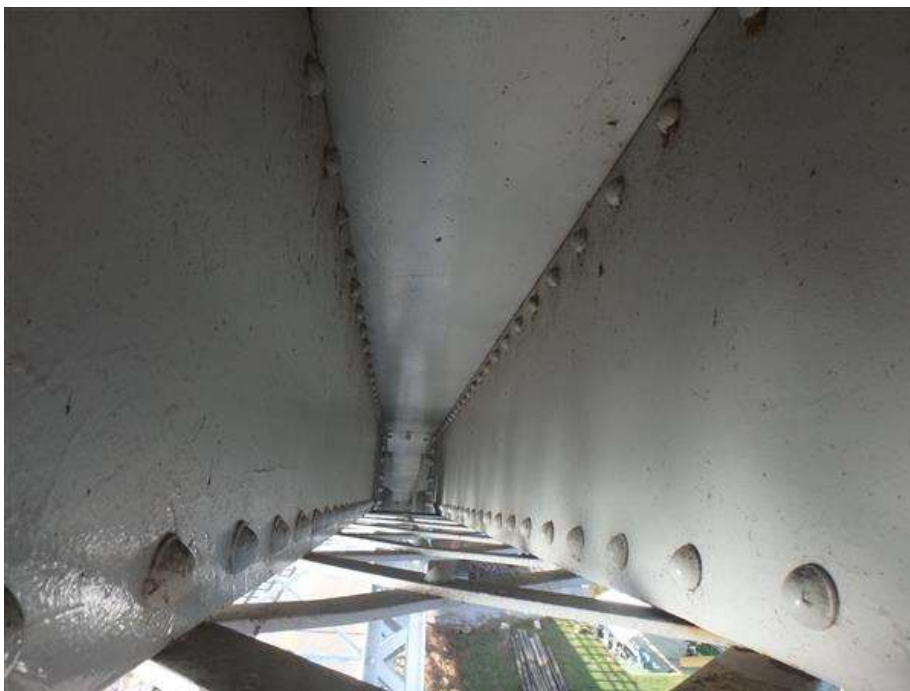
Photo Number: 63

Typical view inside top chord for U5-U4 in north truss, span 2.

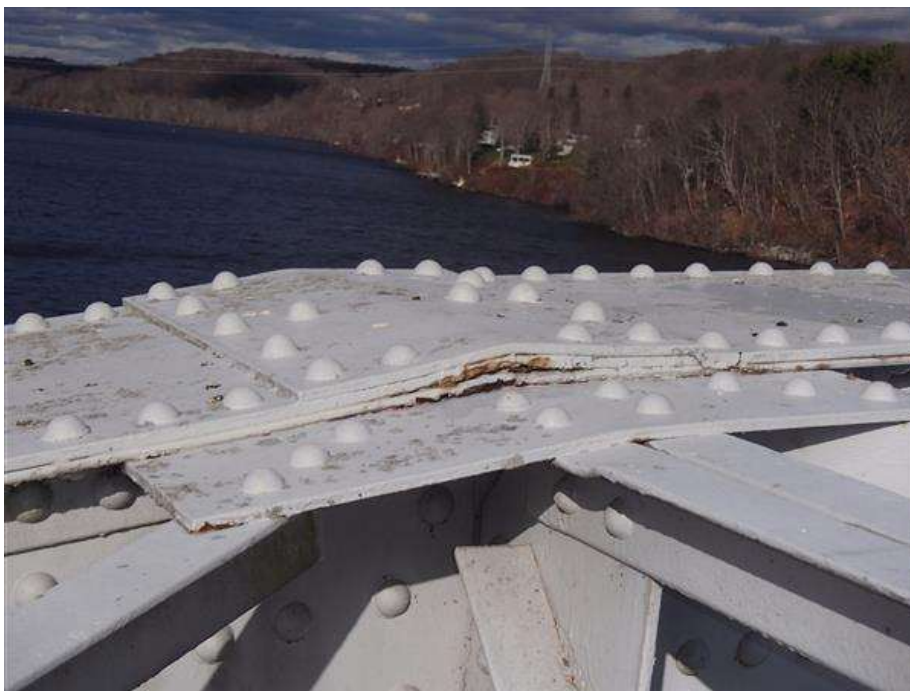
Photo Number: 65

Pack rust between the top chord plates at panel point U6 in north truss, span 2.

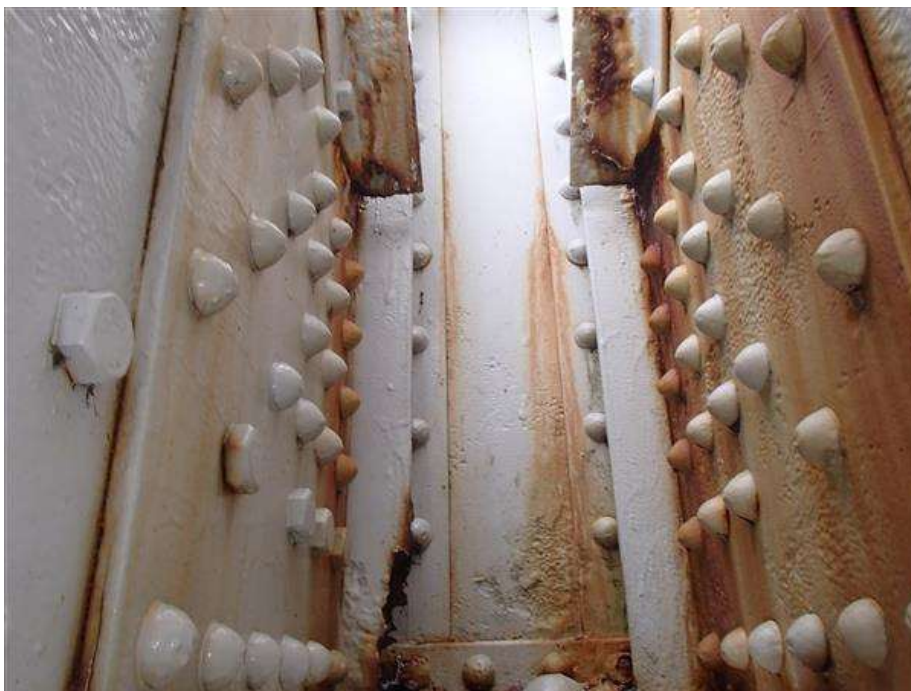
Photo Number: 67

Inside view of panel point L2 of south truss, span 3. Note the section loss with perforations in vertical and diagonal members.

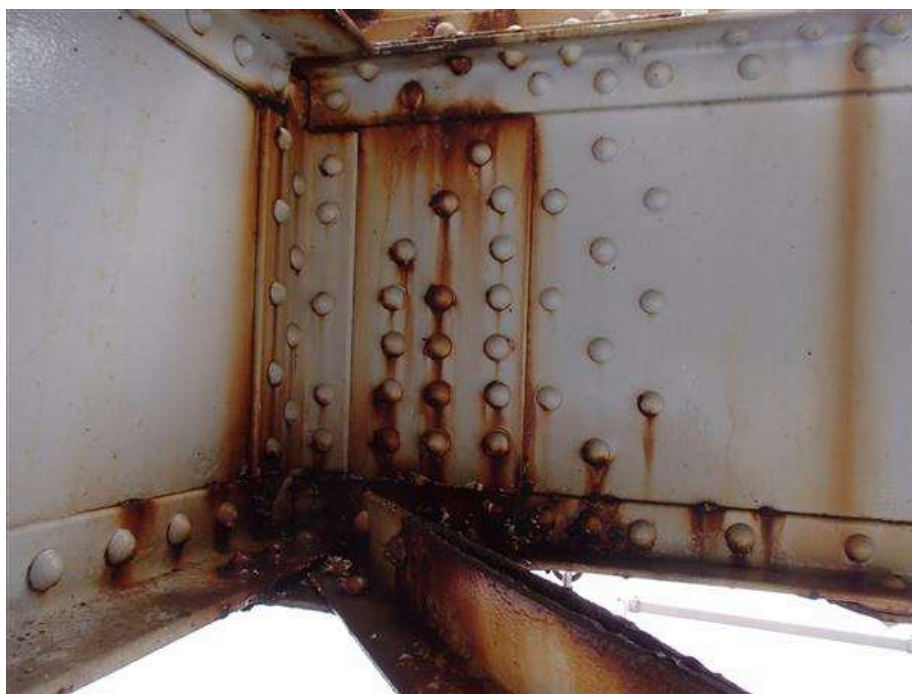
Photo Number: 70

Heavy rust on the bottom chord at panel point L8 of south truss, span 3.

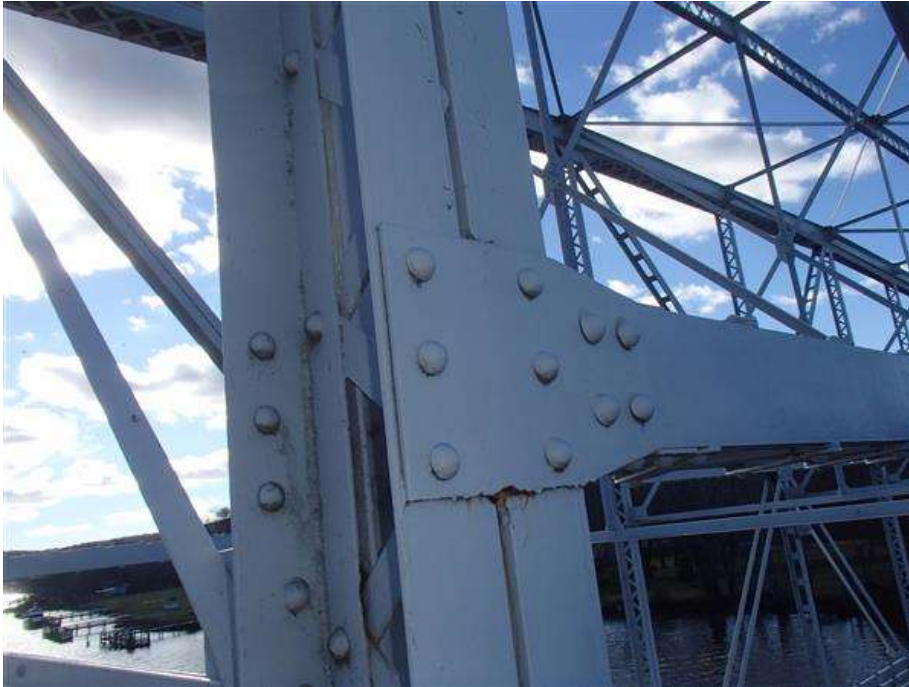
Photo Number: 71

North gusset plate at panel point M6' in north truss, span 2. Note the painted over section/pitting loss and perforation in the back-to-back angles.

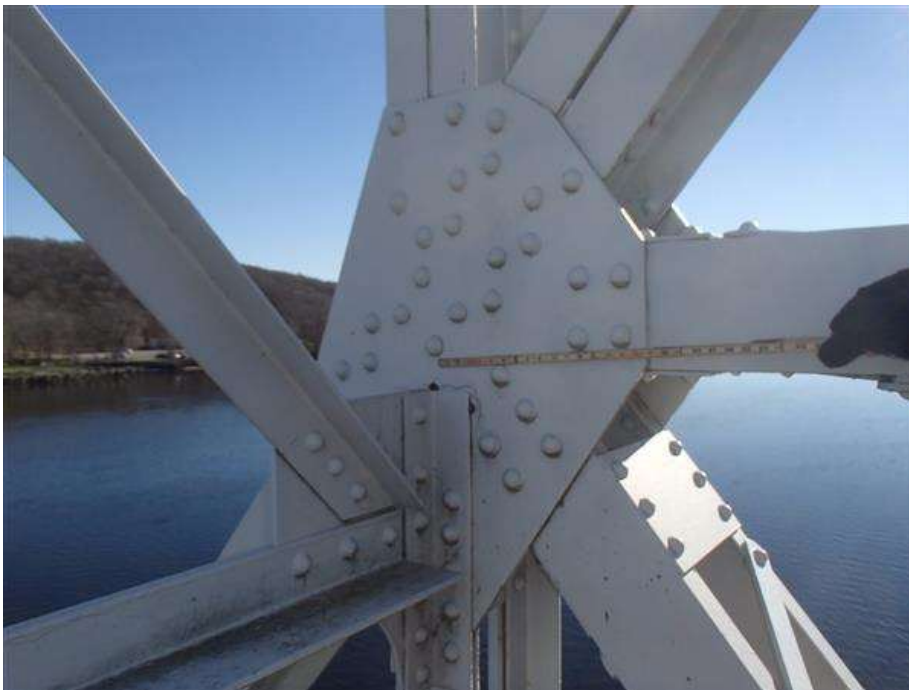
Photo Number: 72

North gusset plate at panel point M7 in south truss, span 2. Note the painted over section loss and missing rivets in the gusset plate.

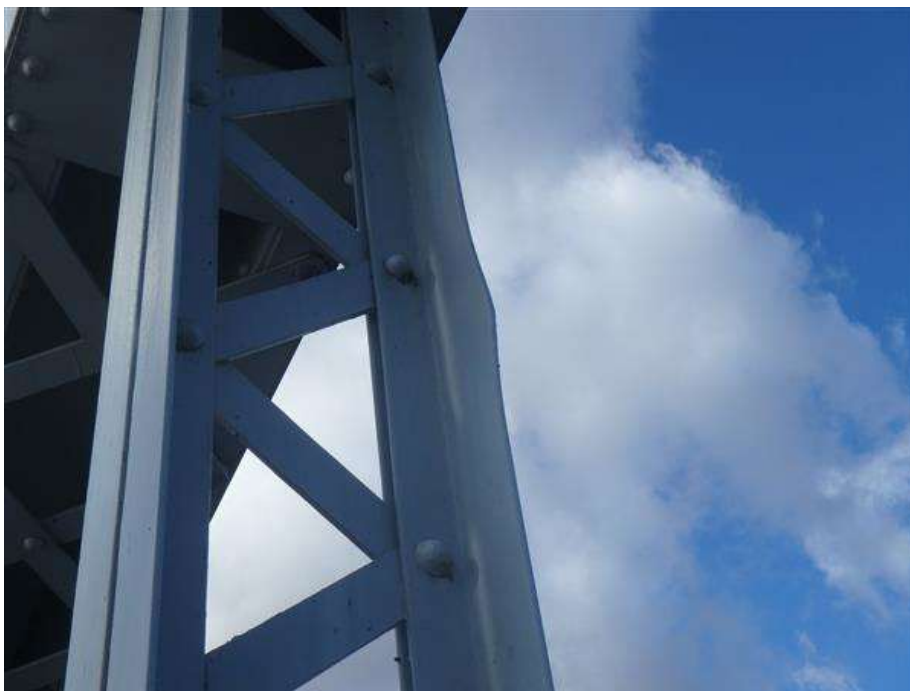
Photo Number: 73

Minor dent in the back-to-back angle of L5-U5 of north truss, span 2.

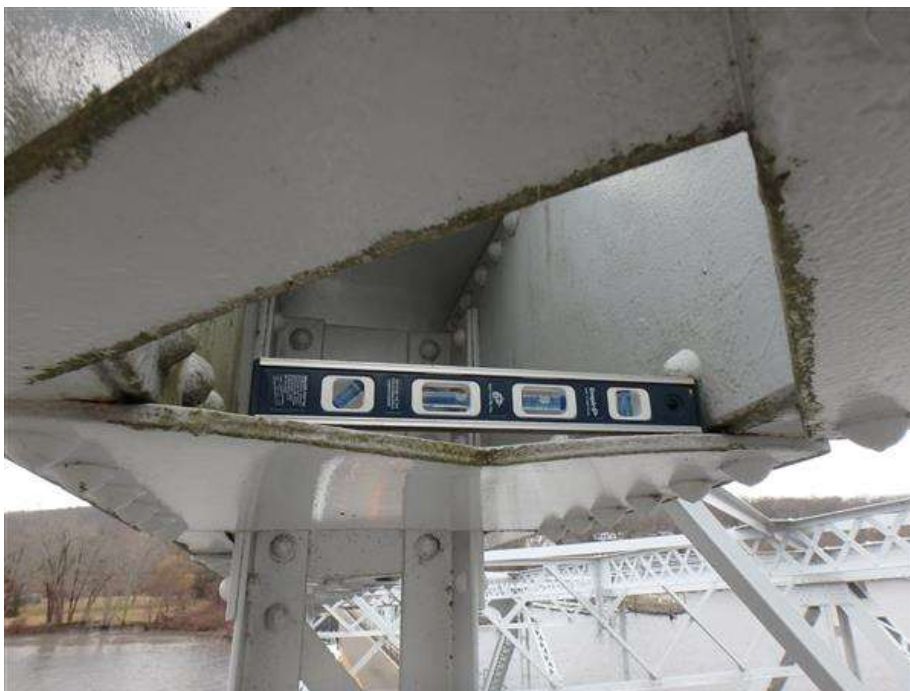
Photo Number: 75

Bent gusset plate at panel point U3 of south truss, span 2.
