# REHABILITATION STUDY REPORT

State Project No. 40-141  
Bridge No. 01138 in East Haddam  
Route 82 over Connecticut River

State of Connecticut  
Department of Transportation  
Newington, Connecticut

*Submitted:* April 2017

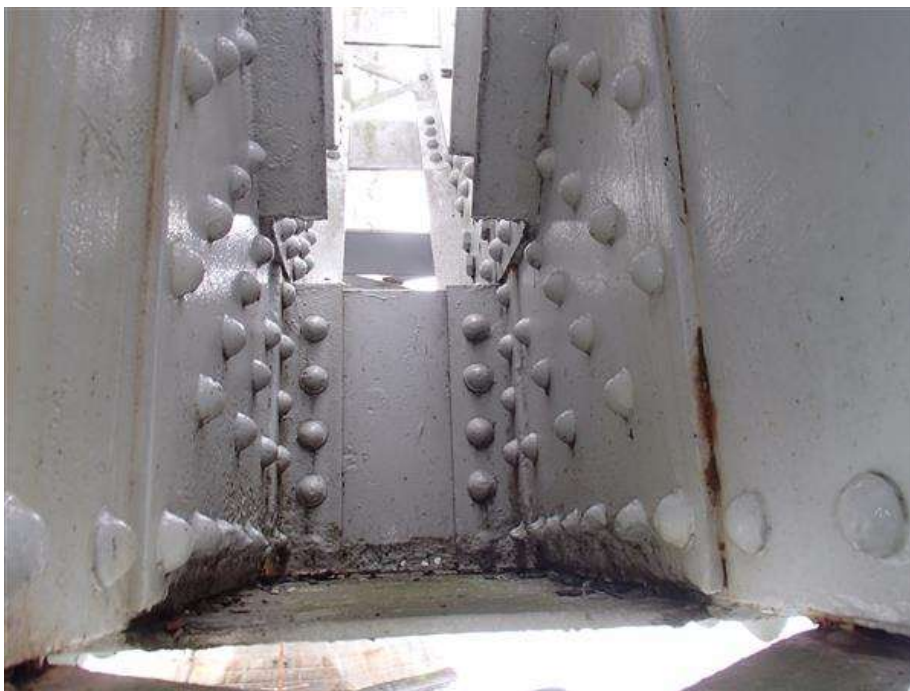
Photo Number: 77

Inside view of panel point L4 in north truss, span 4. Note the section loss and perforations to the batten plate and section loss on the bottom chord members.

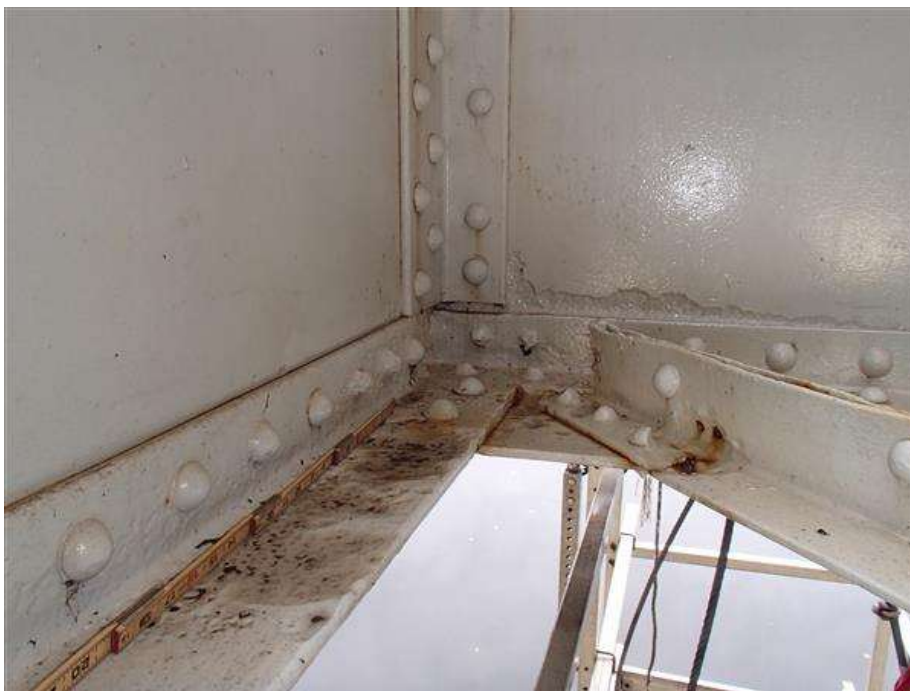
Photo Number: 79

Connection between floorbeam FB5 and north truss in span 3. Note the painted over section loss in the bottom chord web.

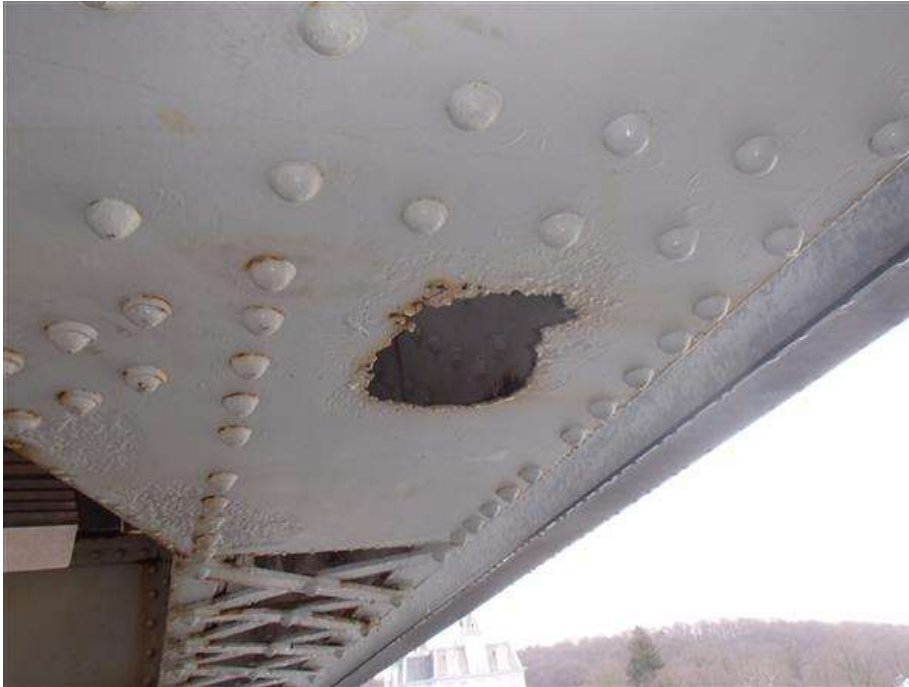
Photo Number: 81

Perforation in the gusset plate at bottom of bottom chord at floorbeam 13 connection to south truss in span 3.

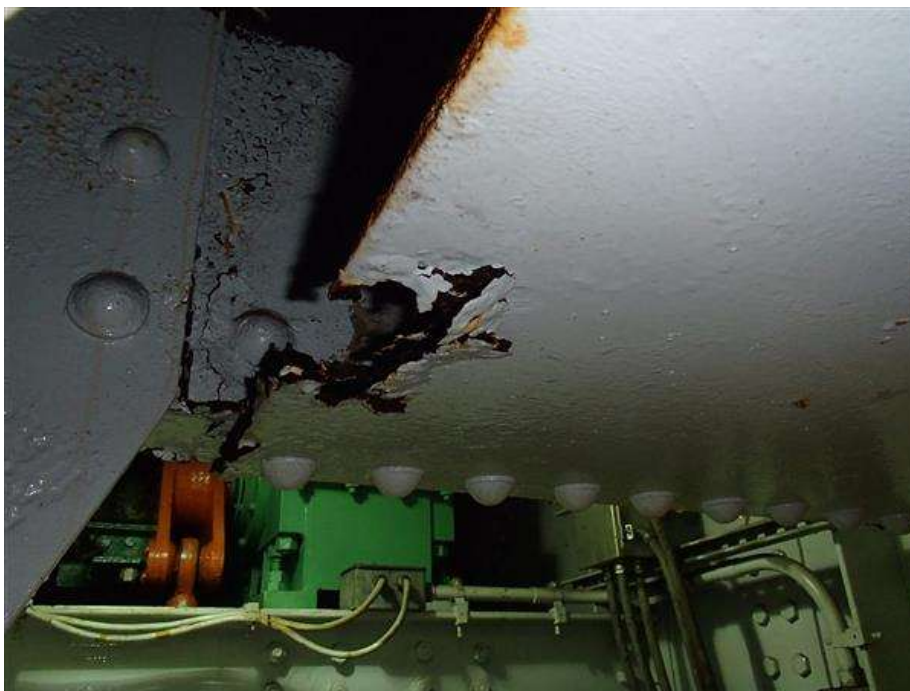
Photo Number: 83

Perforation in the batten plate for south truss between floorbeams FB22 West and FB22 East inside the machinery pit, span 3.

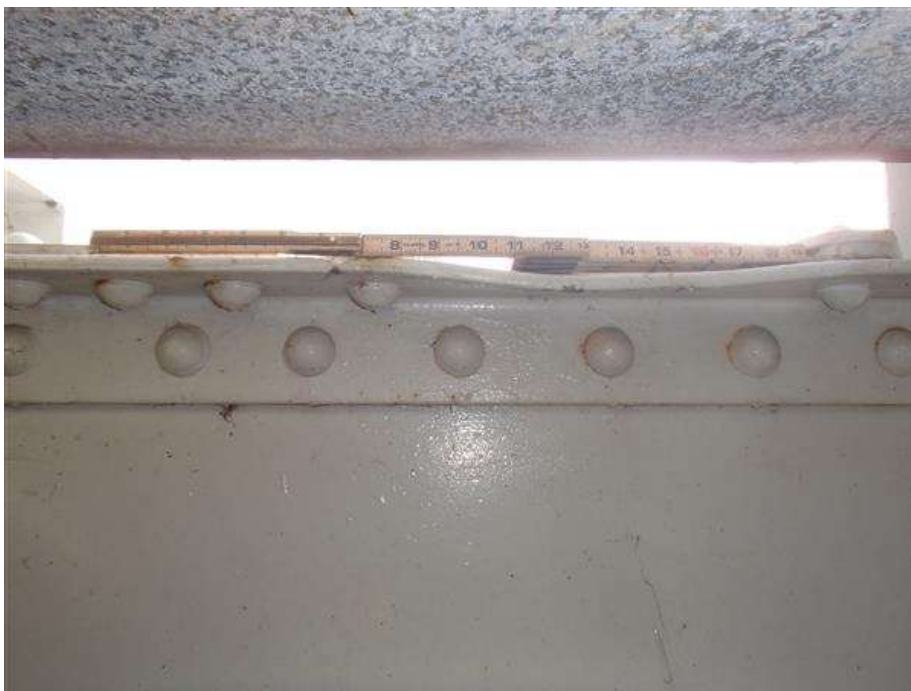
Photo Number: 85

Bent top flange of bottom chord, L8'-L9' of south truss, span 4.

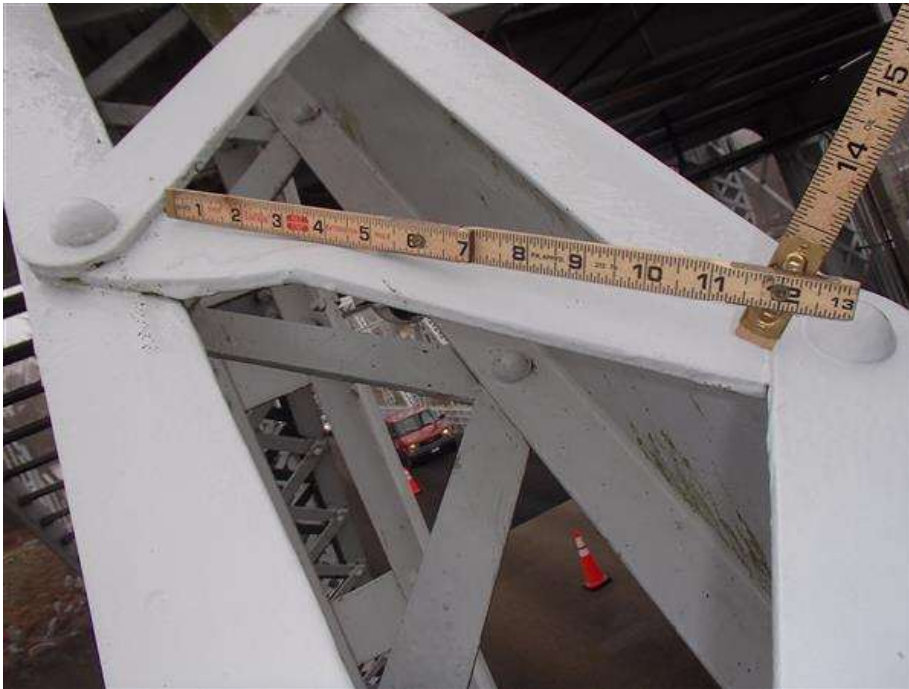
Photo Number: 87

Bent lacing bar on the diagonal member, M9-L8 of south truss, span 2.

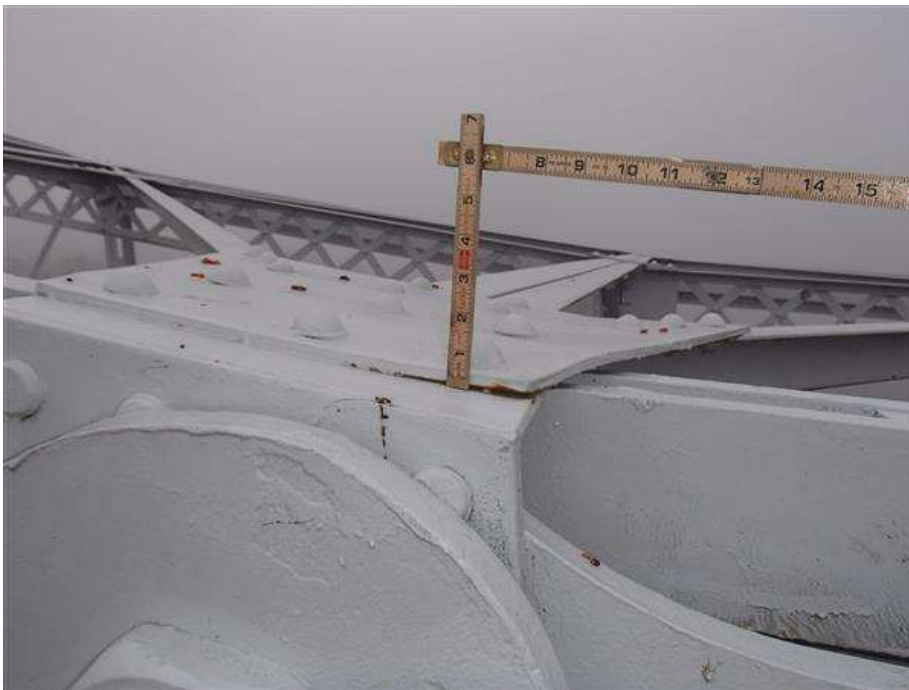
Photo Number: 88

Minor pack rust under the gusset plate for top chord at panel point U6 of north truss, span 3.

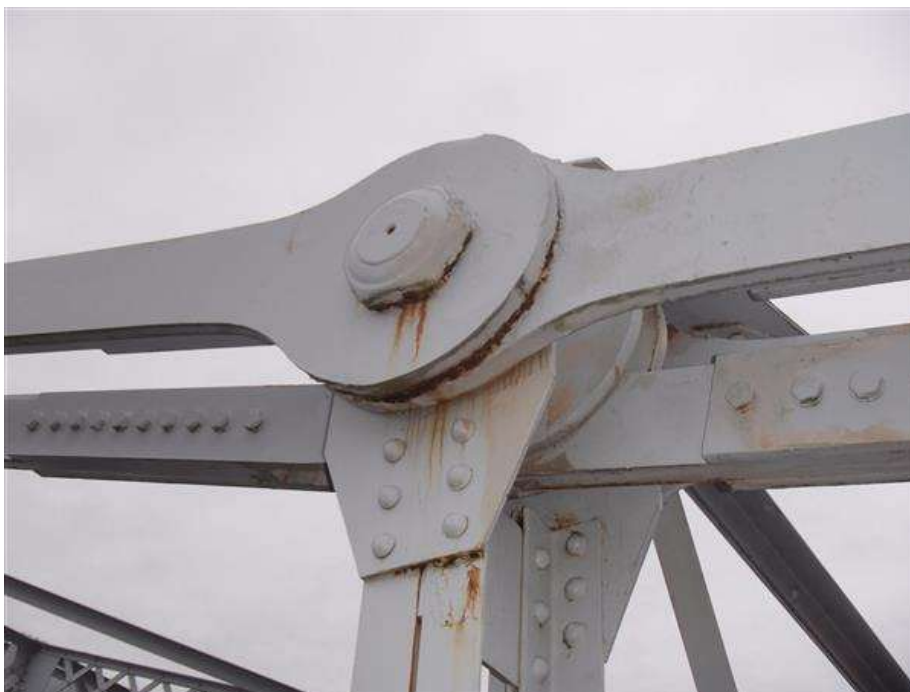
Photo Number: 90

Eyebars and pin at panel point U7' of south truss, span 4. Note the bleeding rust on the pin and pack rust between the eyebars.

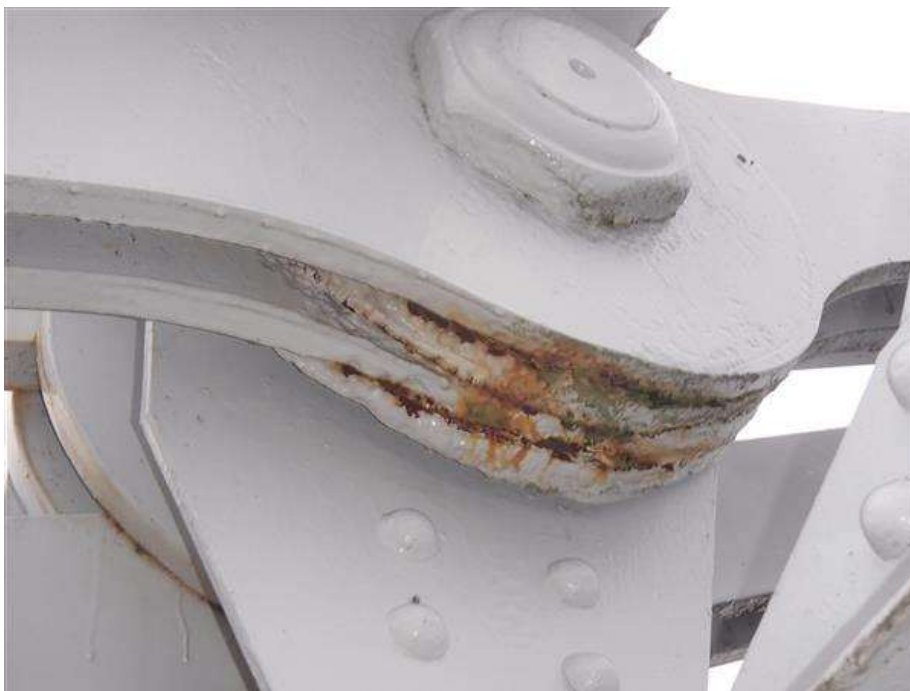
Photo Number: 91

Painted over section loss with pack rust between the eye bars at panel point U9' of south truss, span 4.

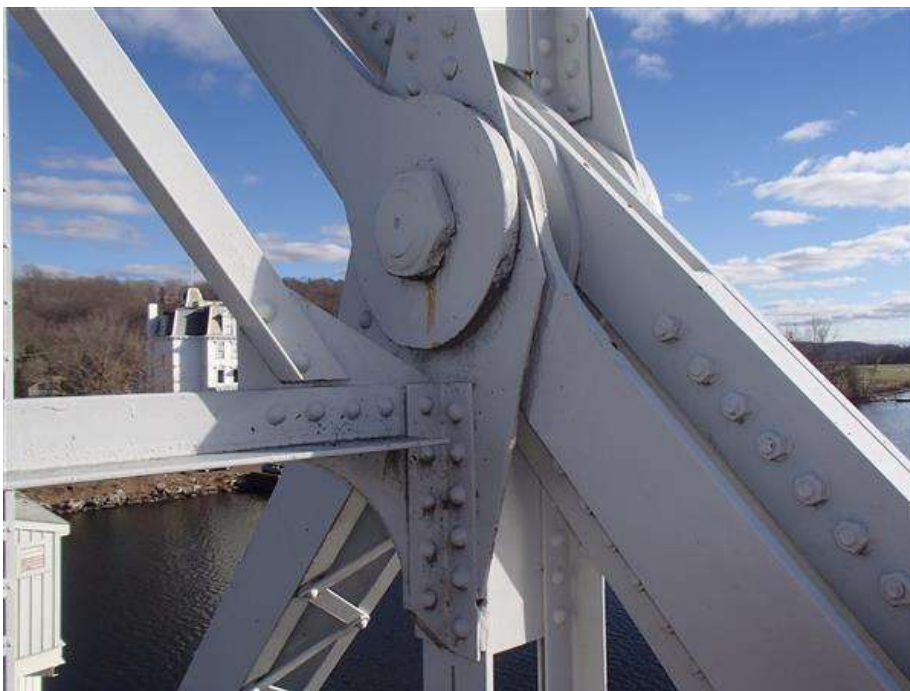
Photo Number: 93

Painted over section loss on eyebars and pin at panel point M7 of south truss, span 3.

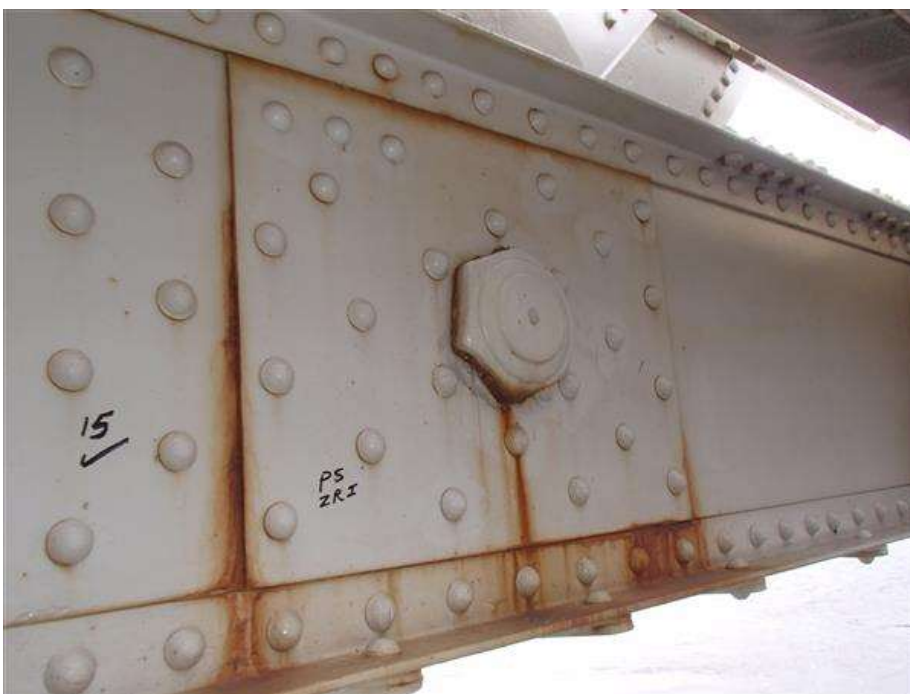
Photo Number: 94

North elevation of panel point L6' of south truss, span 4. Note the bleeding rust and section loss around the pin.

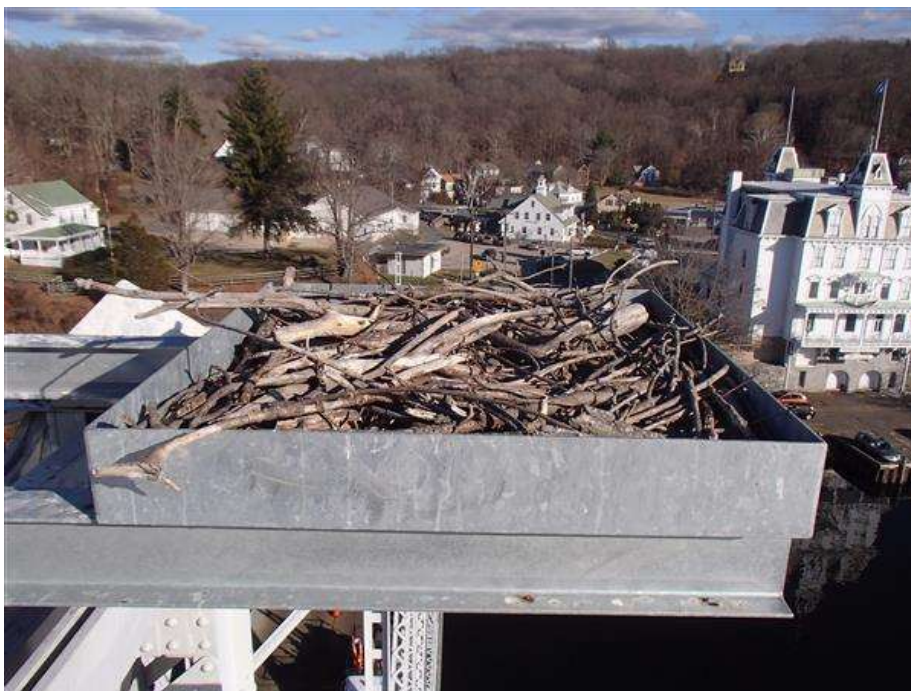
Photo Number: 95

Bird nest on platform adjacent to panel point U10 of south truss, span 3.

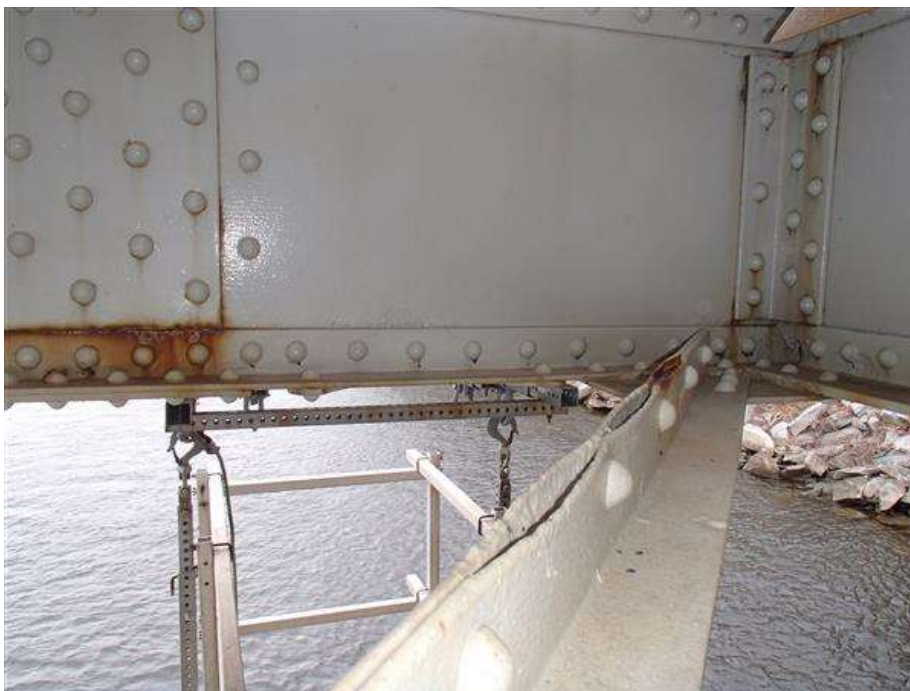
Photo Number: 99

Painted over pack rust with recurring rust between the bracing angles between floorbeams FB8 and FB9 in span 4.

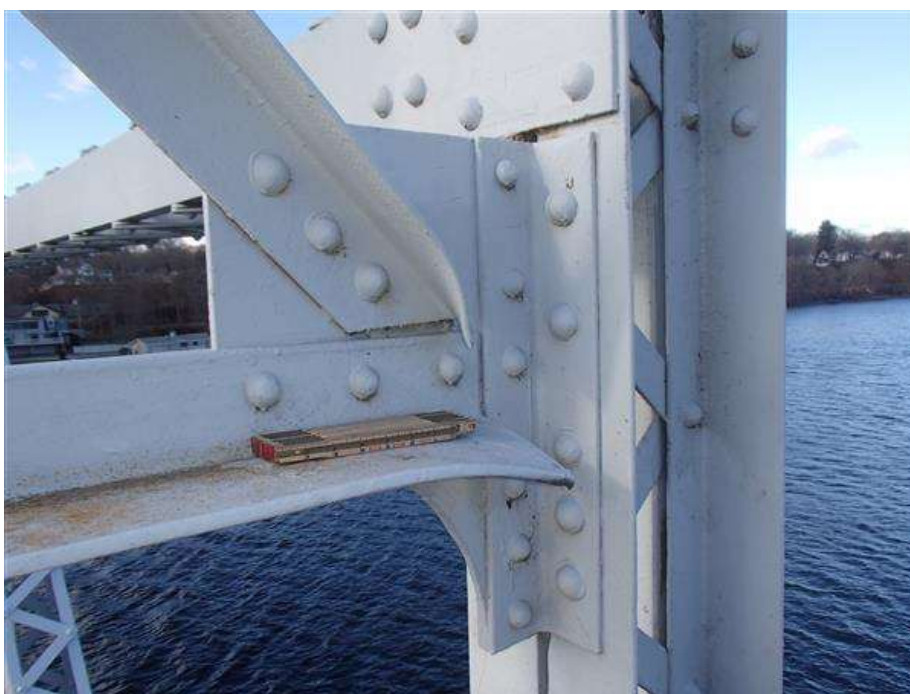
Photo Number: 101

Bent bracing angles adjacent to panel point M6' of north truss, span 2.

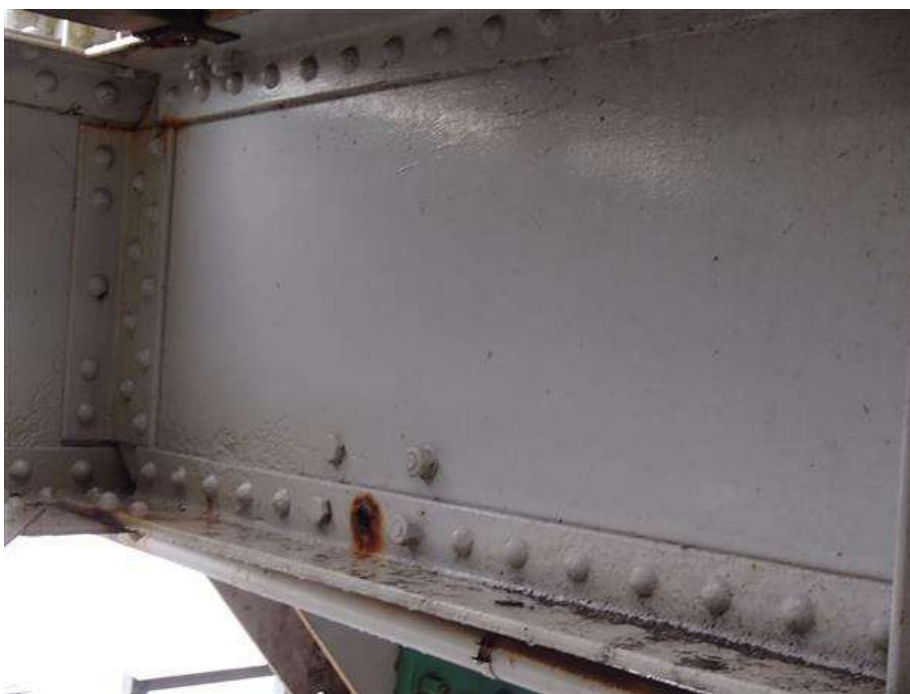
Photo Number: 104

East face of floorbeam FB2 in span 3. Note the missing rivet at the south end of floorbeam web.

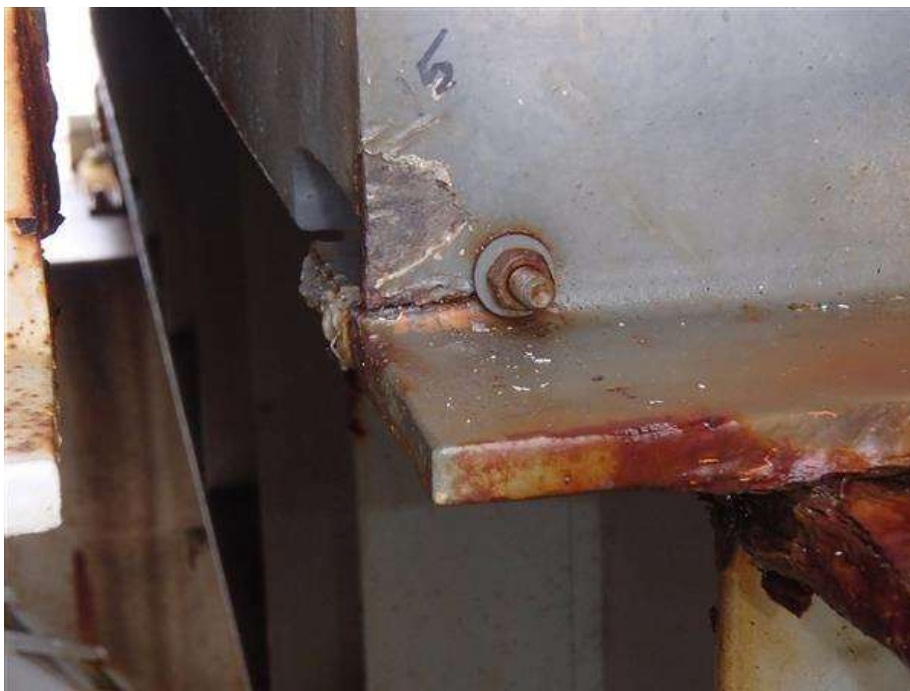
Photo Number: 105

North face of stringer S2 at pier 1 in span 1. Note the repaired crack with a stop hole and bolt since the last inspection.

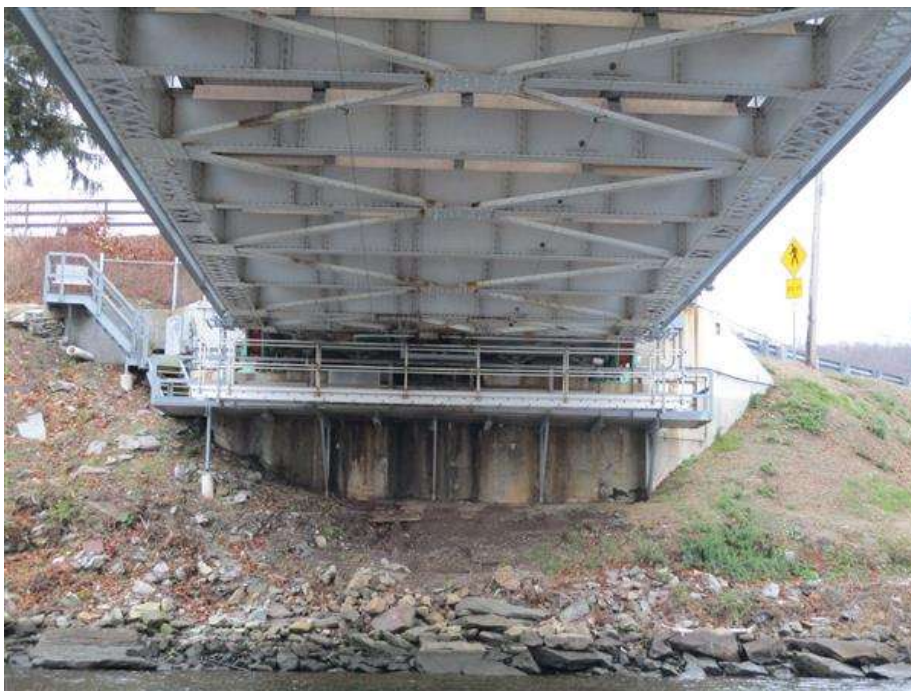
Photo Number: 109

East abutment elevation. Note the evidence of previous leakage and rolling platform along the stem.

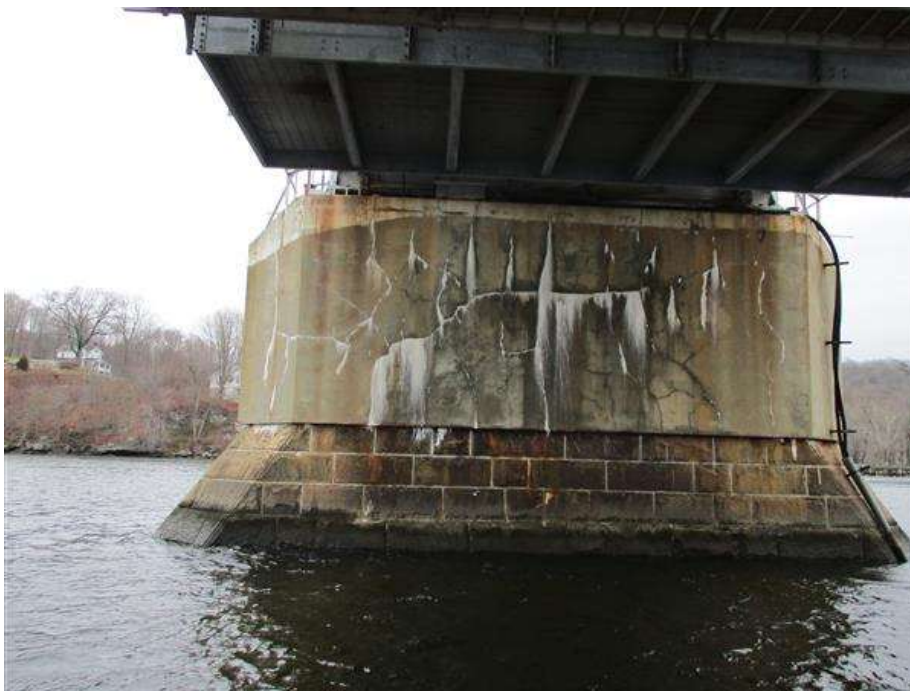
Photo Number: 113

West elevation of pier 2. Note map cracking with efflorescence to concrete cap.

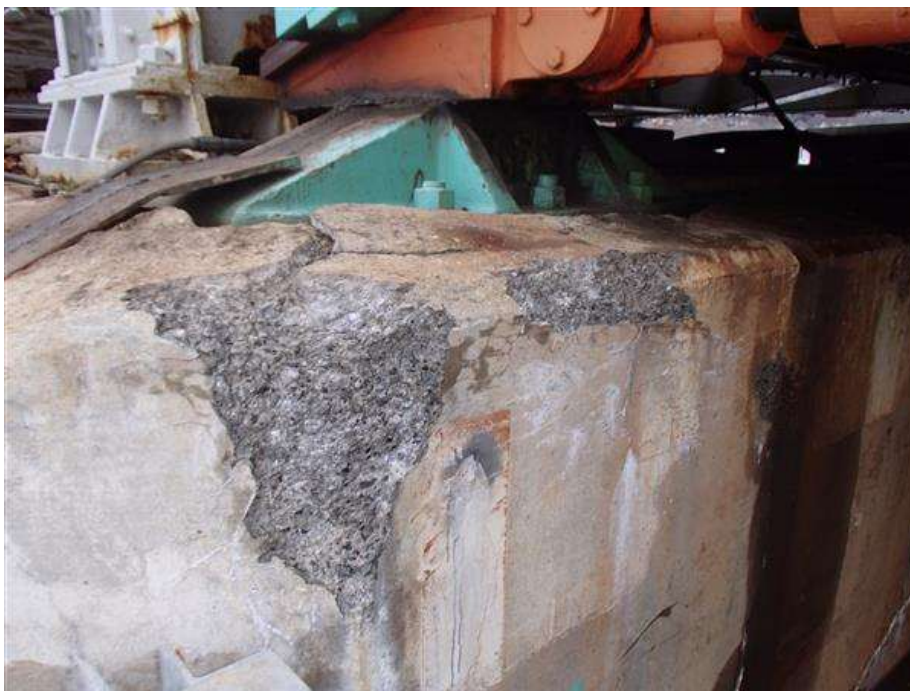
Photo Number: 115

Spall with (2) adjacent areas of scaling at the southwest end of pier 3 cap.

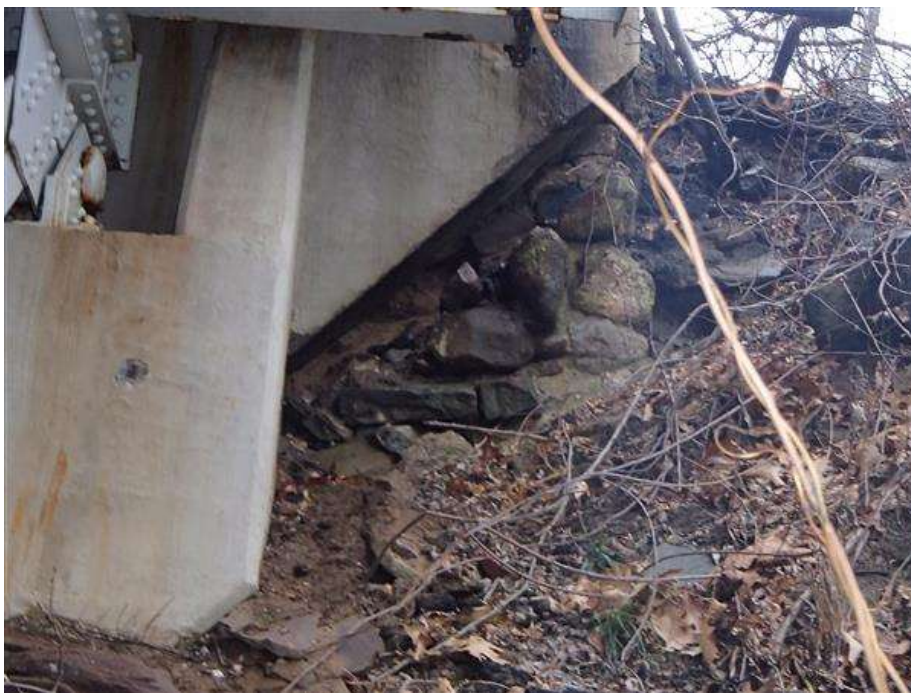
Photo Number: 117

West abutment with erosion area at the north end of the stem.

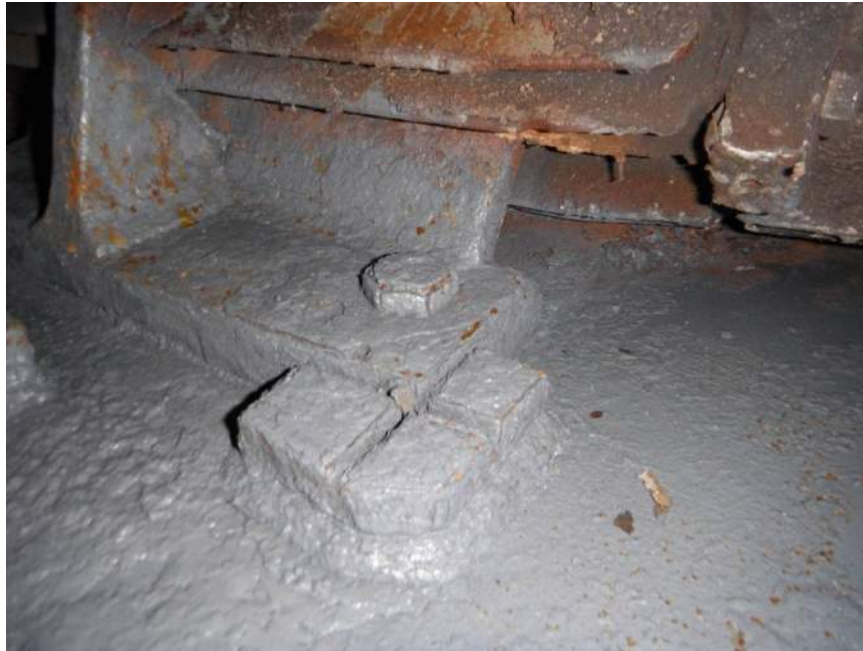
The main drive motors are generally in fair physical condition. Typical on both motors (and most components within the machinery room) was an accumulation of light debris (masonry type materials and road salts) that appears to have originated from the deteriorating overhead structure. There are signs that maintenance has painted some the supports since the previous inspection, which will help slow down the corrosion (see Photograph M01). As noted in the prior report, the overhead structure is the underside of the filled deck panels that form the machinery area roof. Periodic monitoring and painting will help to mitigate additional corrosion on the motors and their ancillary components and extend their service life. At the west motor, the tachometer / overspeed limit switch was reported to have been misaligned in the 2009 report has been corrected with a new coupling insert; however the shaft is still heavily rusted (see Photograph M02). Screws projecting from the west tachometer/overspeed switch cover are interfering with the adjacent jaw coupling (see Photograph M03). This condition may be the cause of the noisy operation of the span drive machinery. This condition could potentially lead to damage of the electrical instrumentation and should be corrected. Additional paint repairs / application is recommended on various components of these units.

**Photo M01:** Close-up view east span drive motor mounting foot showing signs of new paint when compared to prior report photographs. Still signs of minor corrosion and debris from overhead. Note minor debris buildup on motor housing cooling fins.

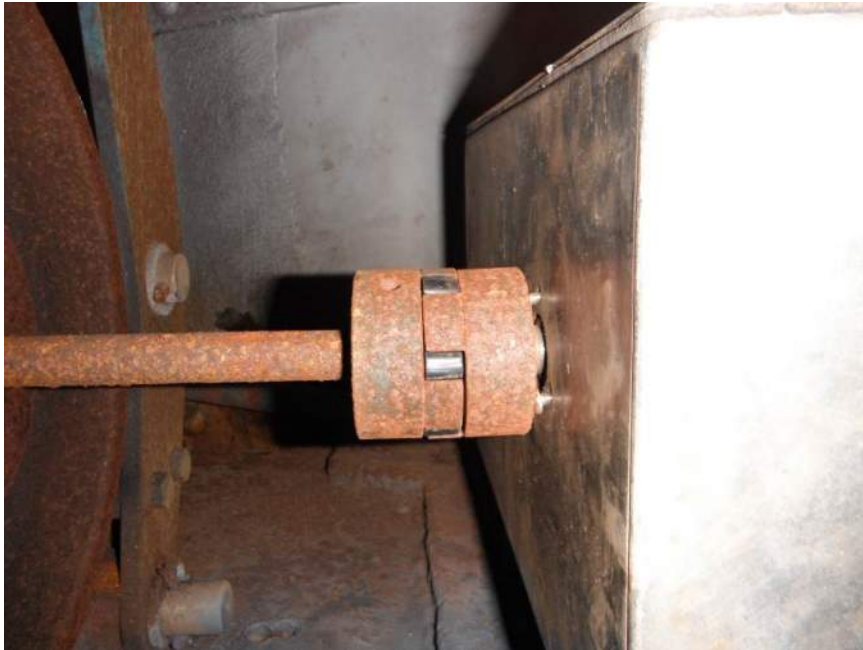
**Photo M03:** Tachometer / overspeed switch cover screws interfering with coupling

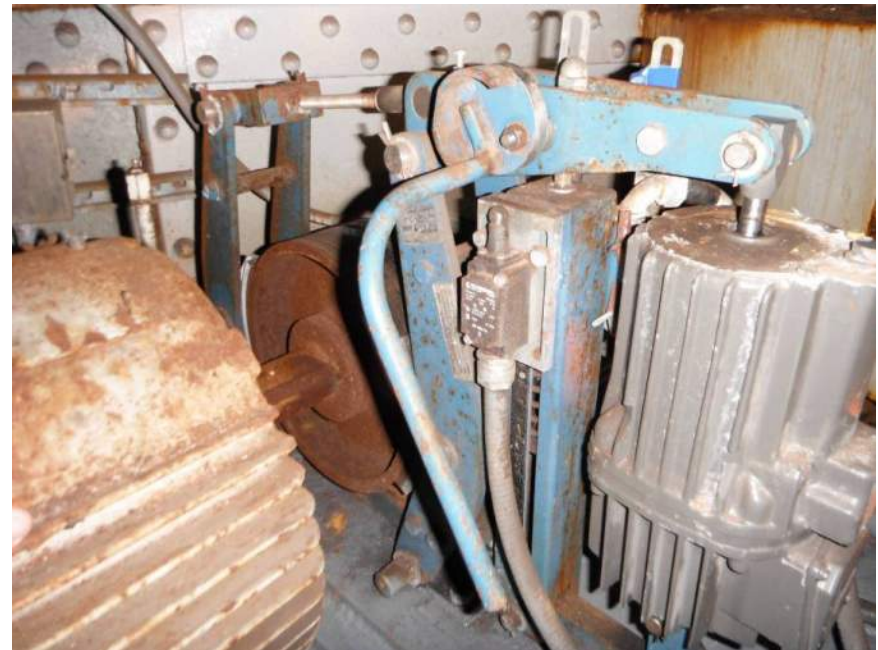
The motor brakes are in fair condition (see Photograph M04). As previously noted, light debris on these units is causing various levels of corrosion to them and their ancillary components. The thrustors on both brakes have exhibited surface corrosion since being replaced between the 2009 and 2014 inspections. Per previous reports, the non-contacting surfaces of the east and the west motor brake wheels exhibit moderate to heavy corrosion with no paint on the face of the wheels and stub shafts (see Photograph 05). The east motor brake wheel braking surface exhibits moderate scoring and the west motor brake wheel exhibits minor grooving on the braking surface. The west brake shoe of the east motor brake does not fully release when the manual release lever is actuated. The manual release levers do not lock in the released position. No brake covers are installed. Paint repairs / application are required on various components of these units. The brake linkages should be adjusted and the brake torques should be physically verified and reset as needed to match the settings indicated in the contract documents and so as to achieve desirable performance of the swing span.

**Photo M04:** General view of east span drive motor brake.

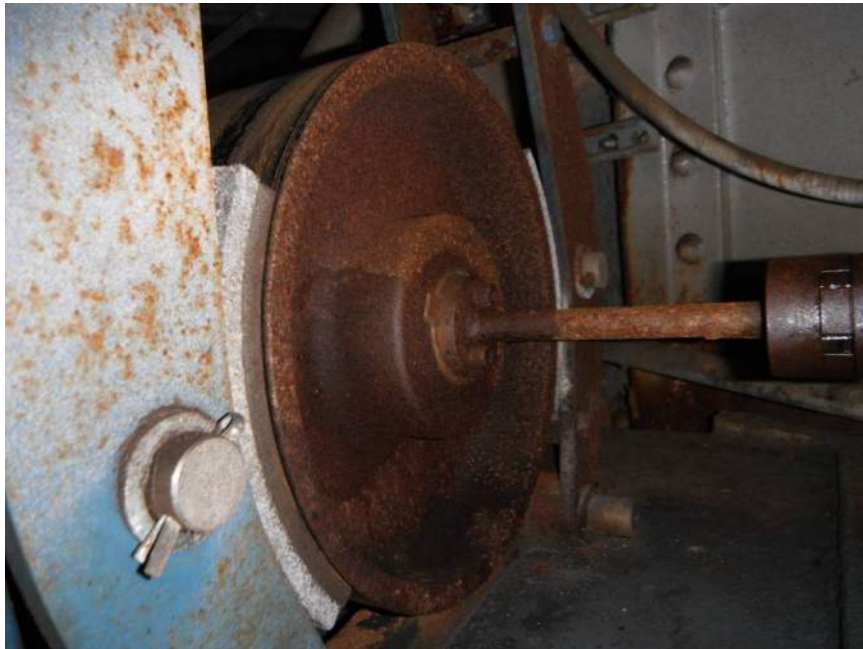
**Photo M05:** View of west motor rear extension shaft coupled to tachometer/overspeed switch assembly. Note lack of paint protection and light to moderate surface corrosion throughout.

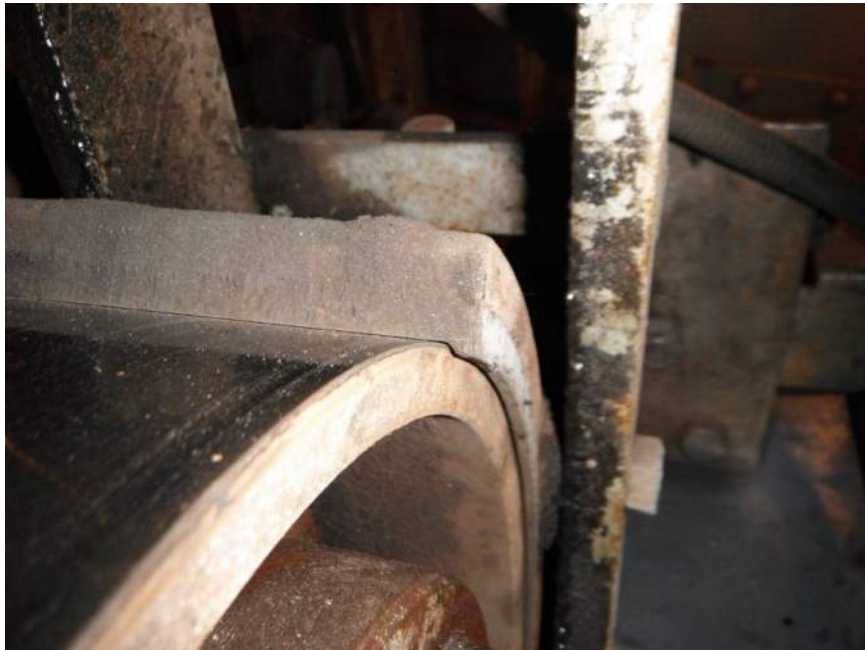
**Photo M07:** View of west machinery brake lining overhanging the brake wheel.

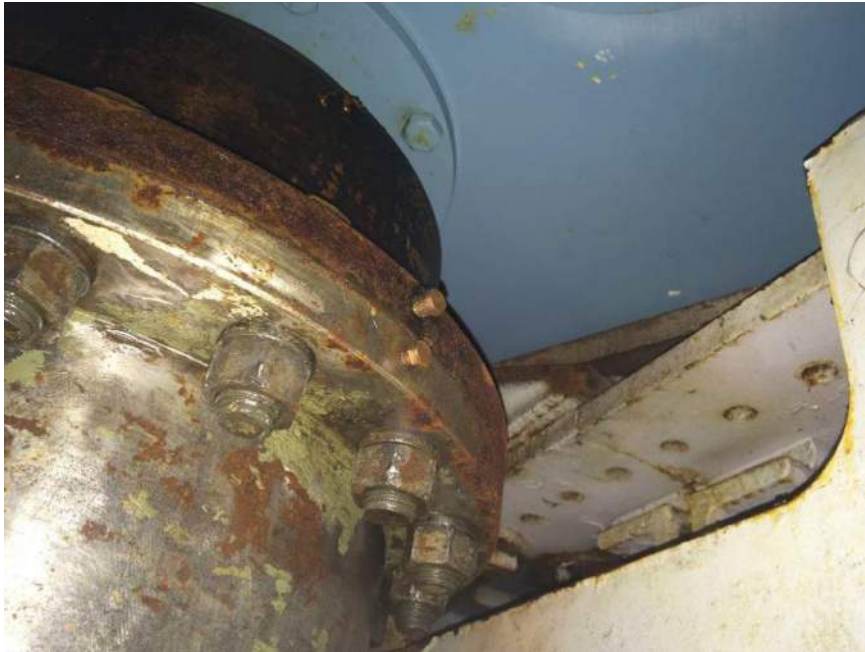
The pinion shaft couplings are in fair condition. As noted during the past inspection, both east and west pinion shaft couplings exhibit minor to moderate grease leakage at the lower hub seal (see Photograph M08). The covers on both pinion shaft couplings are unpainted and exhibit light rust. The lubrication purge ports are oriented 180 degrees from the grease fittings. These ports appear to be in use by ConnDOT maintenance forces (see Photograph M09).

**Photo M09:** Close-up of purge plugs on west main pinion shaft coupling – plugs show signs of recent movement from maintenance activities.

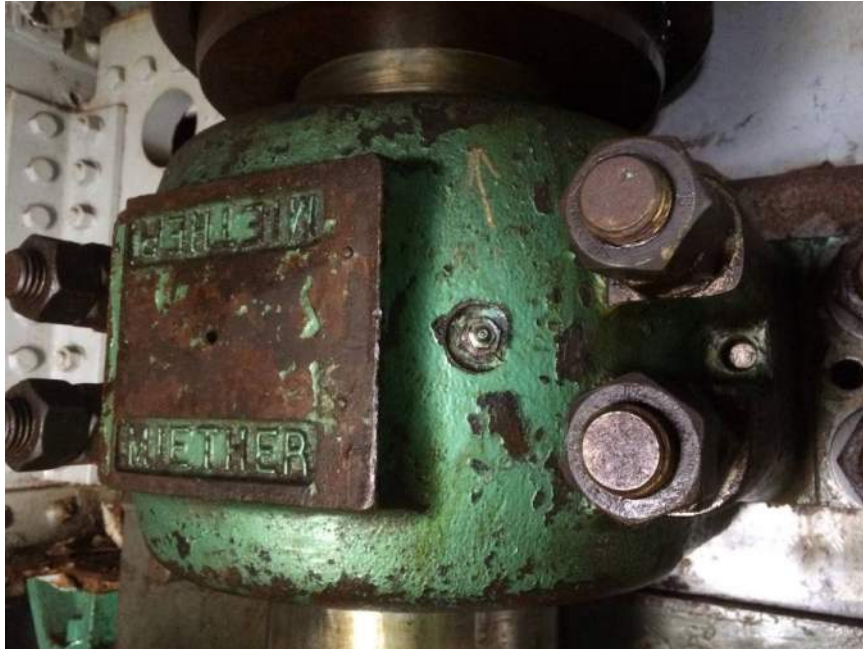
The pinion shaft bearings are in good condition. Both upper and lower bearings on both shafts exhibit minor to moderate surface corrosion (see Photographs M13 and M14). The open holes in the lower bearing face should be sealed with a silicone sealant to prevent debris and moisture. None of the bearing mounting bolts have lock washers or double nuts and all are unpainted. Despite this, there are no indications of relative movement or loosening between the bearing housings and their mounting baseplates. Paint should be field applied to these bearings and their mounting and cap bolts. Note that surface preparation should be limited to solvent cleaning or hand tool cleaning. As indicated in Photograph M15, the east bearings both have supplementary mounting/retaining bolts with a single nut, which were part of a prior repair. This hardware appears to be of unpainted stainless steel and is in good condition.

**Photo M13:** View of west upper pinion shaft bearing.

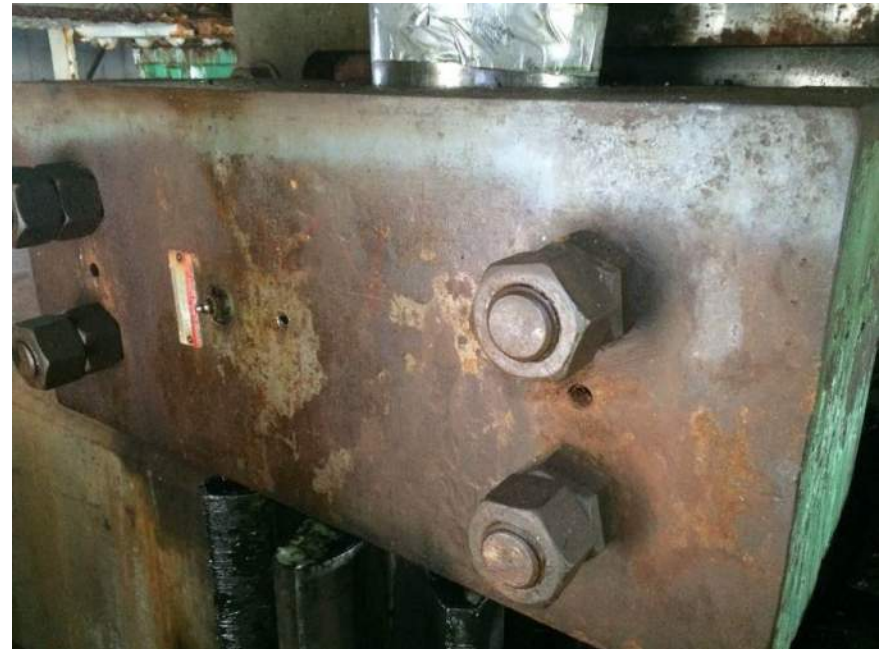
**Photo M14:** View of east lower pinion shaft bearing. Note three open holes in face.

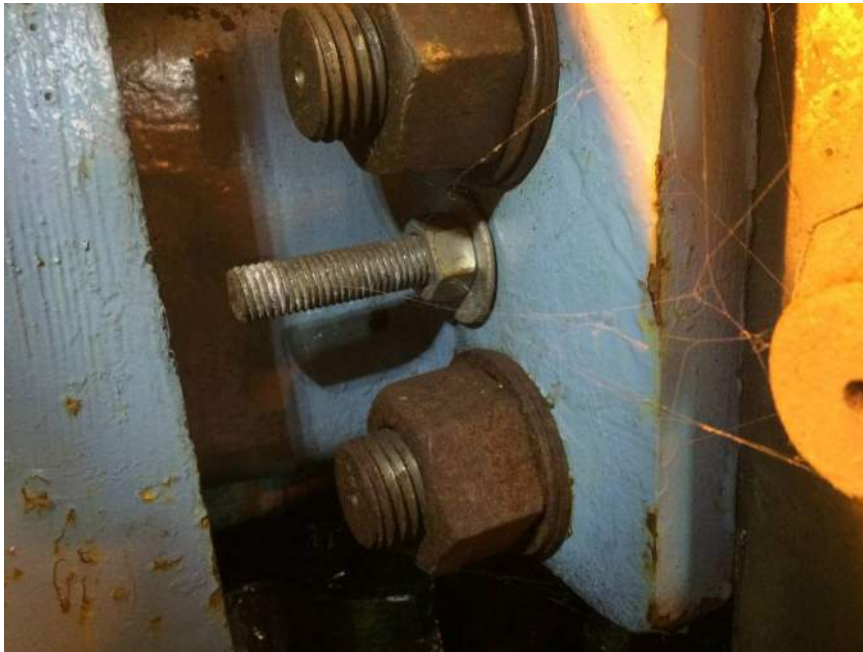
**Photo M15:** Note additional mounting bolt, likely from prior repair or replacement work.

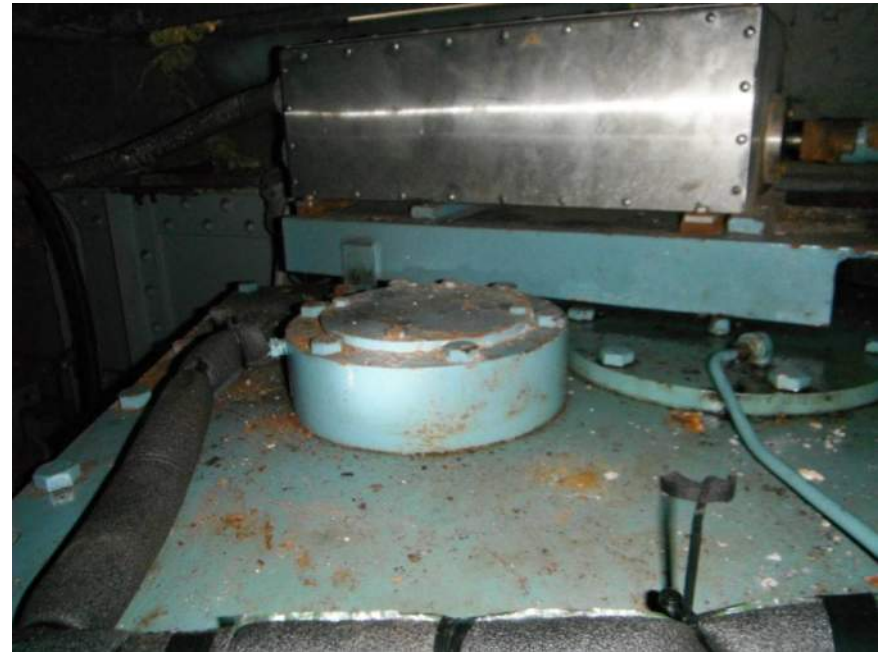
The reducers generally are in good condition (see Photograph M16). As previously noted, light debris on these units is causing various levels of corrosion to them and their ancillary components, particularly their mounting bolts. The desiccant breather on each reducer is brown-green in color and should be replaced (see Photograph M17).

**Photo M16:** View of east span drive enclosed speed reducer. Note debris accumulation and surface corrosion on top of unit.

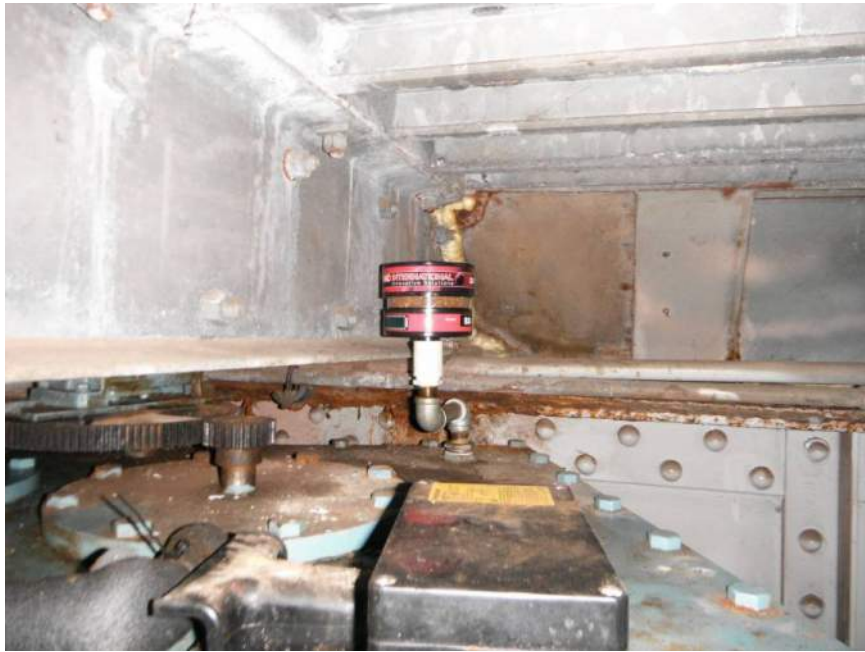
**Photo M17:** View of east span drive reducer desiccant breather requiring replacement.

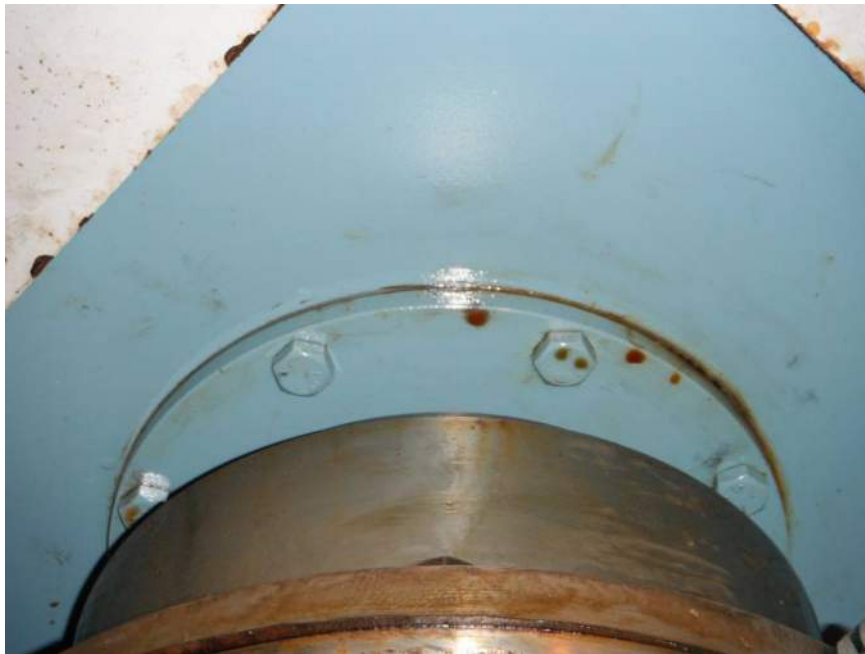
There are signs of possible oil seepage at the vertical output shaft lower seal at the east speed reducer (see Photograph M19). This condition does not appear to have worsened since the previous inspection. This condition should continue to be monitored by maintenance forces and as part of future inspections.

**Photo M19:** View of possible light oil seepage from east enclosed speed reducer output shaft bearing.

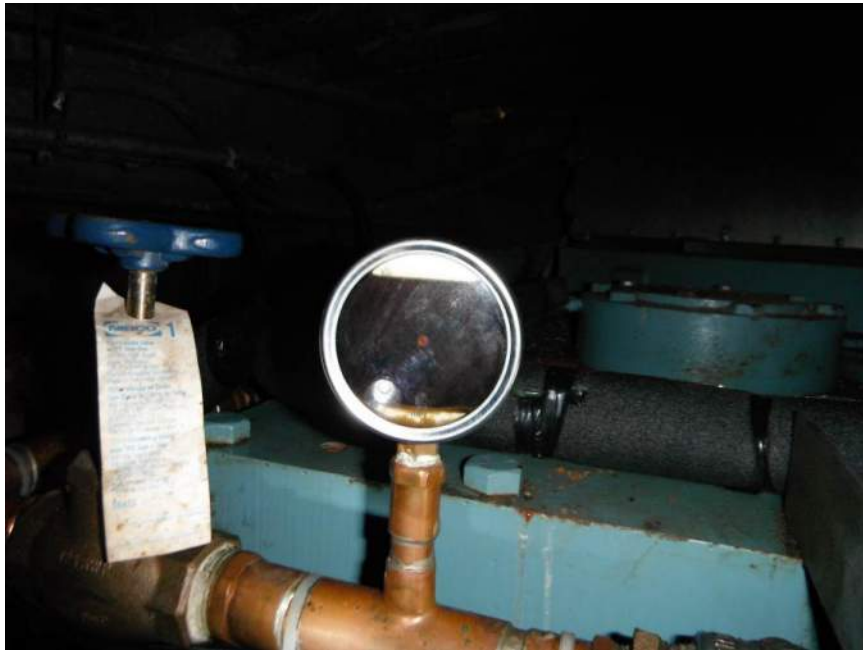
**Photo M21:** East circulating pump oil gauge with coagulated oil

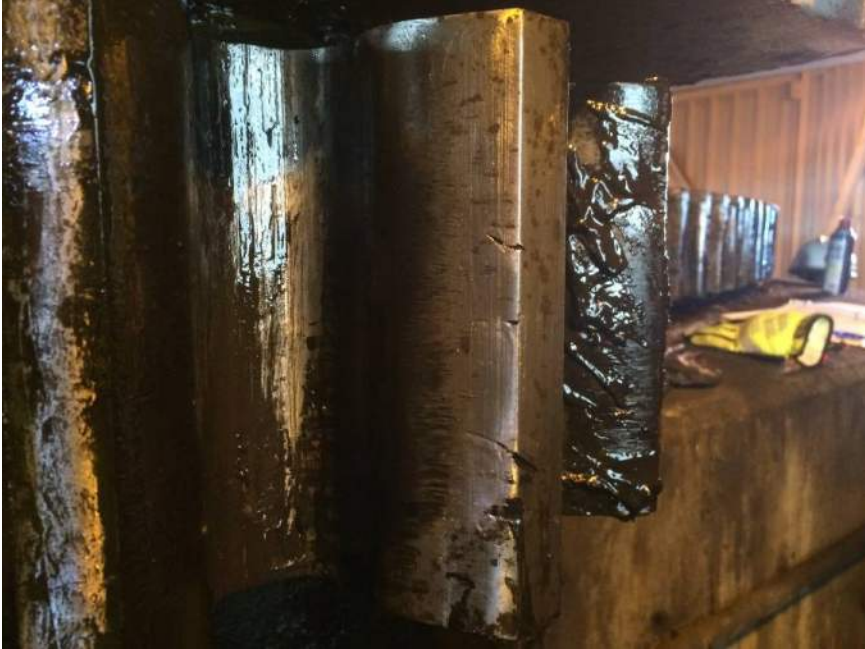
<p><b>Photo M23:</b> Closeup view of closing face of east main pinion gear showing past impact damage in addendum and topland of tooth.</p>		<p><b>Photo M24:</b> Close up of opening face of west main pinion gear tooth. Note pitting and scoring</p>
