# REHABILITATION STUDY REPORT

State Project No. 40-141  
Bridge No. 01138 in East Haddam  
Route 82 over Connecticut River

State of Connecticut  
Department of Transportation  
Newington, Connecticut

*Submitted:* April 2017

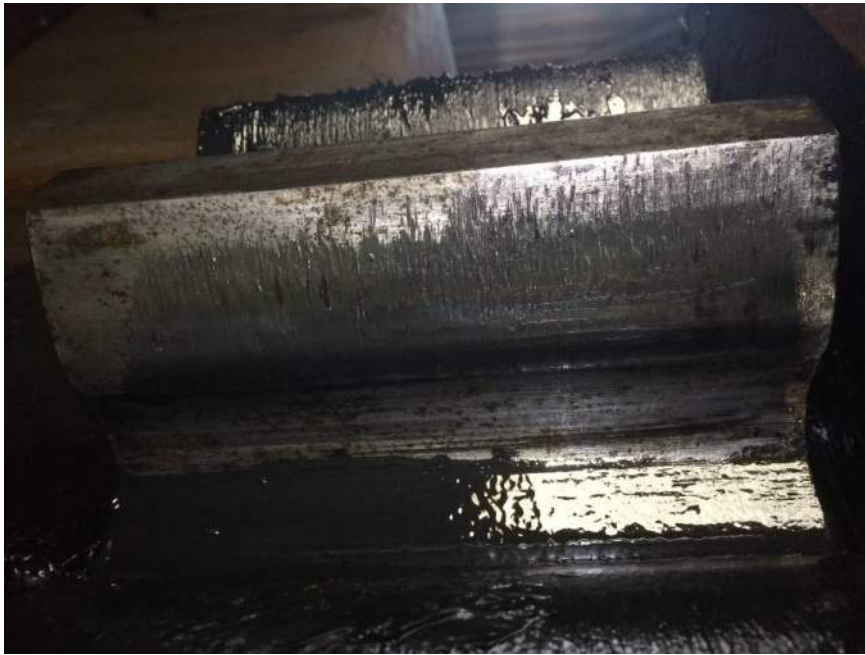
**Photo M25:** Close up of closing face of west main pinion gear tooth.

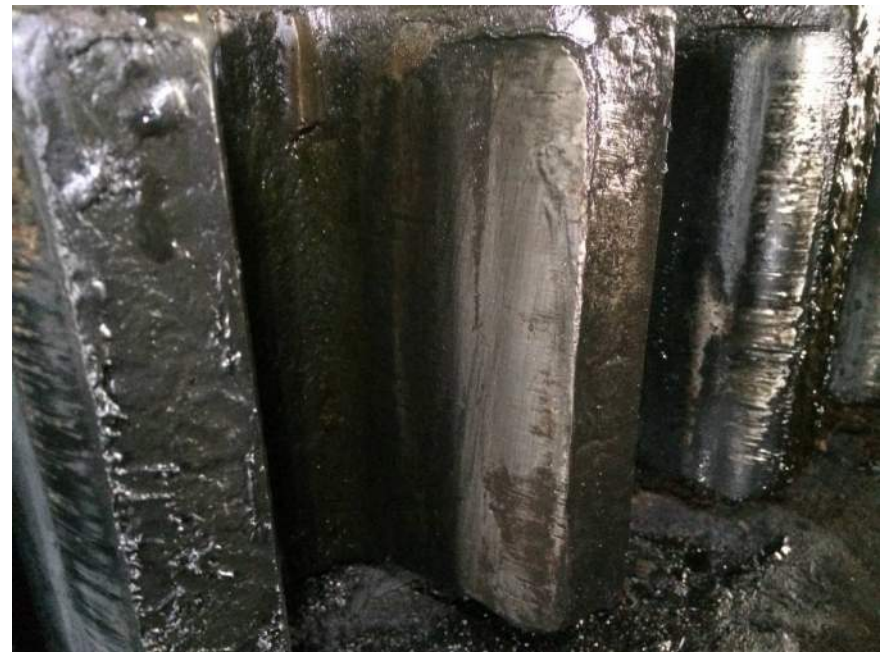
The gear teeth on the east and west sides of the rack assembly generally show signs of moderate wear and appear unchanged since the 2011 inspection. East rack teeth exhibit moderate plastic flow with the creation of metal ridges on the closing face near the fully closed position. West rack teeth near the fully closed position exhibit minor full face tip flow and minor to moderate plastic flow across the whole closing face. At the near fully open position, west rack teeth exhibit heavy full face tip flow with minor to moderate plastic flow across their entire face (see Photographs M26 and M27). Minor to moderate pitting is present in the dedendum.

**Photo M26:** Close up of closing face of west rack gear tooth in segment #10, near where the west pinion engages the rack at fully open position.

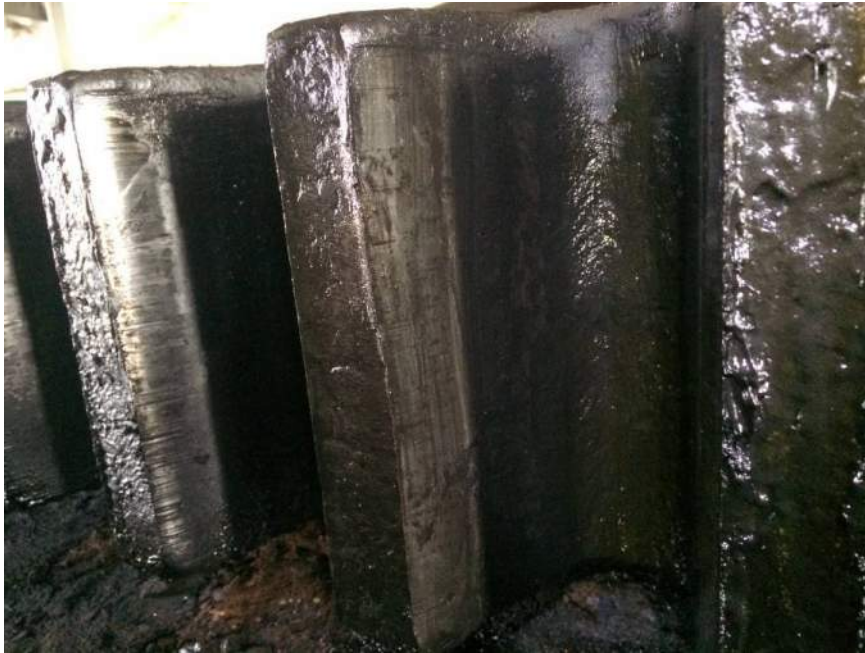
**Photo M27:** Close up of opening face of west rack gear tooth in segment #10, near where the west pinion engages the rack at the fully open position.

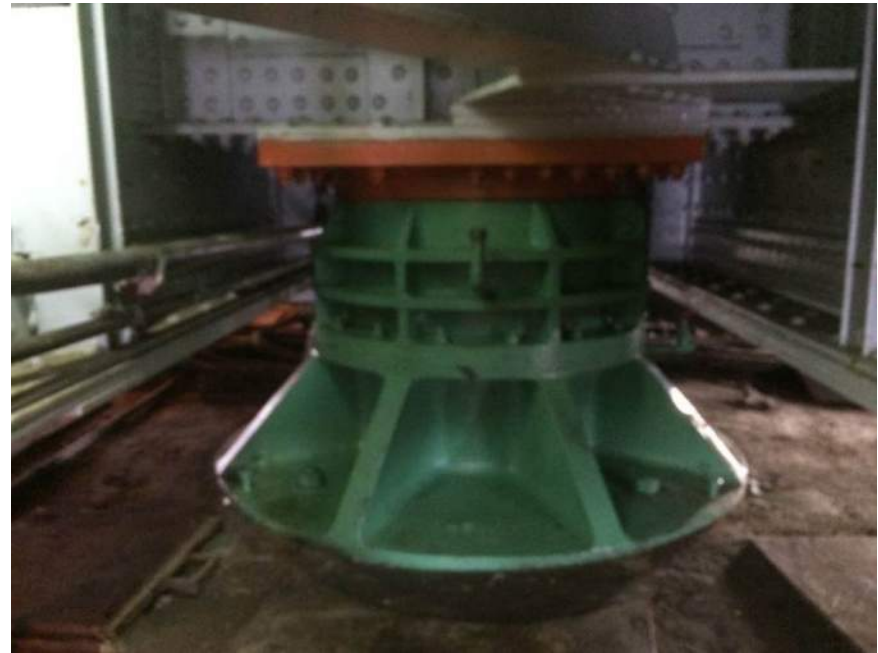
The center bearing assembly is in good condition overall (see Photograph M28). Paint system is in good condition with some minor areas of chipped paint. No oil level gage could be located. It is recommended that such a gage be installed. The previously noted oil leak on the north side of the fill elbow appears to have been fixed.

**Photo M28:** View looking south at center pivot bearing.

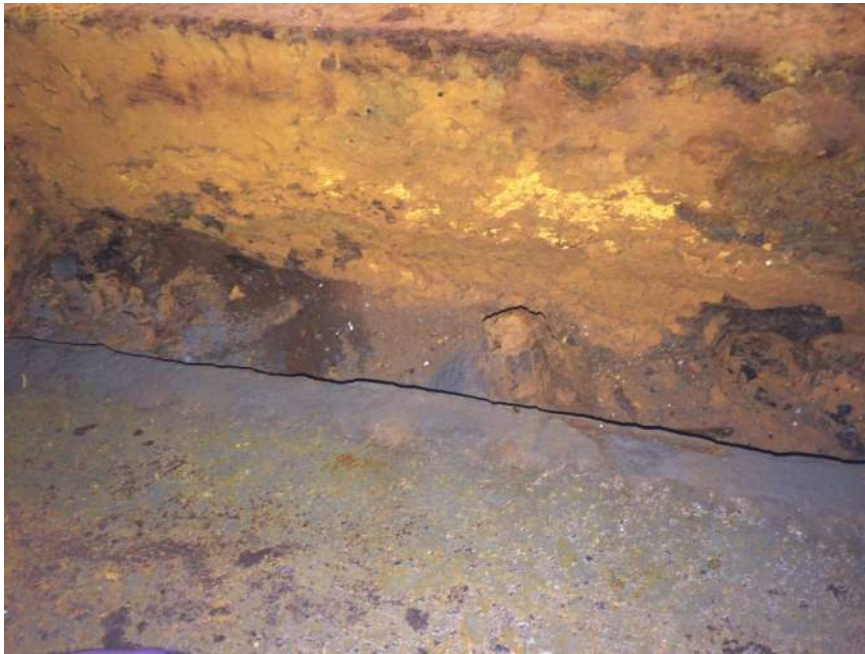
The track is generally in adequate condition. There are six drainage holes within each segment; including Segment 7 (see Photograph M29) which was indicated in the past report to be blocked with debris. It appears all segments were cleaned of debris buildup. Of the 128 anchors that secure the circular rack and track, rough 1/4 exhibit 80% or higher levels of section loss and a little over 1/3 exhibit 50% or higher levels of section loss. This condition is similar to the last report but should be monitored for any signs of further section loss. There are isolated indications of flaking of the track tread surface, suggesting high localized stresses due to intermittent contact between the balance wheels and the track.

**Photo M29:** Closeup view of rack/track segment #7, note debris buildup in casting pockets has been removed.

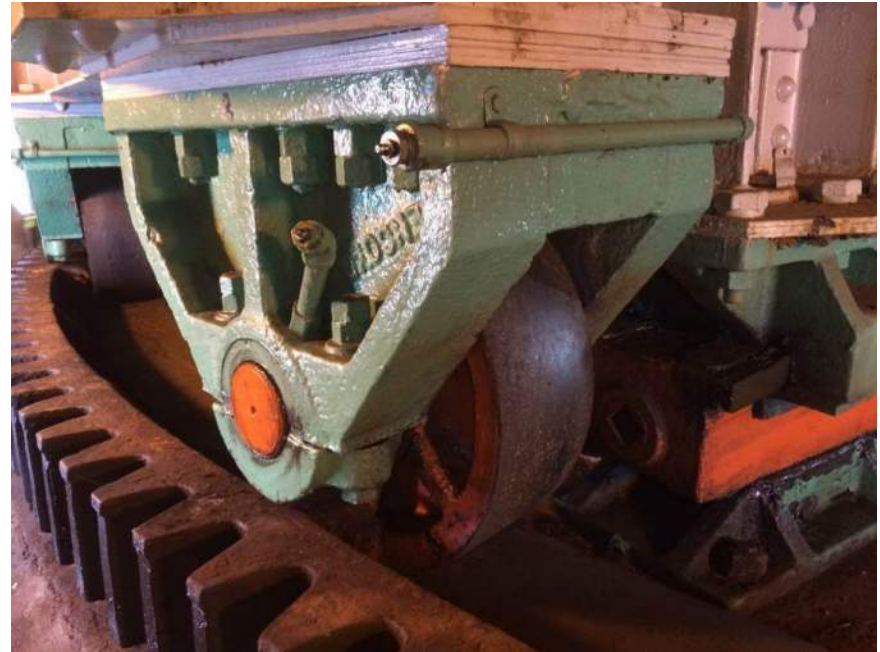
The balance wheel assemblies are in good condition (See Photograph M30). Bearing clearances were checked and minimal wear was detected. Wheel clearances with the track were checked with an average clearance of approximately 1/16 inch except for Wheels 6 and 7 (east pair), these wheels have no clearance. Axle clearance measurements were taken at the inboard and outboard bearings of each wheel. A majority of the axle clearances were at or below an ANSI RC6 running class fit. Those few clearances which are greater than this fall within an ANSI RC9 running class fit, which is typically considered a maximum permissible limit for worn equipment.

**Photo M30:** Looking at South East balance wheel

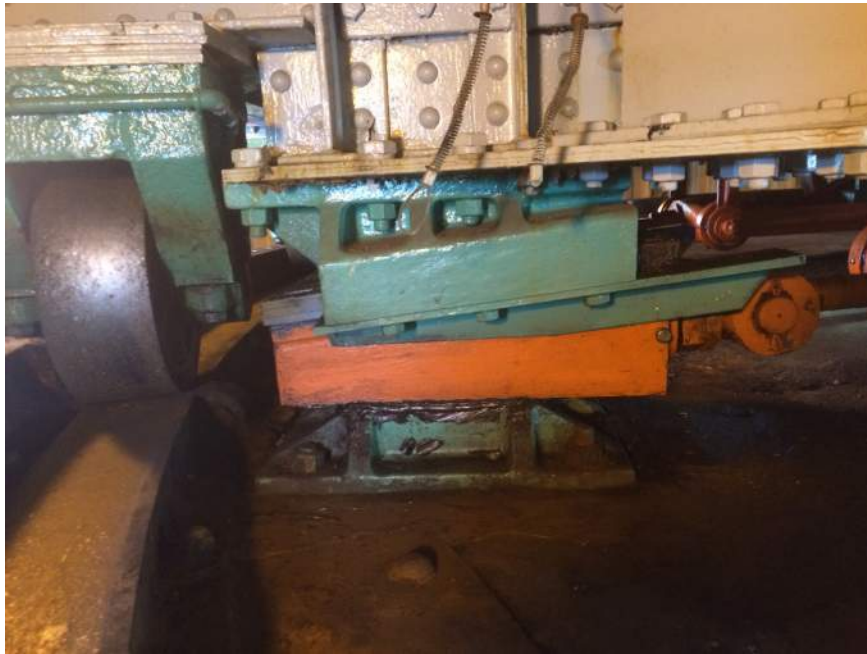
The center wedges are in good condition overall (see Photograph M31). In general, the paint protection on the majority of the center wedge components is in very good condition. In isolated areas, principally near the gearmotors, reducers, etc., light debris on components is causing various levels of surface corrosion.

**Photo M31:** View looking east at SE center wedge assembly.

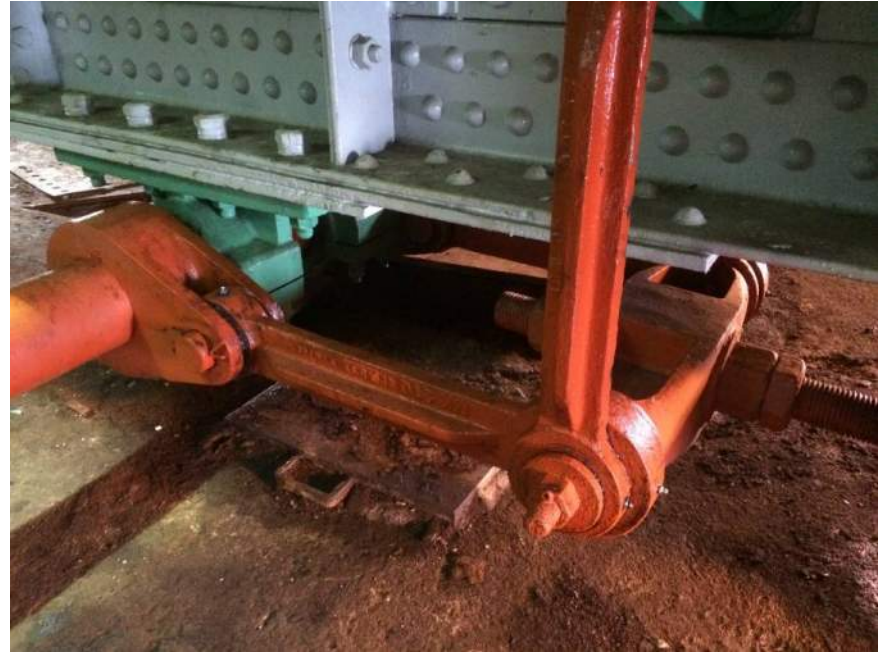
**Photo M32:** View looking west at NW center wedge lower crank/connecting rod assembly.

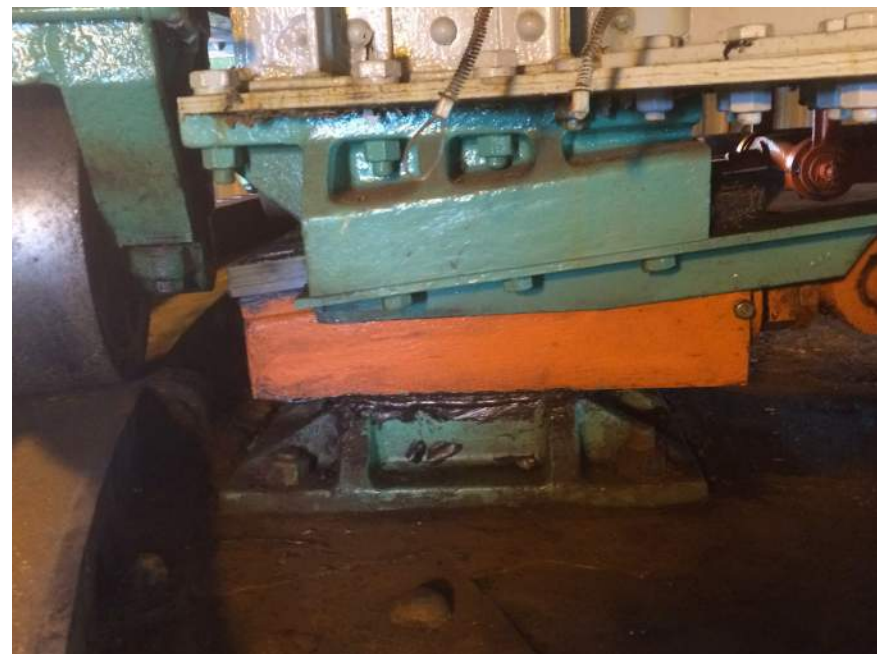
**Photo M34:** Corrosion on mounting bolts at SE wedge.

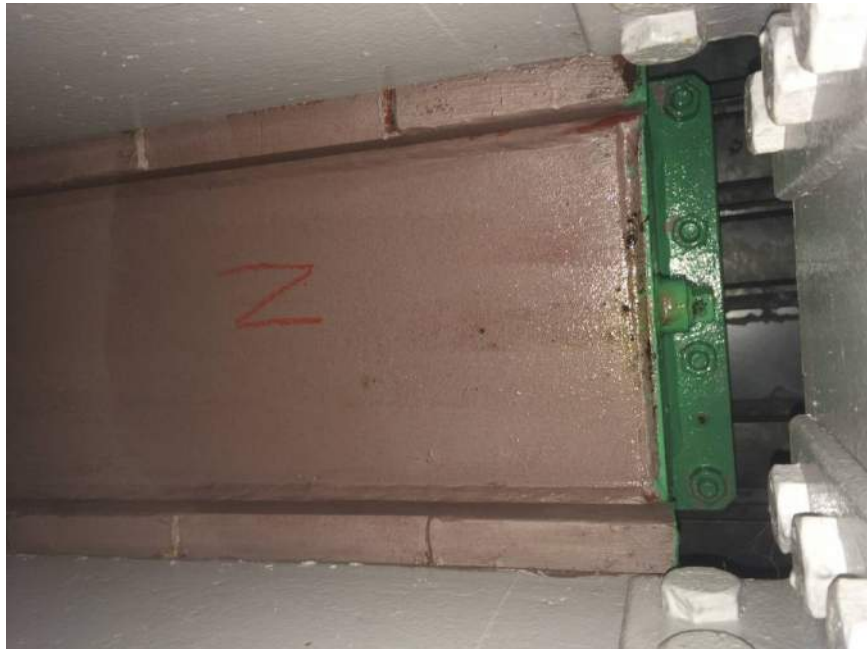
**Photo M35:** View looking up and south at underside of north center wedge gear reducer. Note presence of primer coat only as noted during prior inspection.

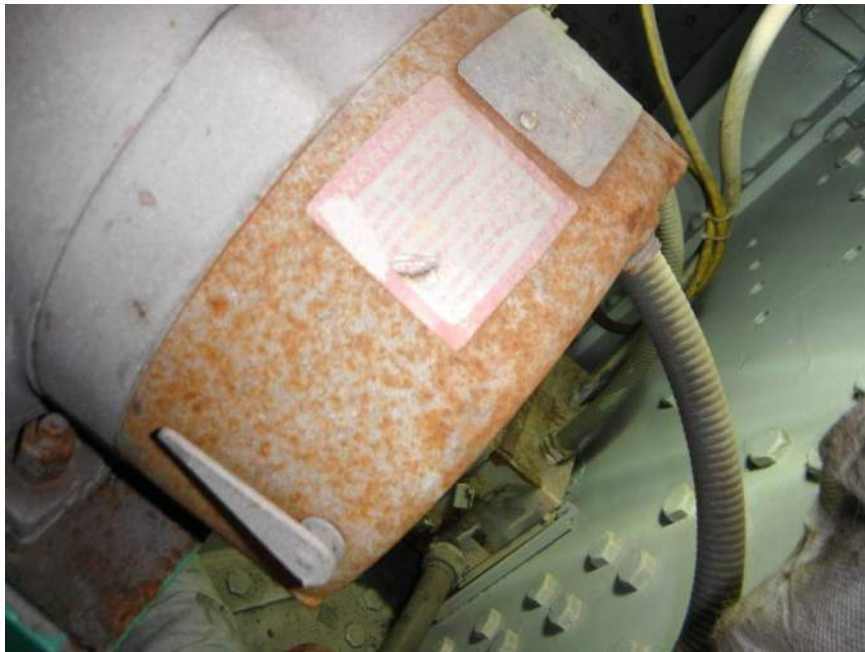
**Photo M37:** View of north center wedge brakemotor housing. Note lack of paint protection and developing surface corrosion.

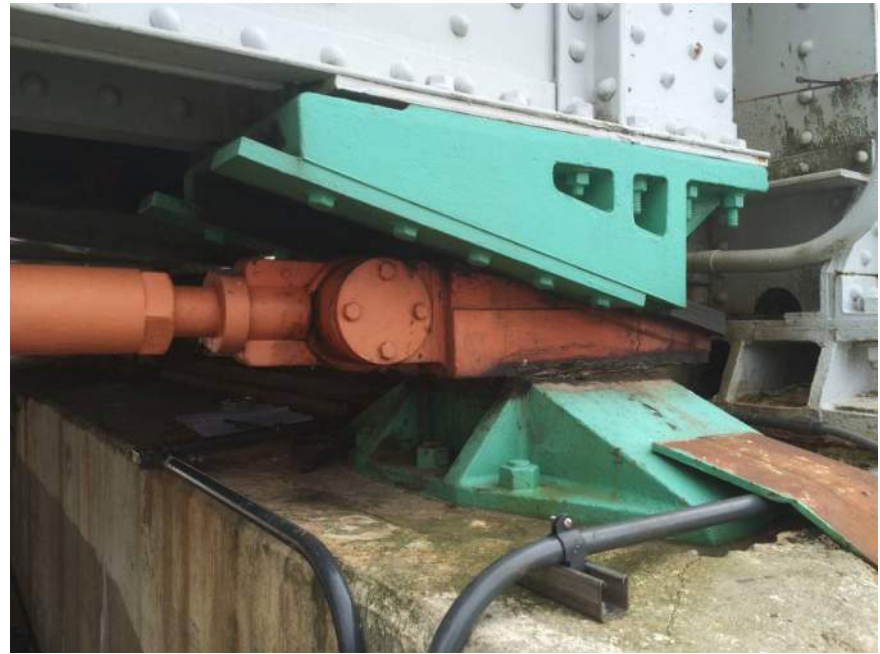
**Photo M44:** View looking south at NW end wedge assembly.

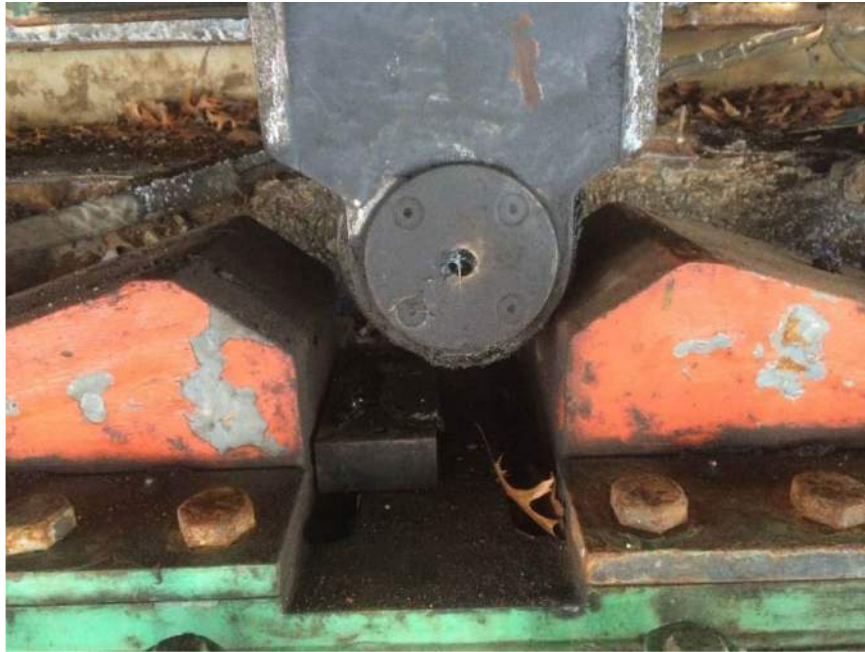
**Photo M45:** View of east end latch receiver. Note that spring loaded sliding socket blocks are displaced and latch does not fully seat.

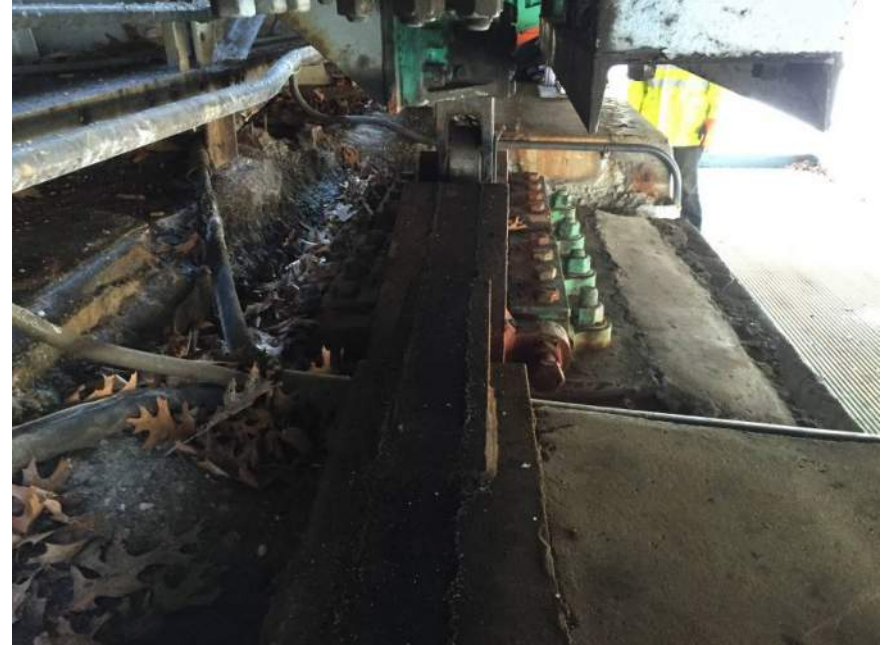
**Photo M46:** View of east latch not fully seated. Roller on latch follows the steel plates to return back to receiver as the latch does not fully retract to clear the pier prior to the socket blocks.

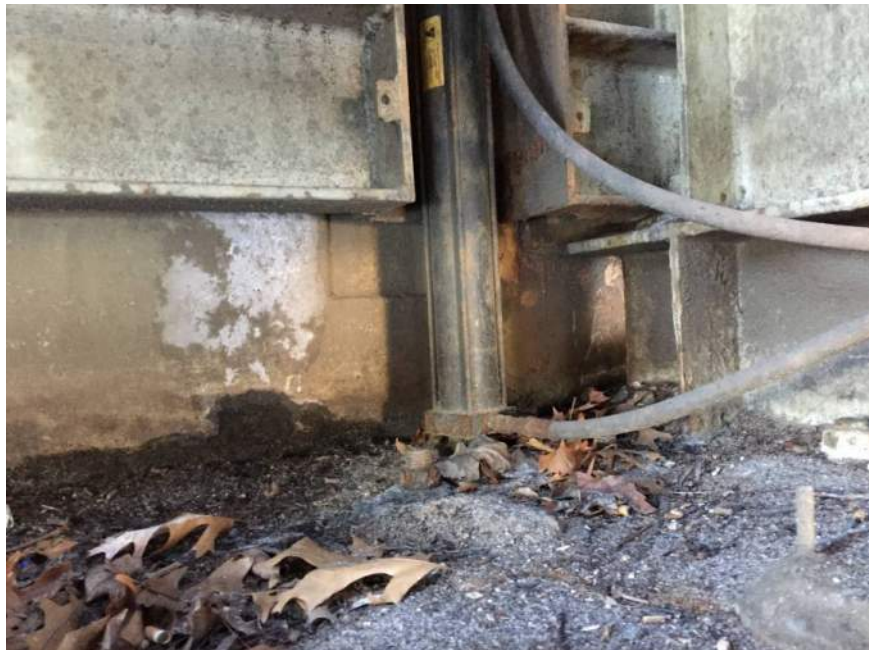
**Photo M47:** View of NE barrier gate piston with corrosion at base.

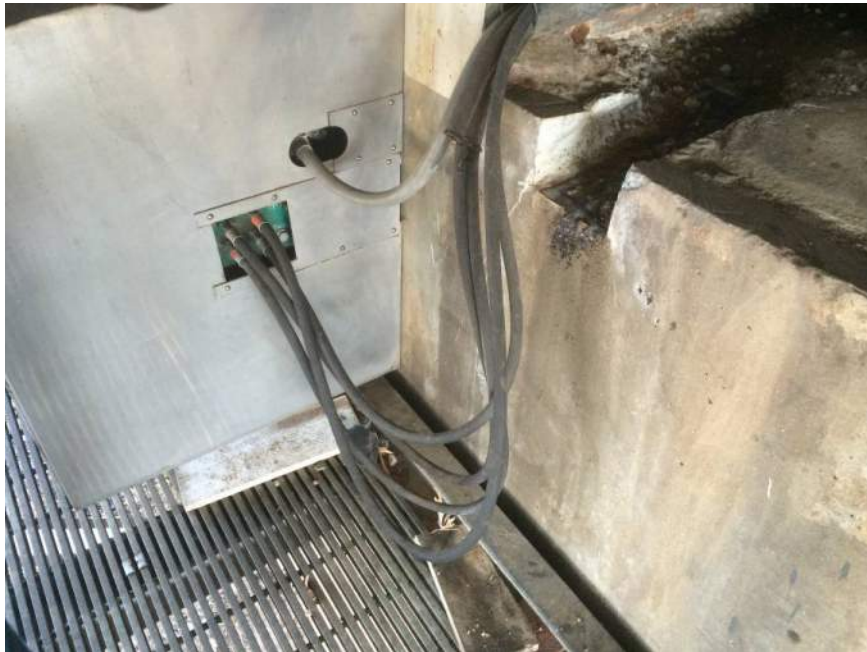
**Photo M49:** View of W barrier gate hydraulic tubing without heat tracing. Tubing at the west gate can be felt pumping under live load.

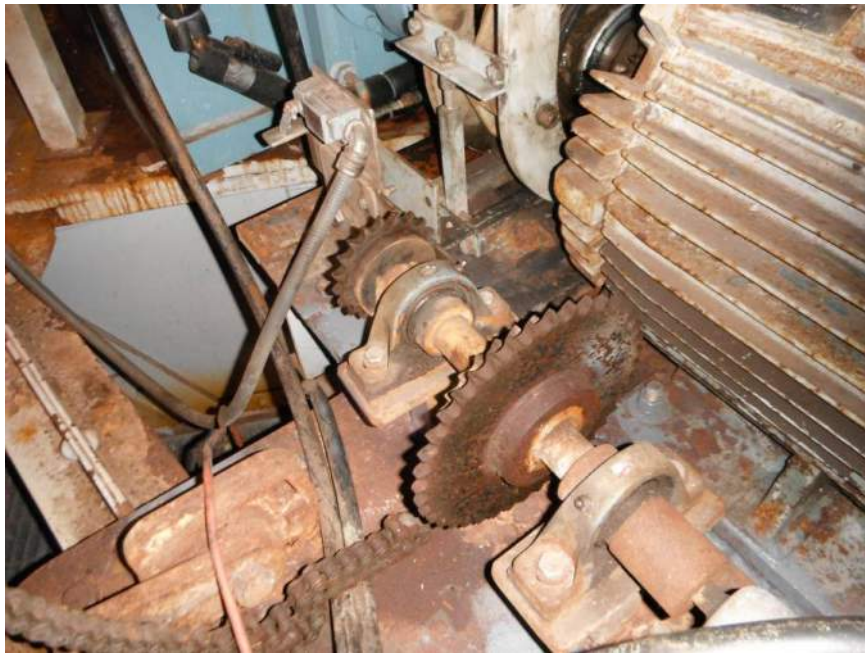
**Photo M51:** View of west auxiliary drive air motor and sprocket attachment

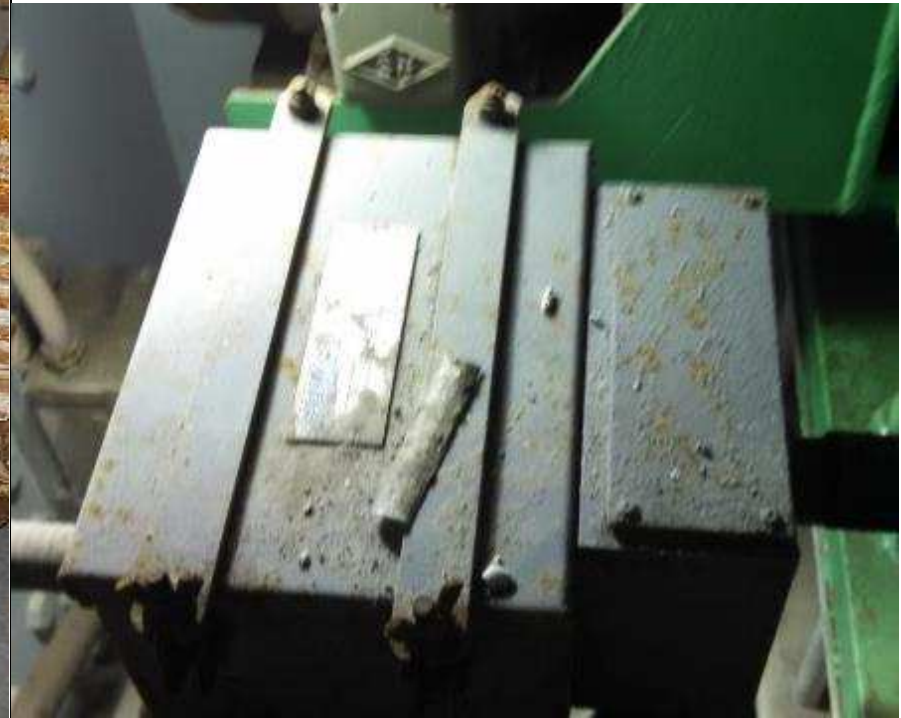
Photo E 2 Typical Rotary Cam Limit Switch Enclosure

Note Corrosion on the exterior of frame.

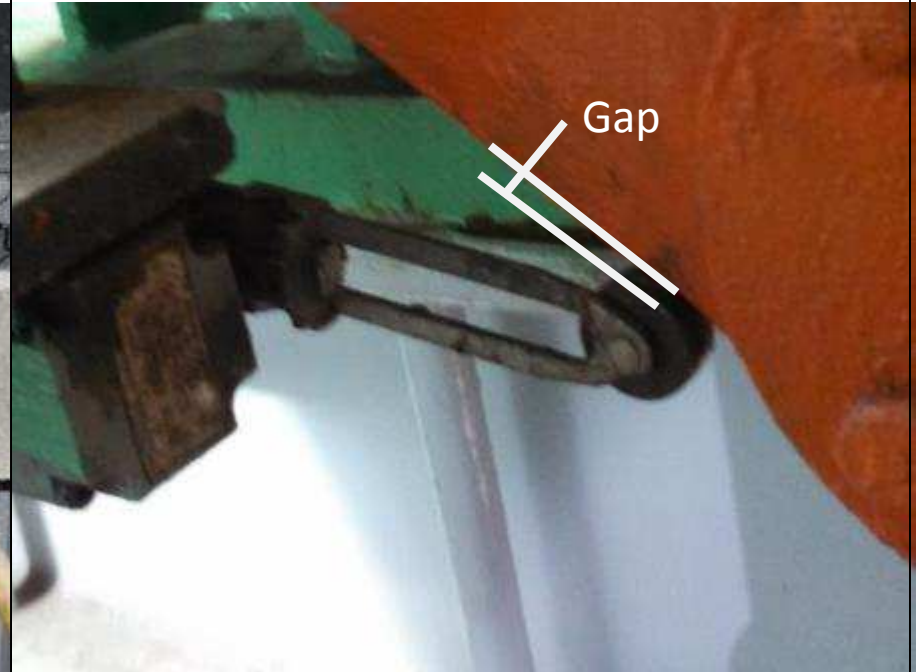
Photo E4 East Side Wedge Limit Switch  
Note that the switch arm is not making contact with the axel. .

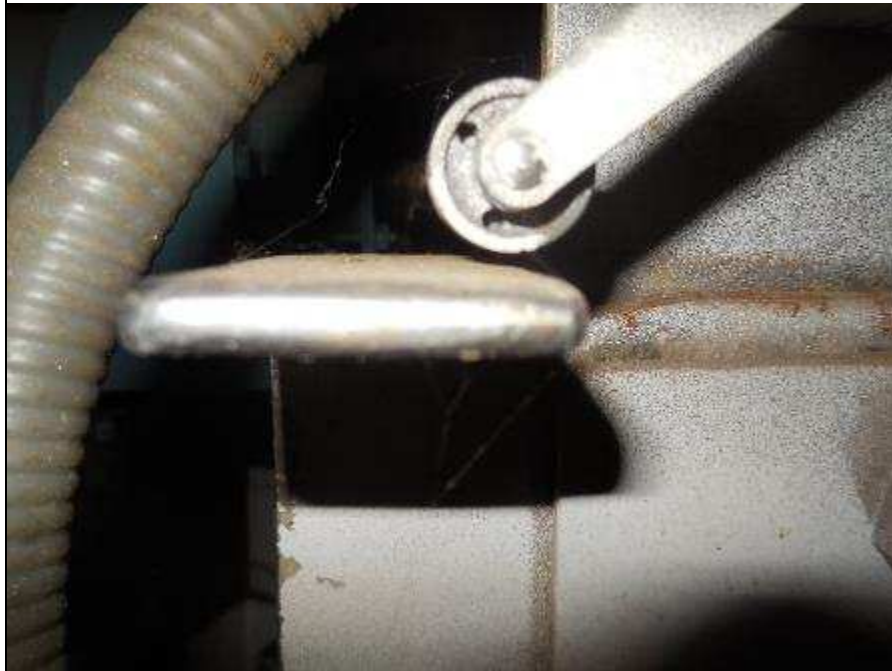
Photo E 5 East Motor Brake Limit Switch

Note that the limit switch is not making contact with the strike plate.

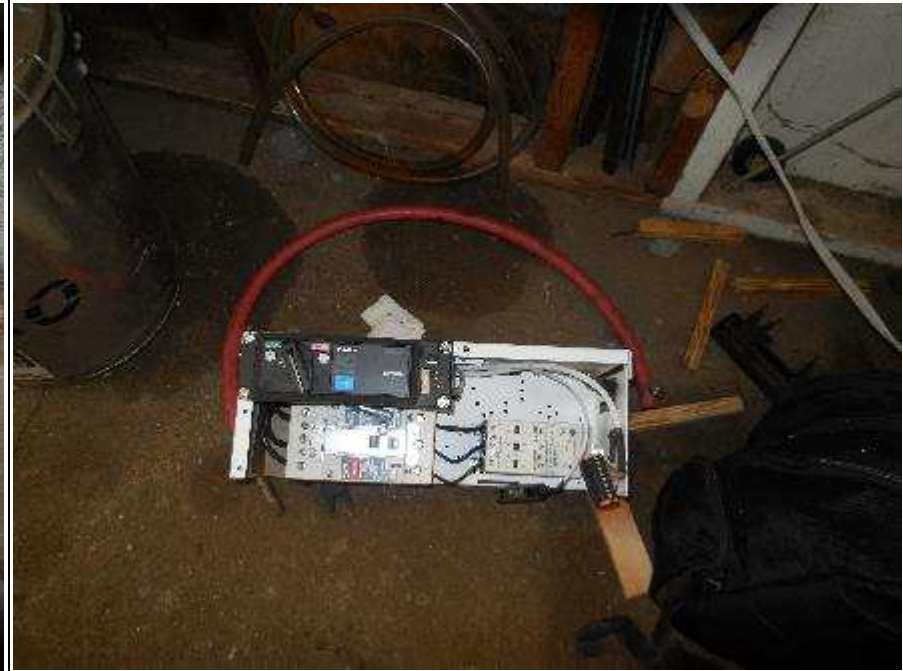
Photo E 6 Motor Brake #2 Starter

Started not installed within enclosure.

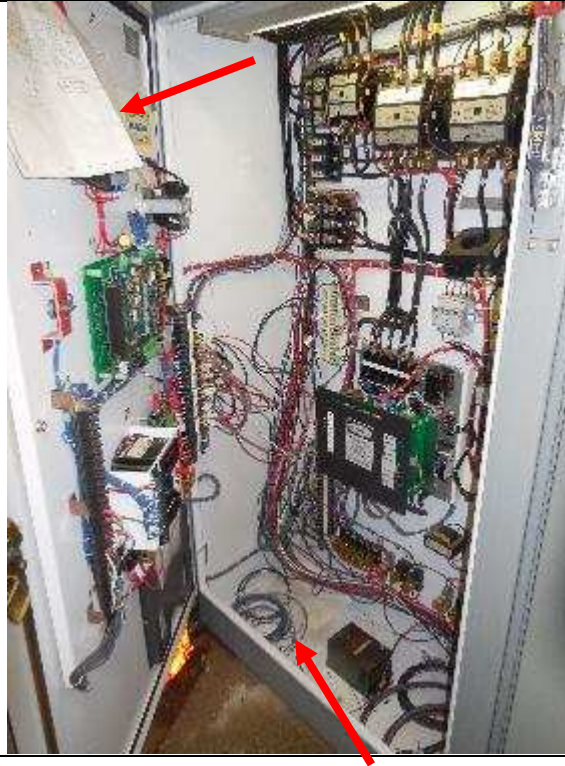
Photo E 7 Drive A Enclosure Interior  
Note loose wires and paper within enclosure.

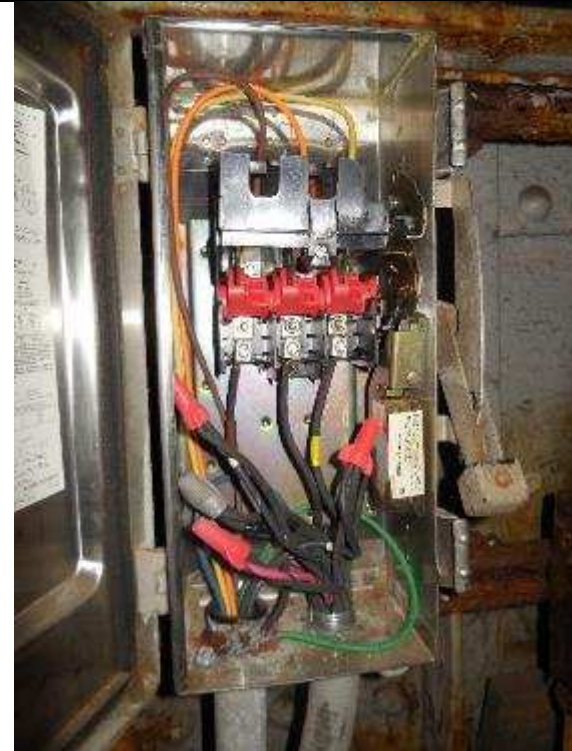
Photo E 8 Center Pier Motor disconnect Switches  
Note that corrosion on the enclosure, conduit terminals, ground and supports.

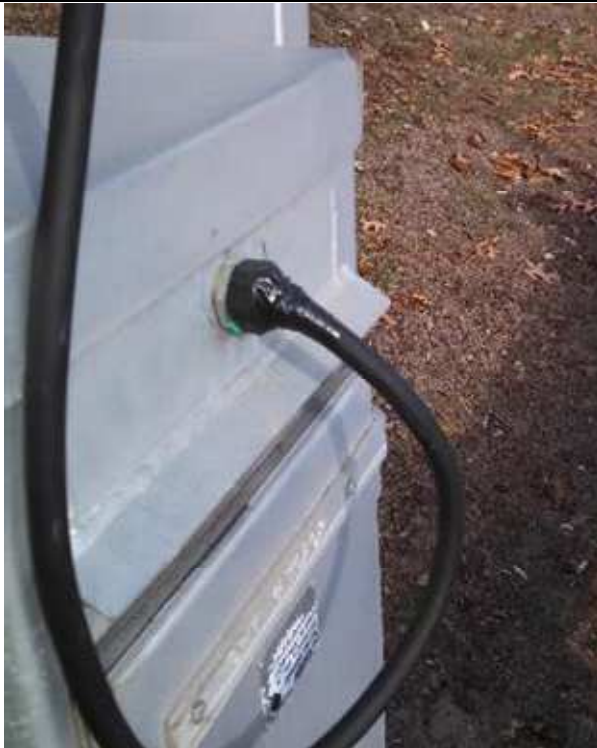
Photo E 9 East Side Oncoming Traffic Gate  
Note tape over conduit termination.

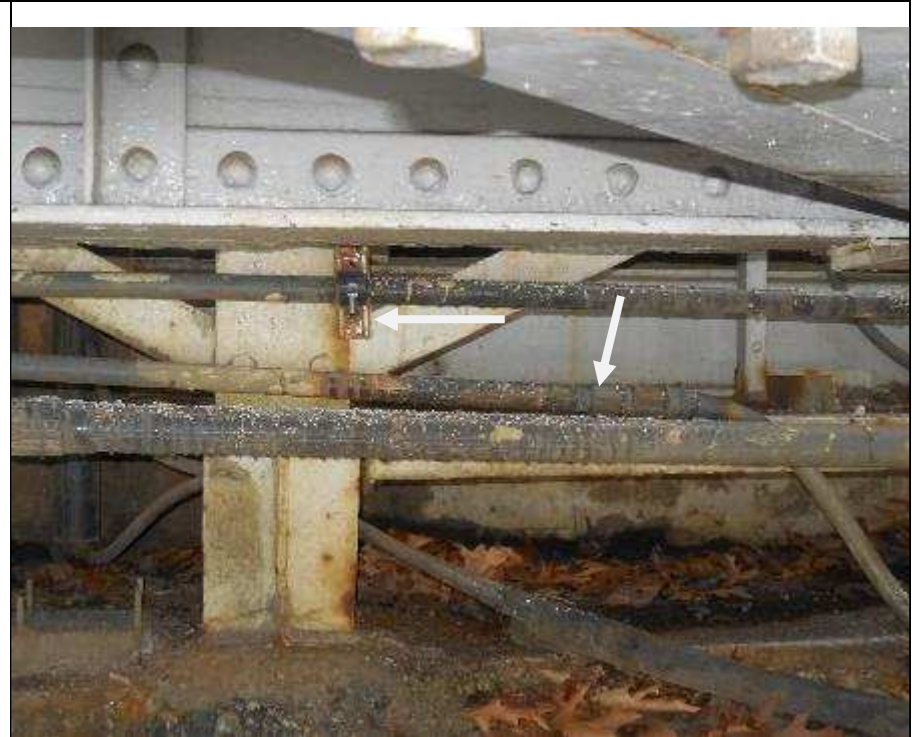
Photo E 10 East Traffic Barrier Gate Hydraulic Feeder Conduit  
Note that the conduit is not supported.

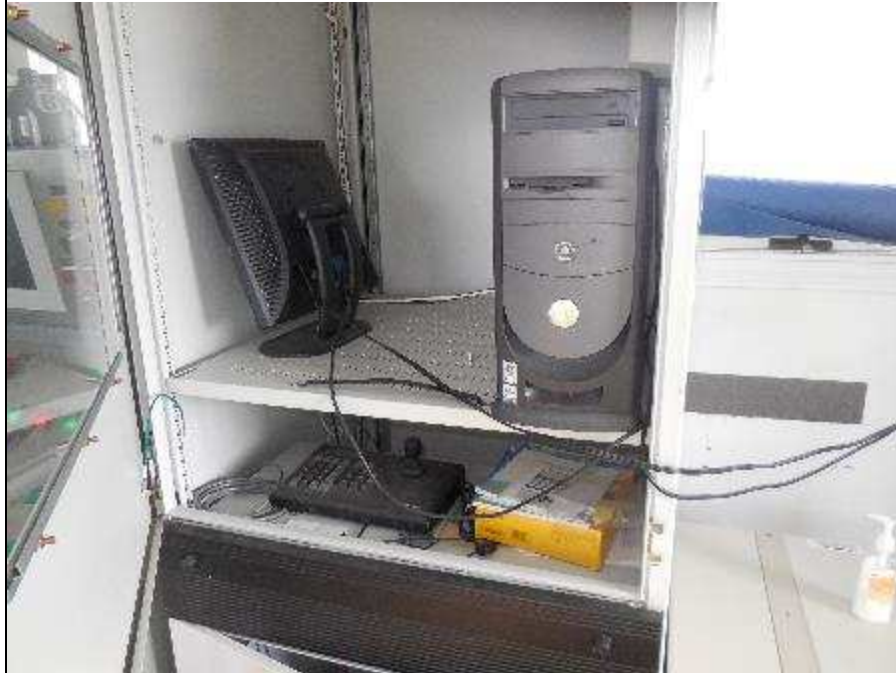
Photo E 11 CCTV Equipment Enclosure  
Note that cord closes on wires.

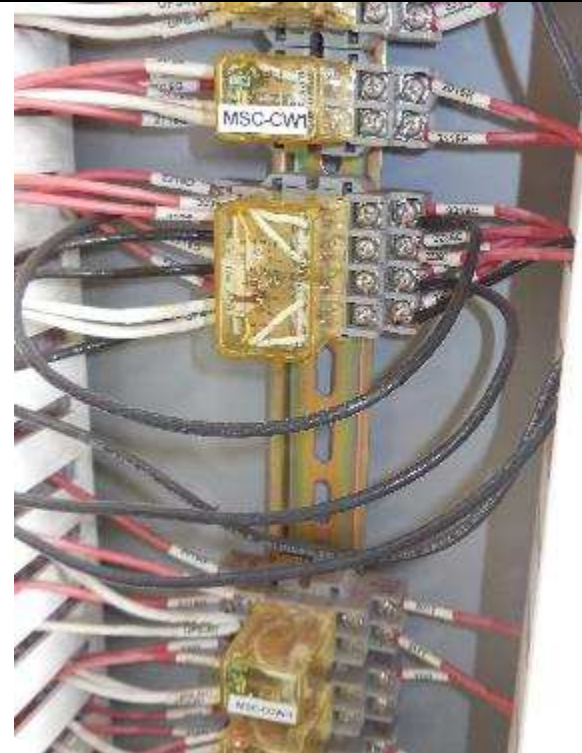
Photo E 16 Inside PLC Cabinet  
Note bypassed and unlabeled relay

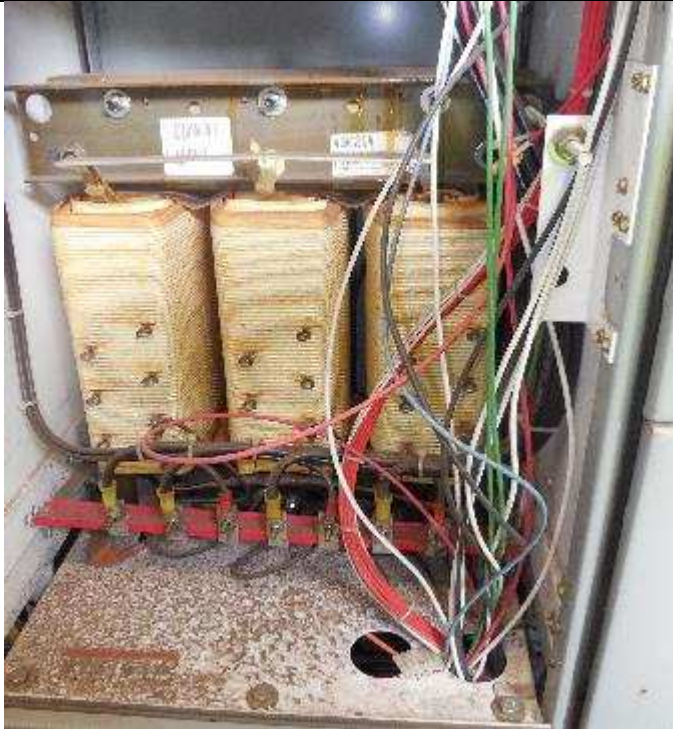
Photo E 21: Lighting Transformer within MCC  
Note dust accumulation and loose wires.

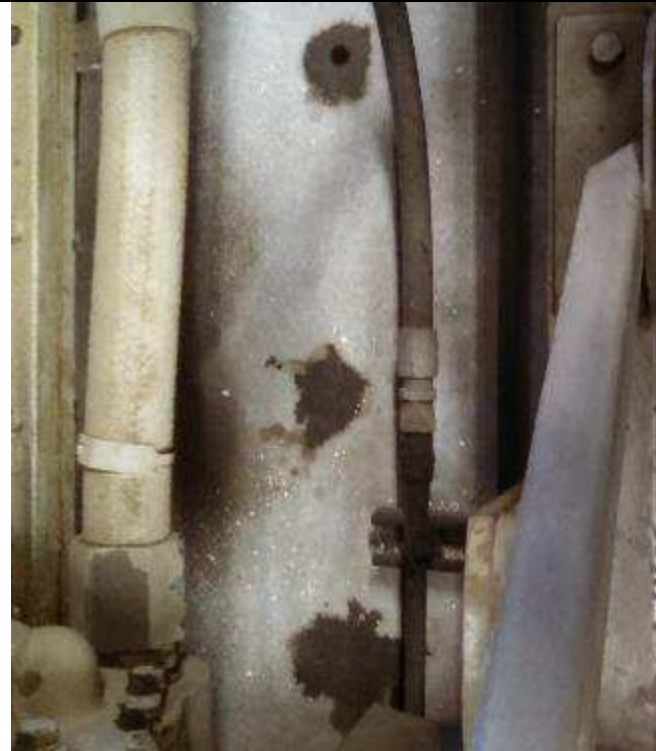
Photo E 22: Generator  
Note fluid freshly leaked during generator exercising.

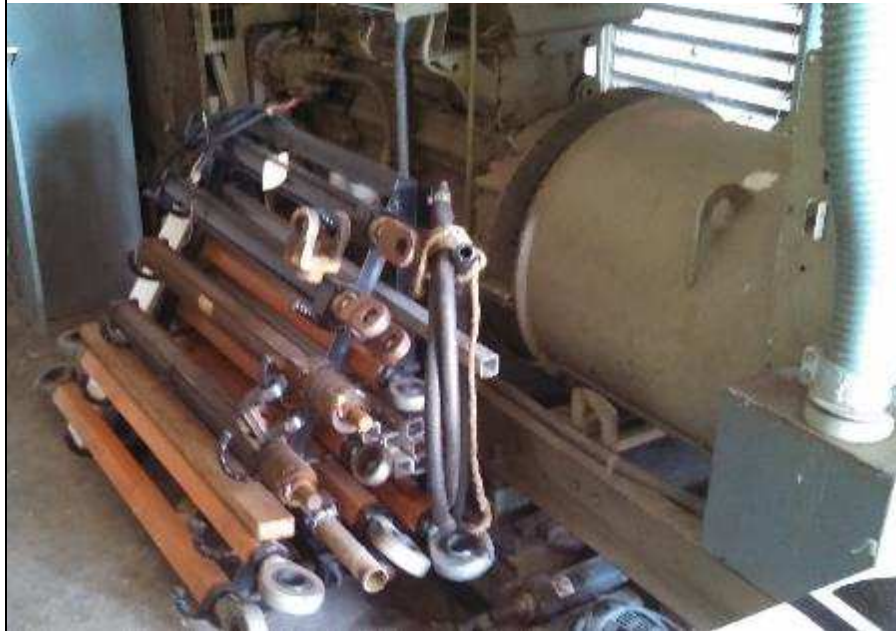
Photo E 23: Generator Room

Note items being stored around generator restrict access to the generator.

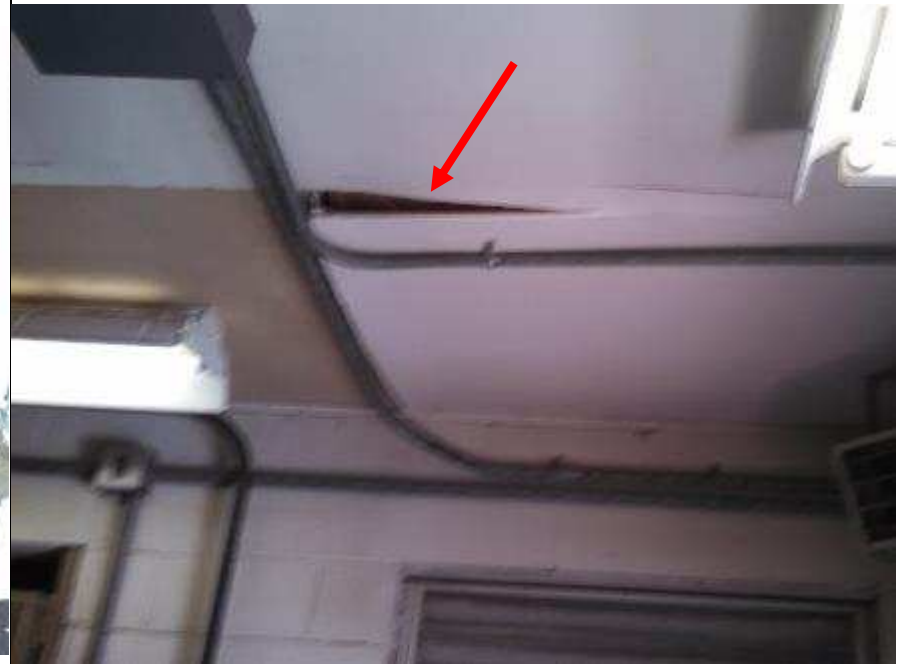
Photo E 24: Generator Room

Note conduit is supported by part of the ceiling that is falling down.

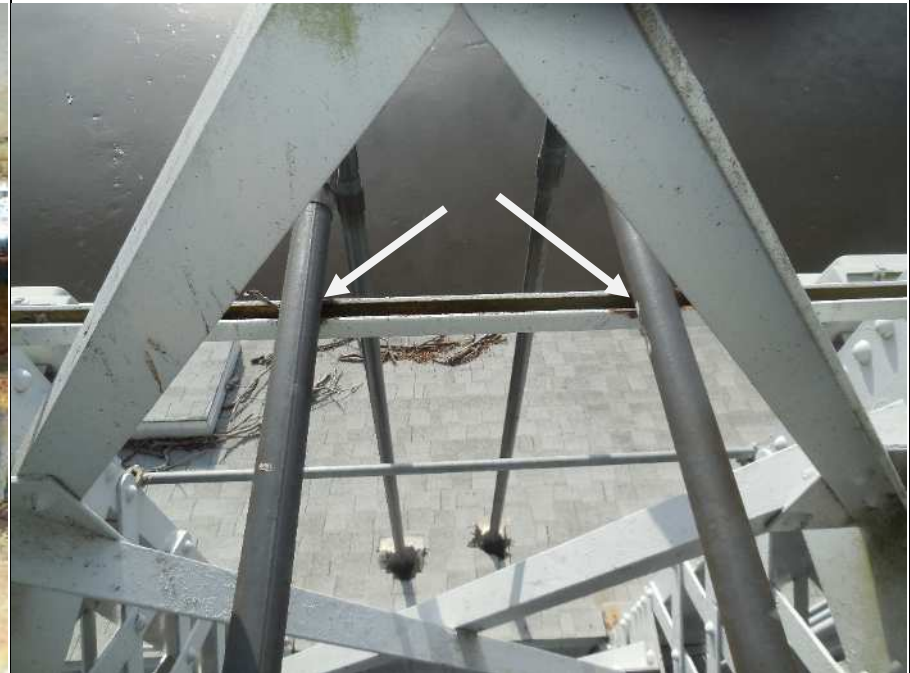
Photo E 26: Control House Platform Conduit To Secondary Resistors

Note missing conduit clamps.

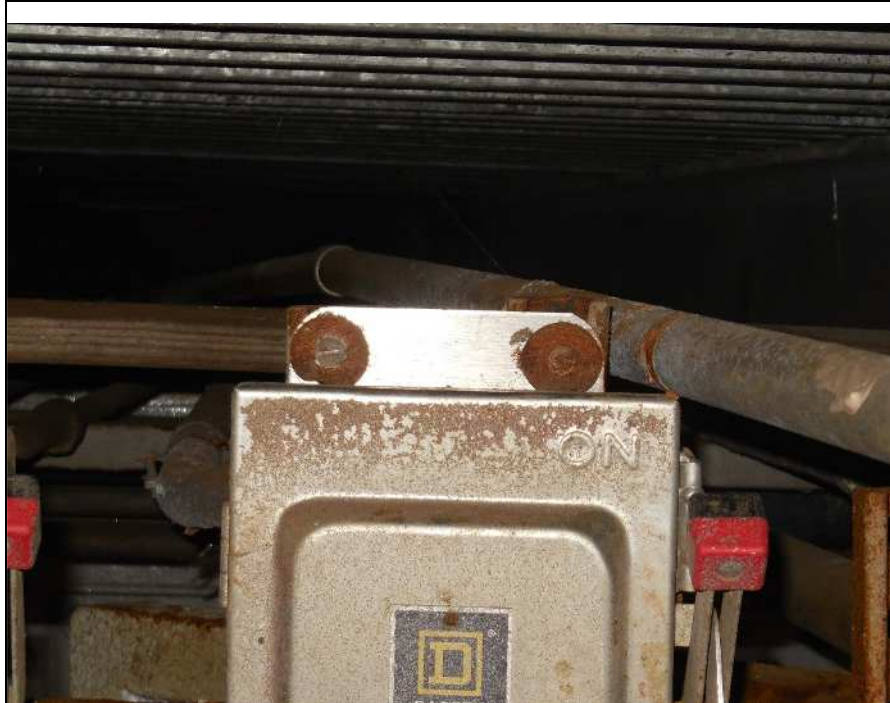
Photo E 27: West Motor Equipment Conduit Feed

Note that conduit is unsupported and starting to bend at the previous coupling.

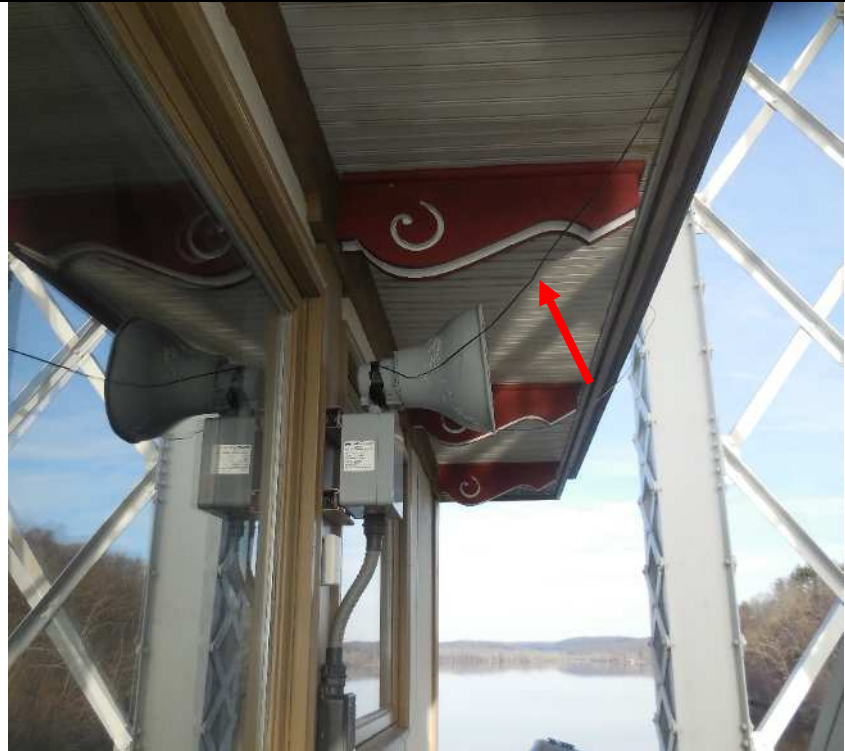
Photo E 28: Control House Weather Device

Note that the cable is missing taped to the horn and unprotected.
